# DETAILED INSPECTION REPORT

## PARTIALLY EXECUTED WORK OF MAJOR BRIDGE

**KM 28+400 OVER MAHANADI ON NH-153 RAIGARH  
SARANGARH SARAIPALI IN THE DISTRICT SAKTI  
OF CHHATTISGARH UNDER THE PWD, NH  
DIVISION BILASPUR**

**IDDC ENGINEERS PVT. LTD.**

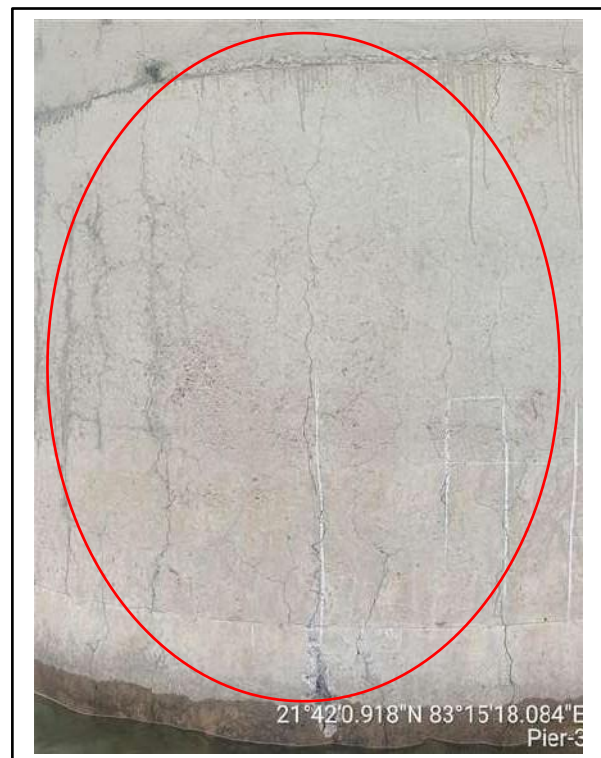
Picture-2: Cracks on pier surface.

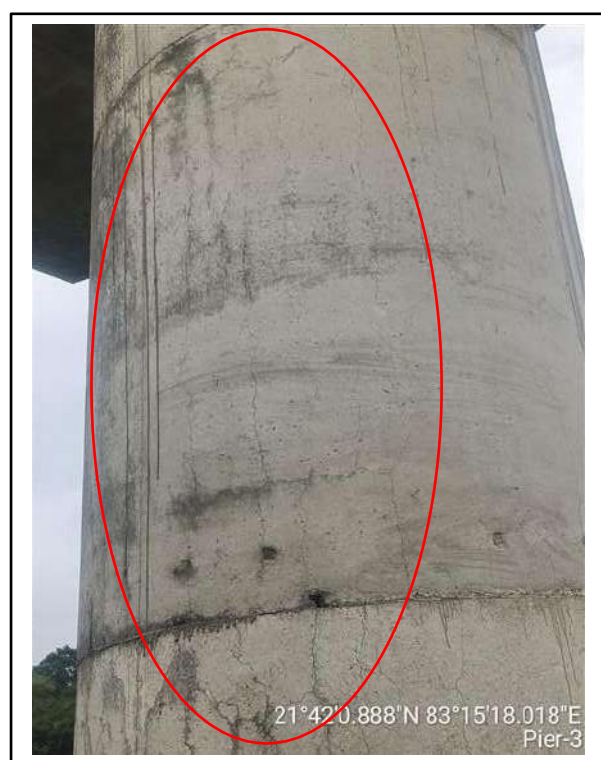
Picture-3 & 4: Cracks on pier surface

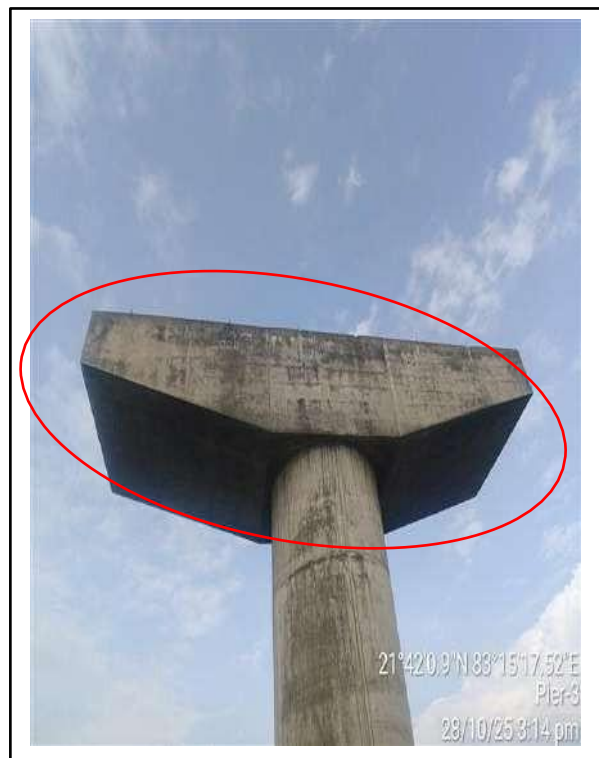
**Picture- 5 & 6: Minor cracks & leaching on pier cap.**

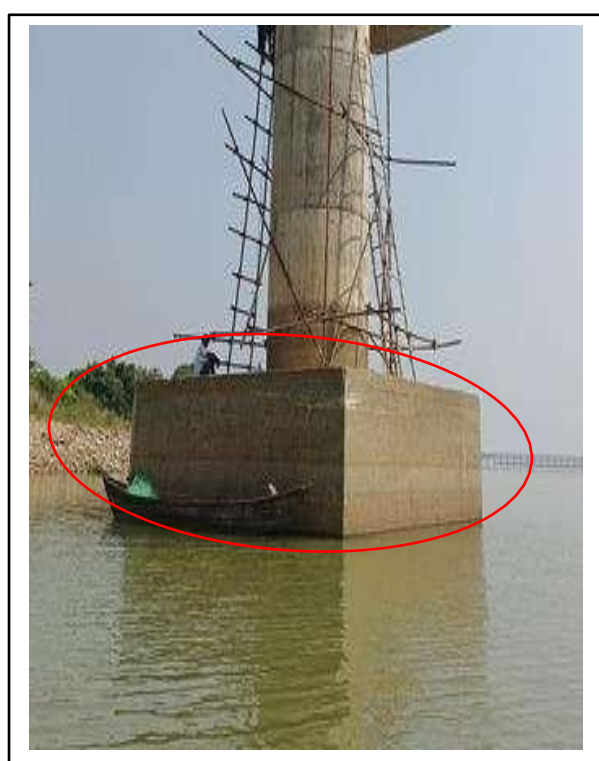
**Picture-7 & 8: Cracks on pile cap surface**

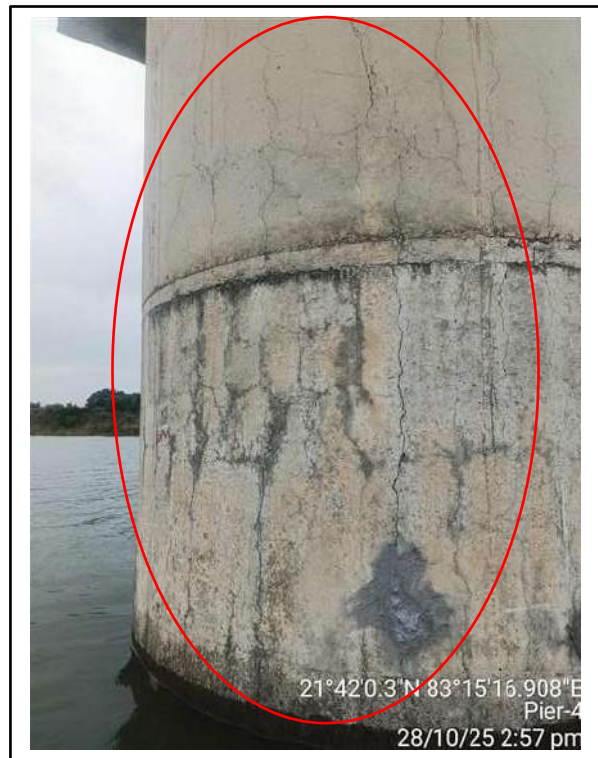
Picture-2: Cracks on pier surface.

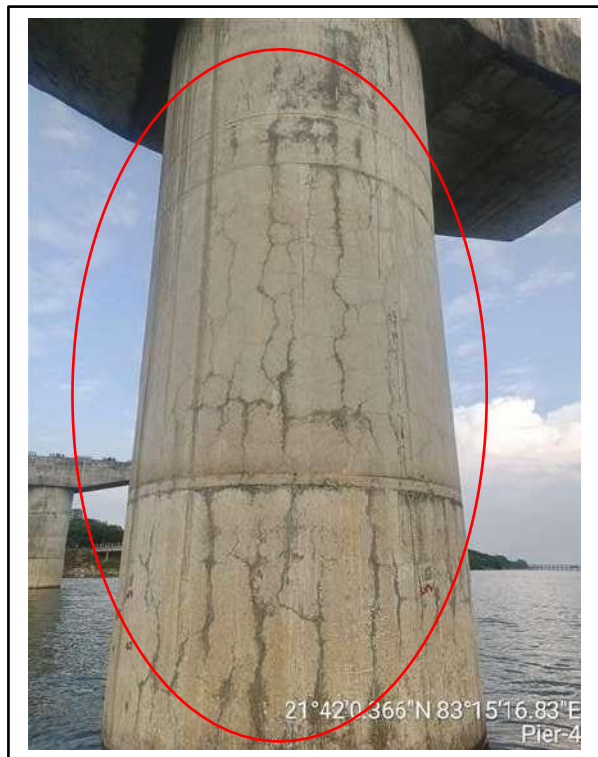
Picture-3 & 4: Cracks on pier surface

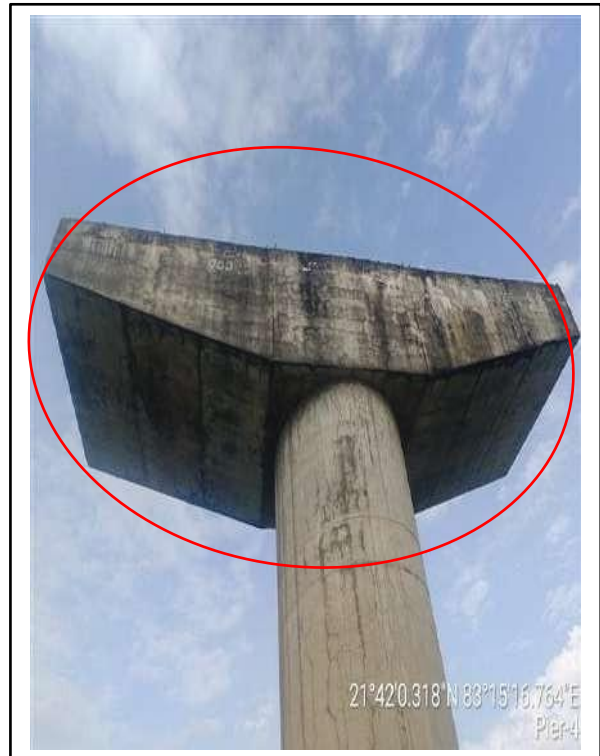
Picture- 5 & 6: Minor cracks & leaching on pier cap.

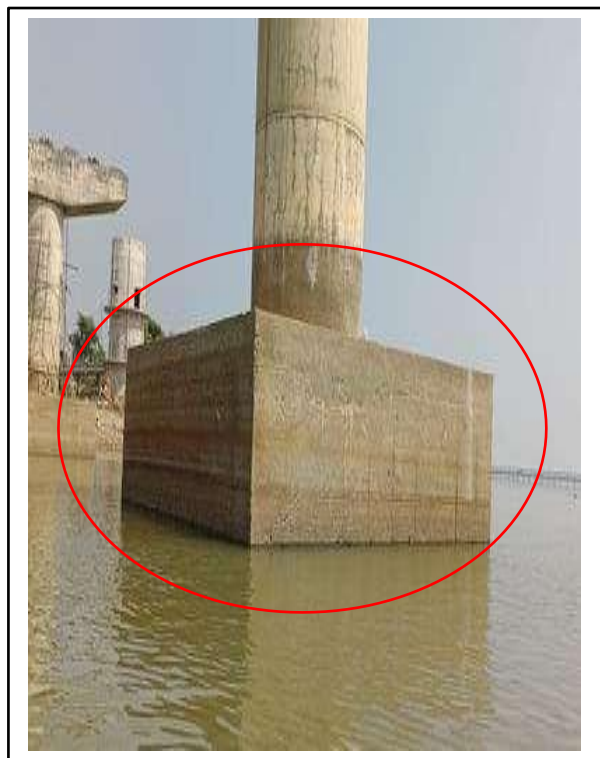
Picture-7 & 8: Cracks on pile cap surface

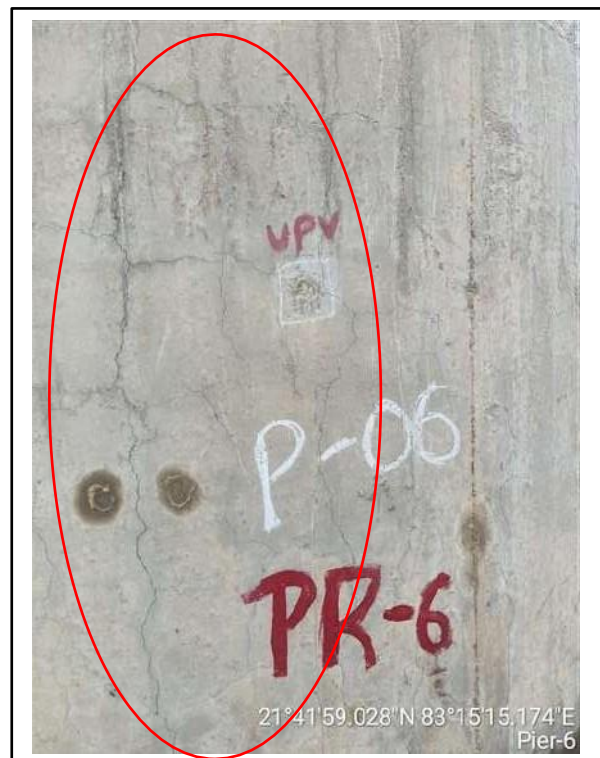
Picture-2: Cracks on pier surface

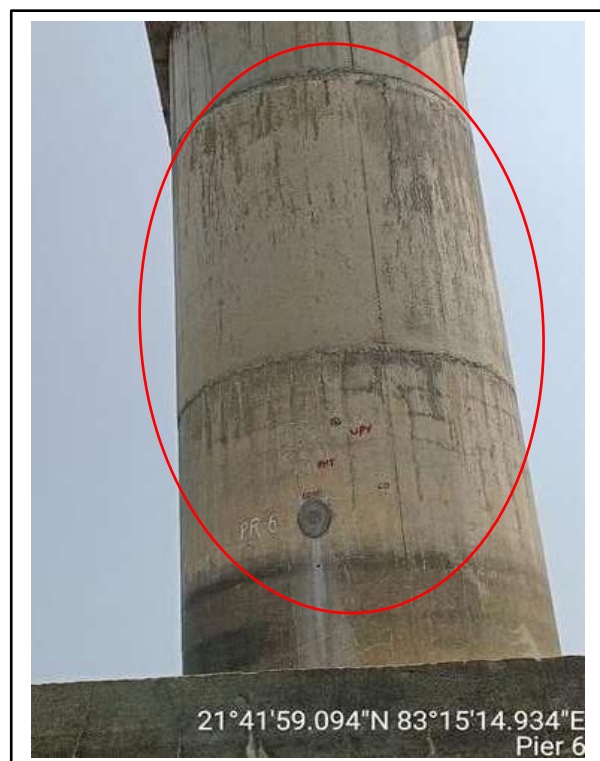
Picture-3 & 4: Cracks on pier surface

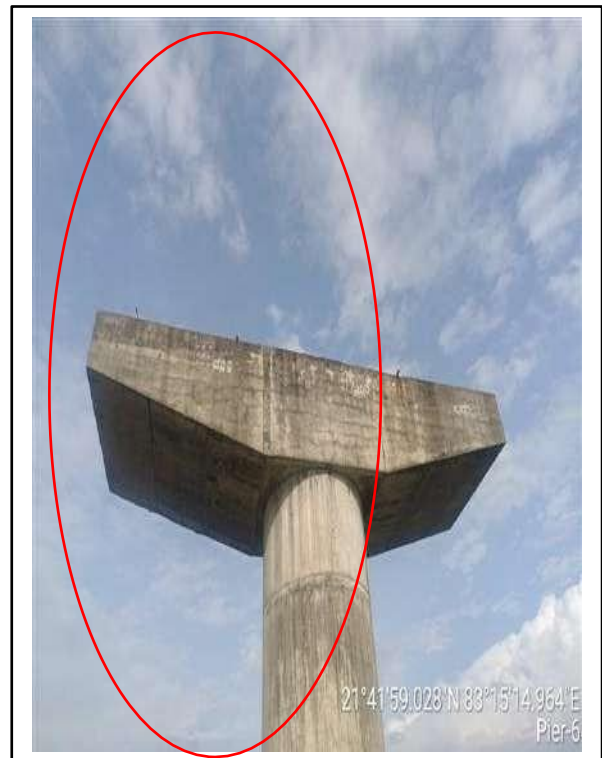
**Picture- 5 & 6: Minor cracks, leaching & efflorescence on pier cap.**

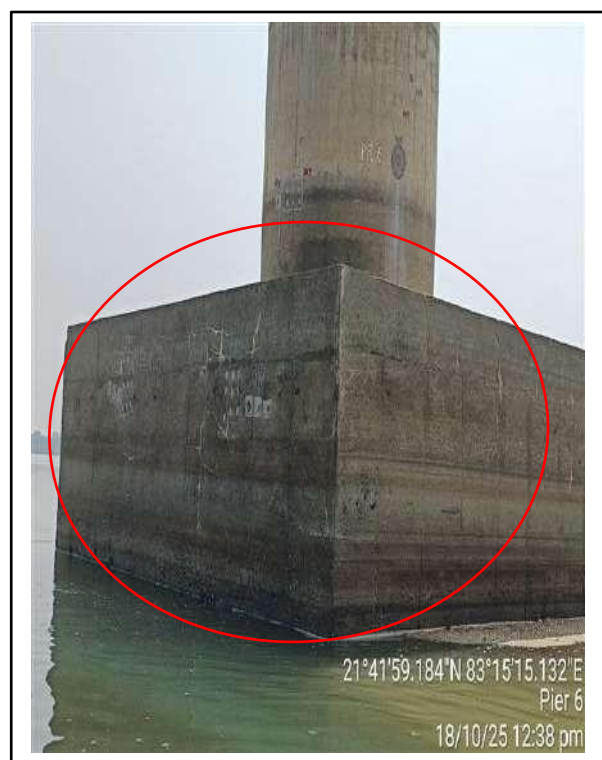
**Picture-7 & 8: Cracks on pile cap surface**

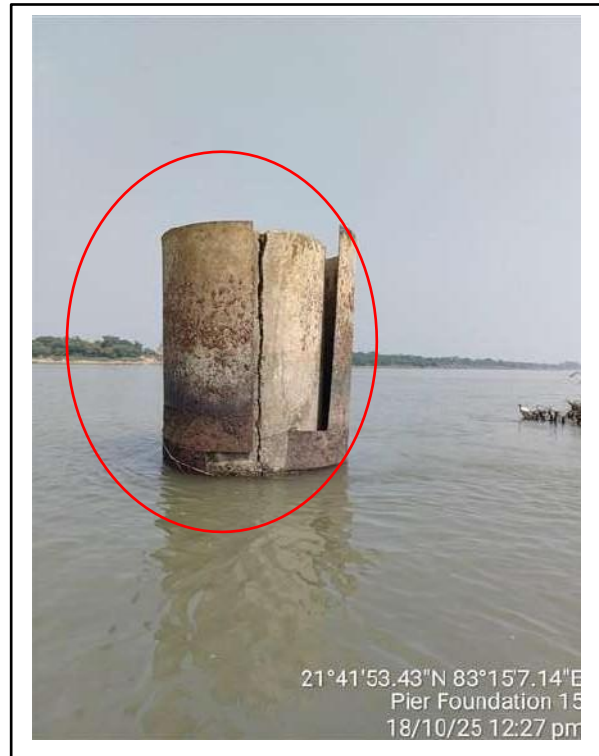
Picture-2: Severe crack on pile concrete

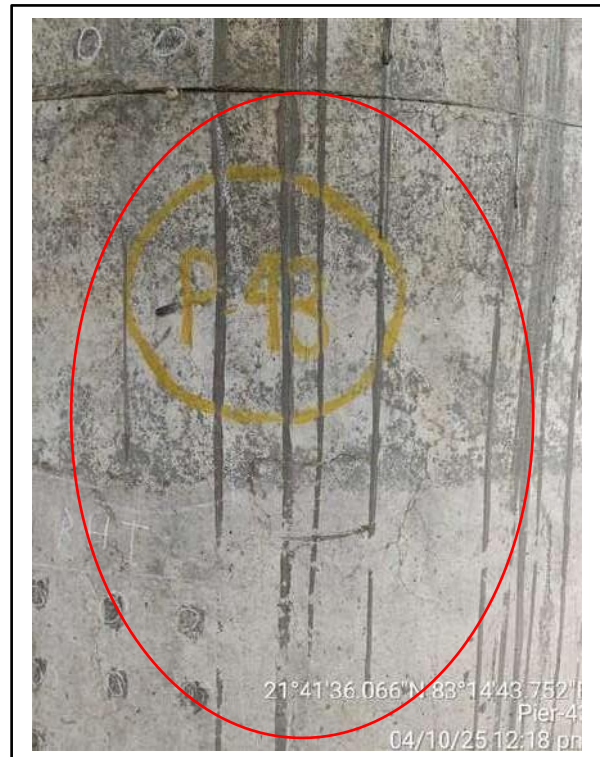
Picture-2: Cracks on pier surface.

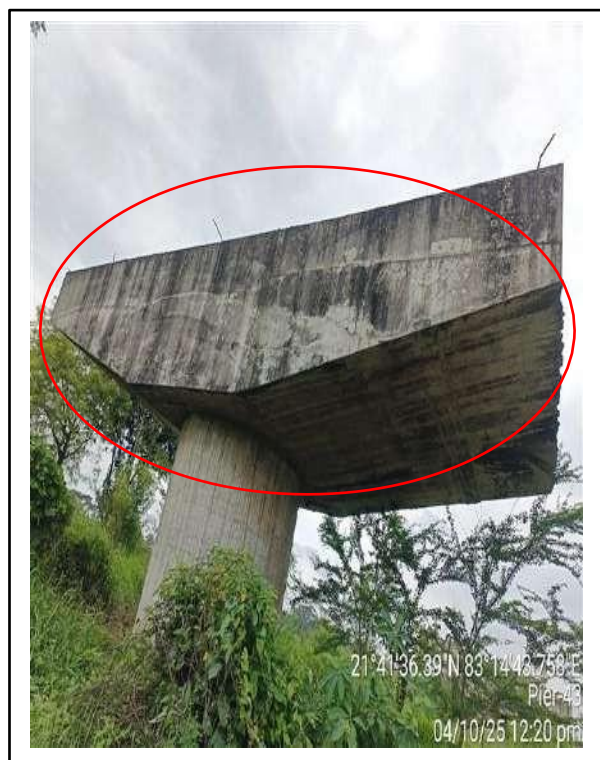
Picture-4: Leaching & minor cracks on cap

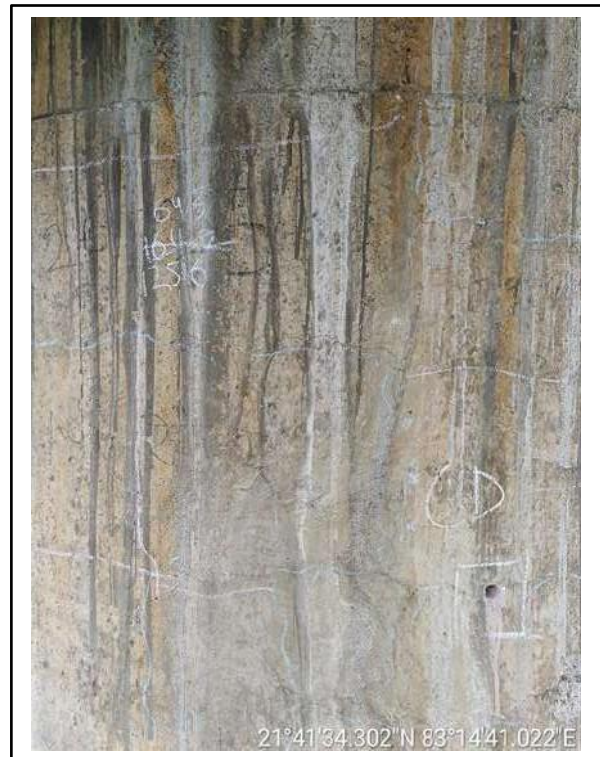
Picture-2: Cracks on pier surface.

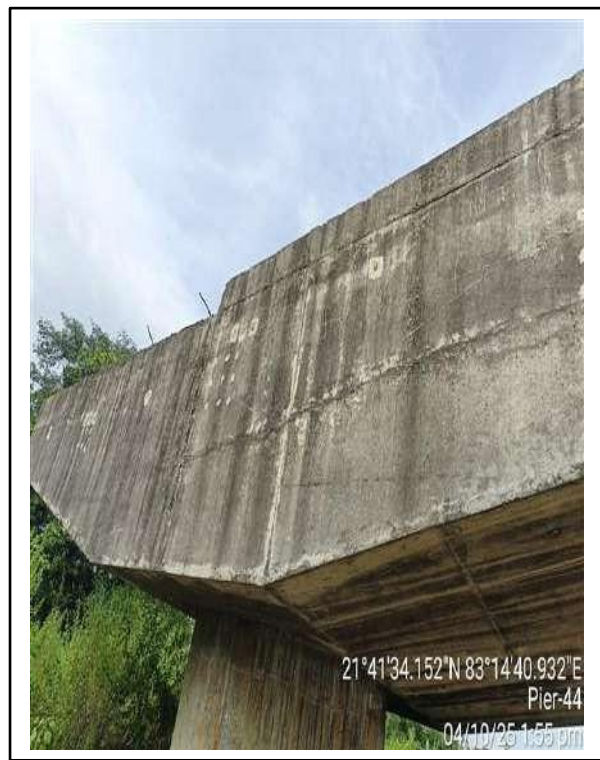
Picture-4: Leaching & minor cracks on cap

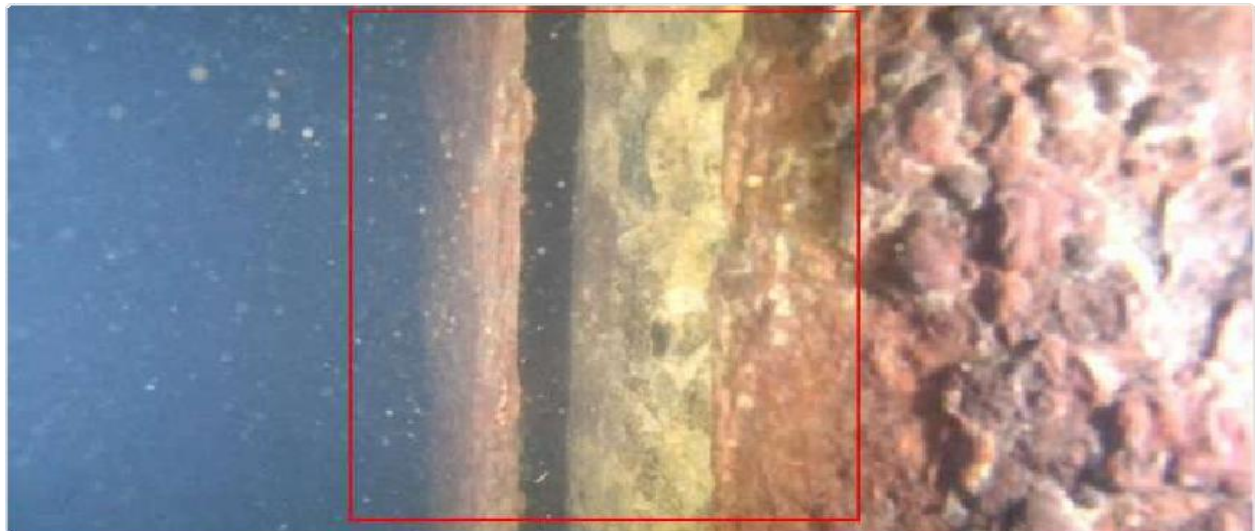
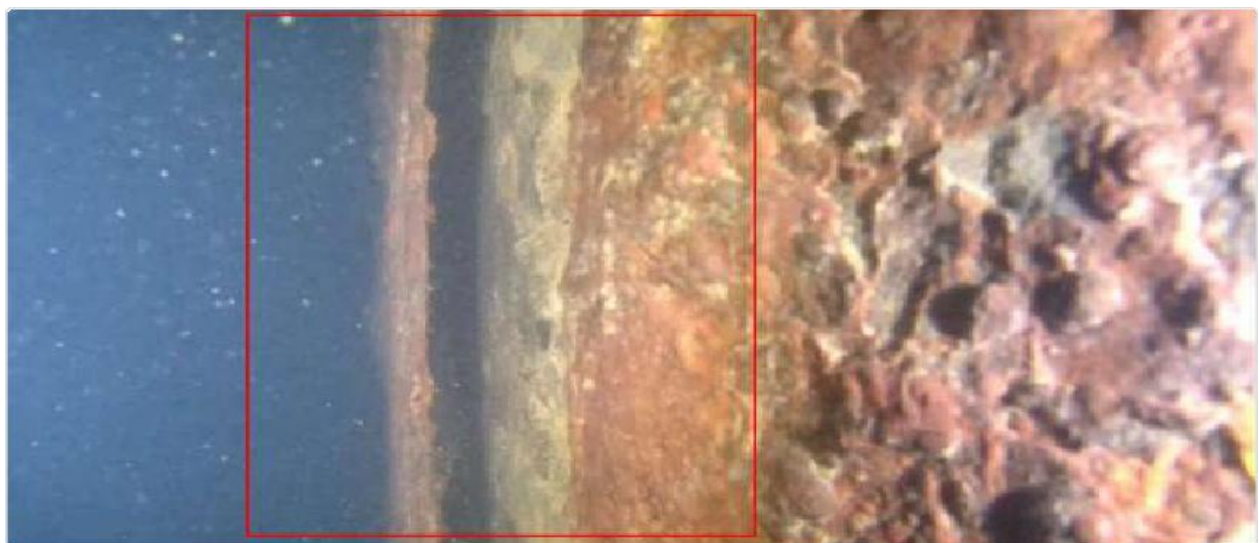
Liner Opening on Piles at various locations

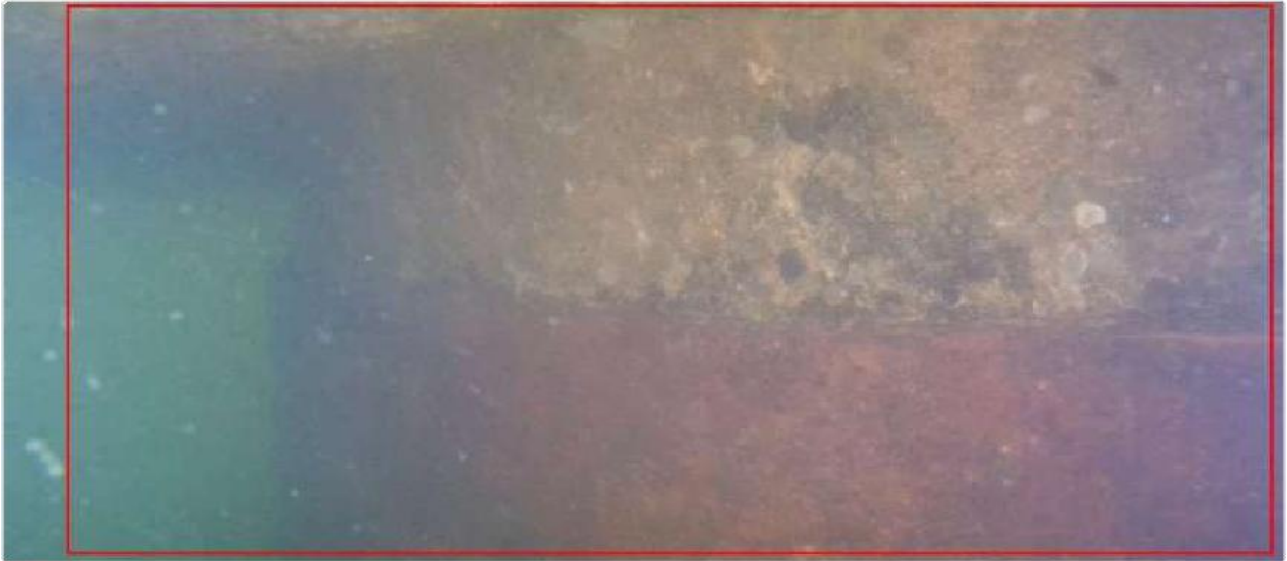
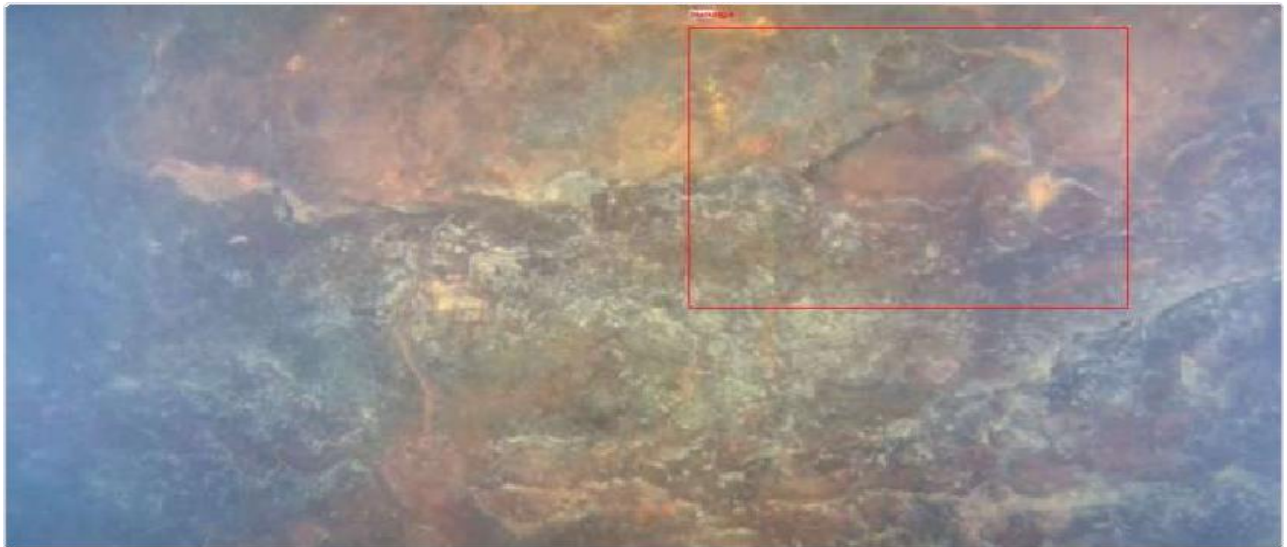
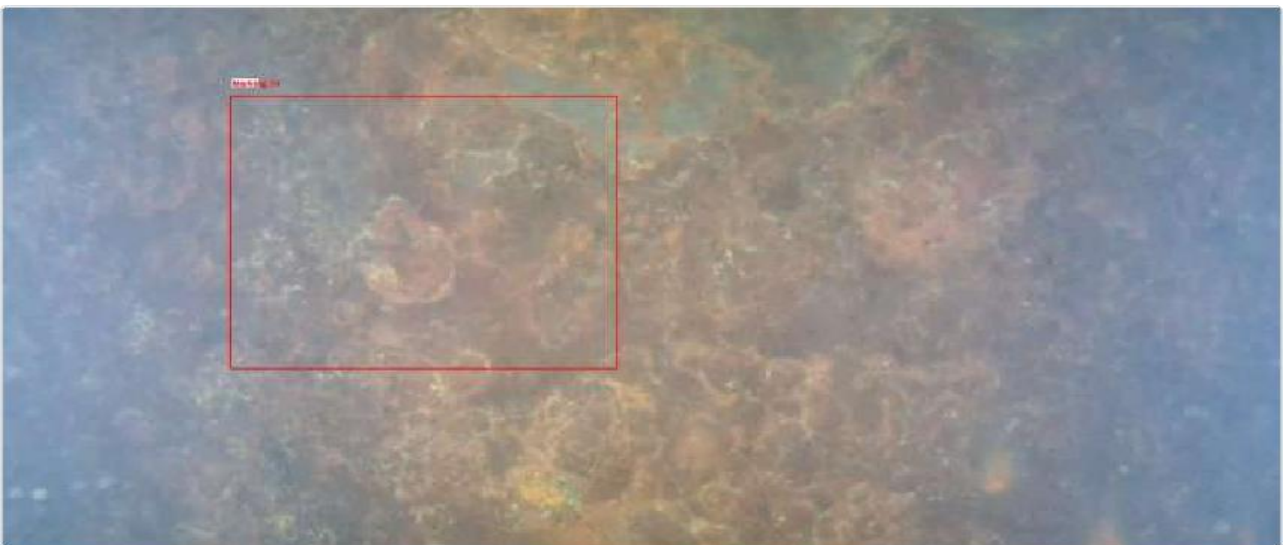
**Corrosion on Liners**

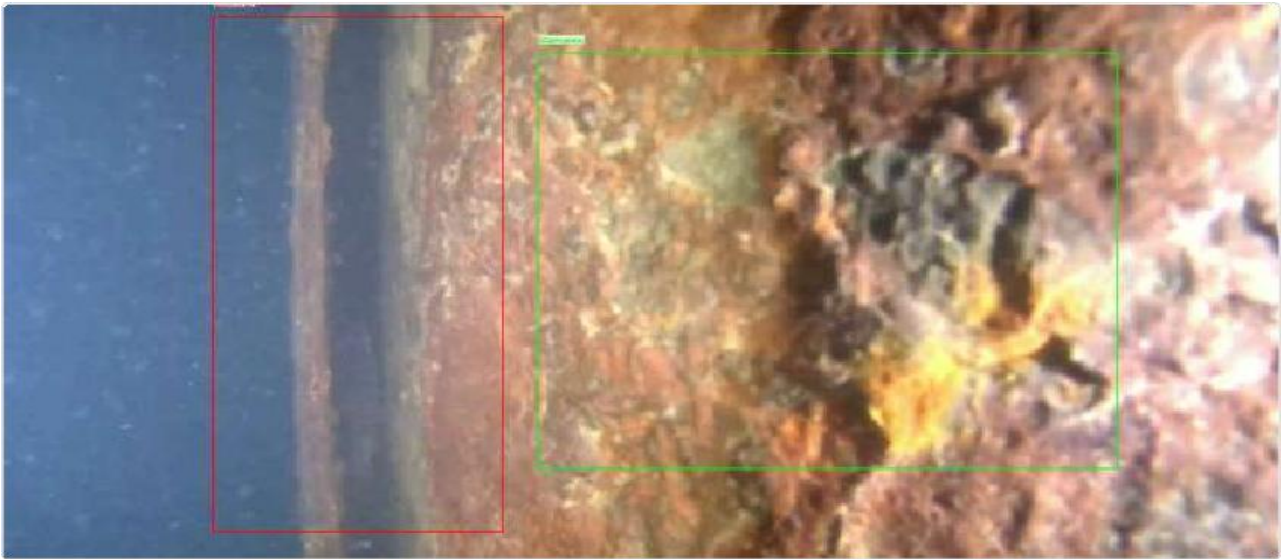
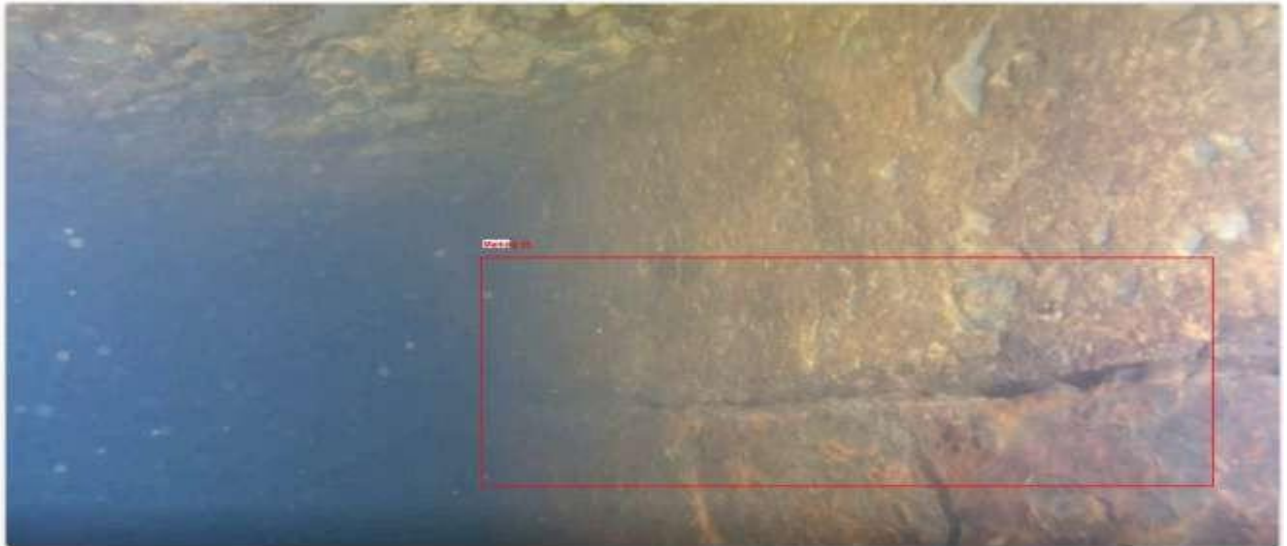
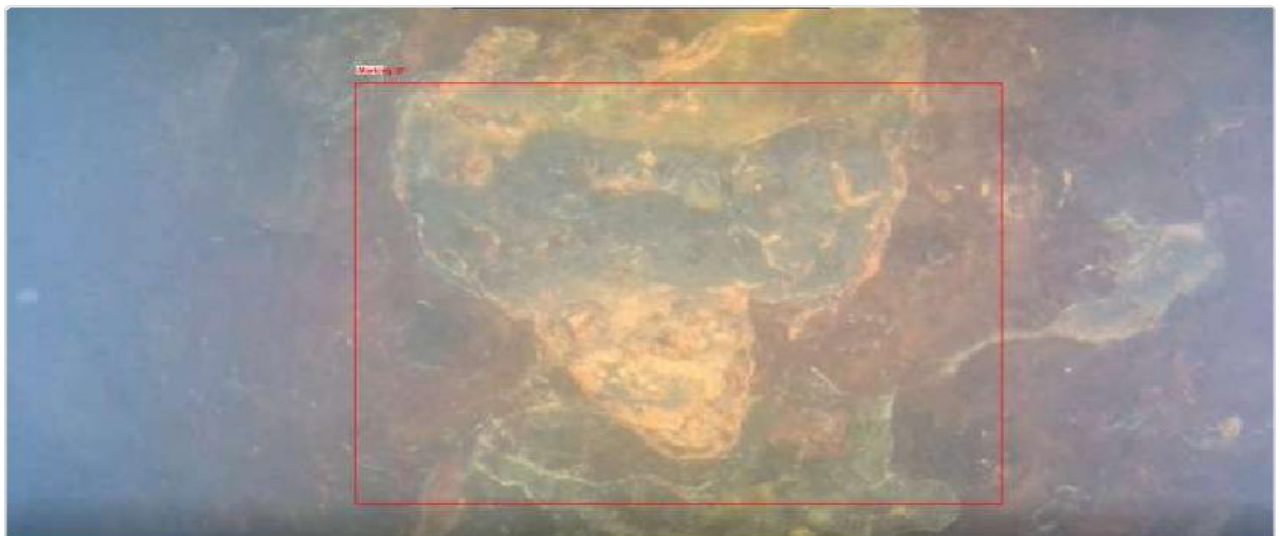
**Corrosion and Section loss observed on Piles at various locations.**

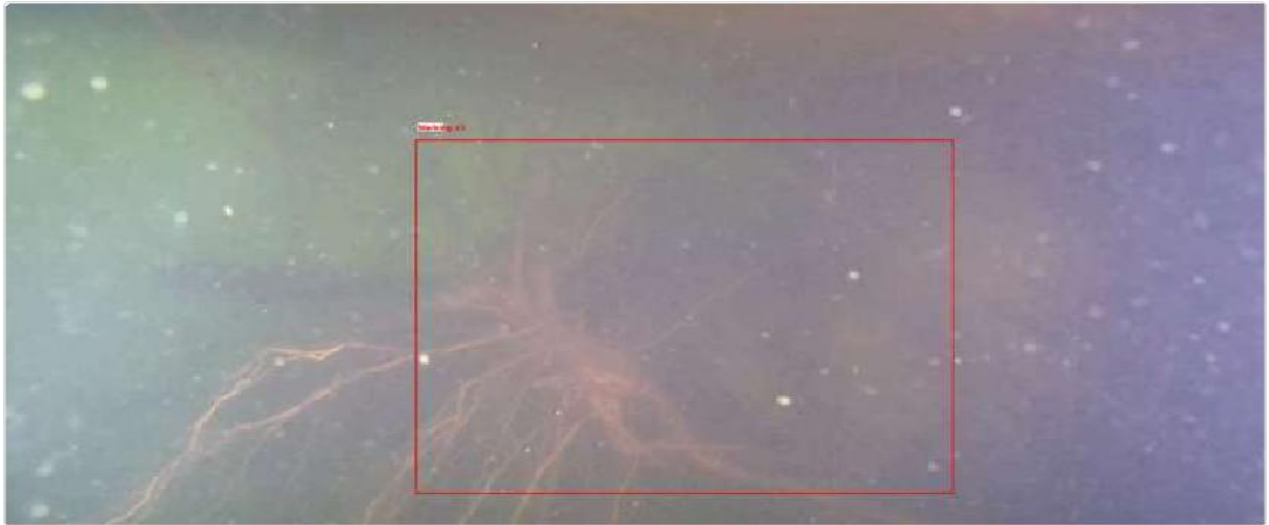
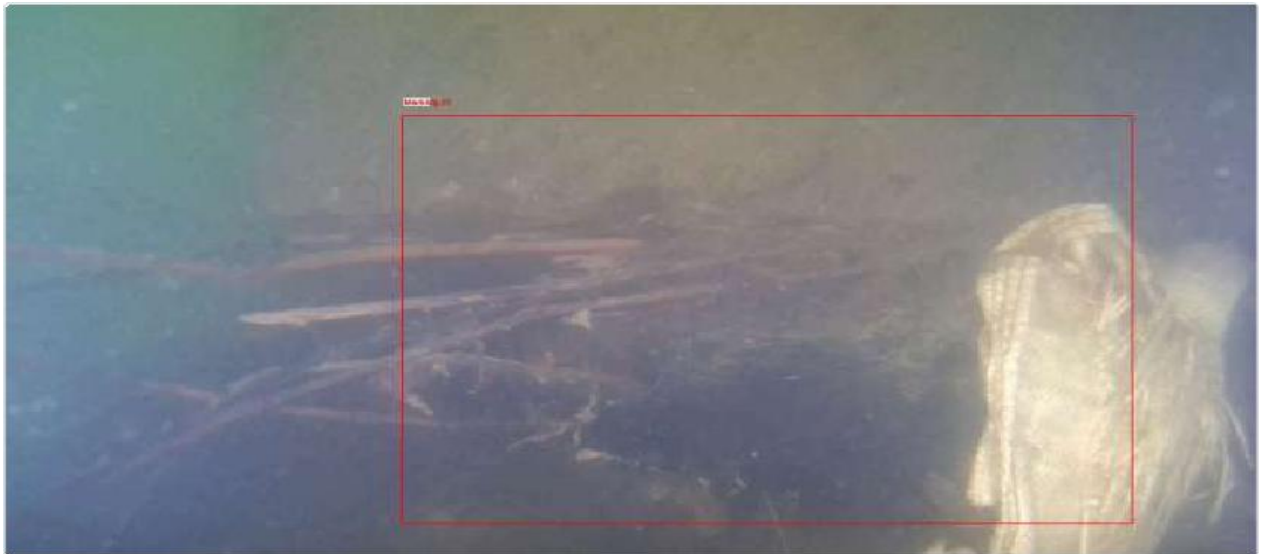
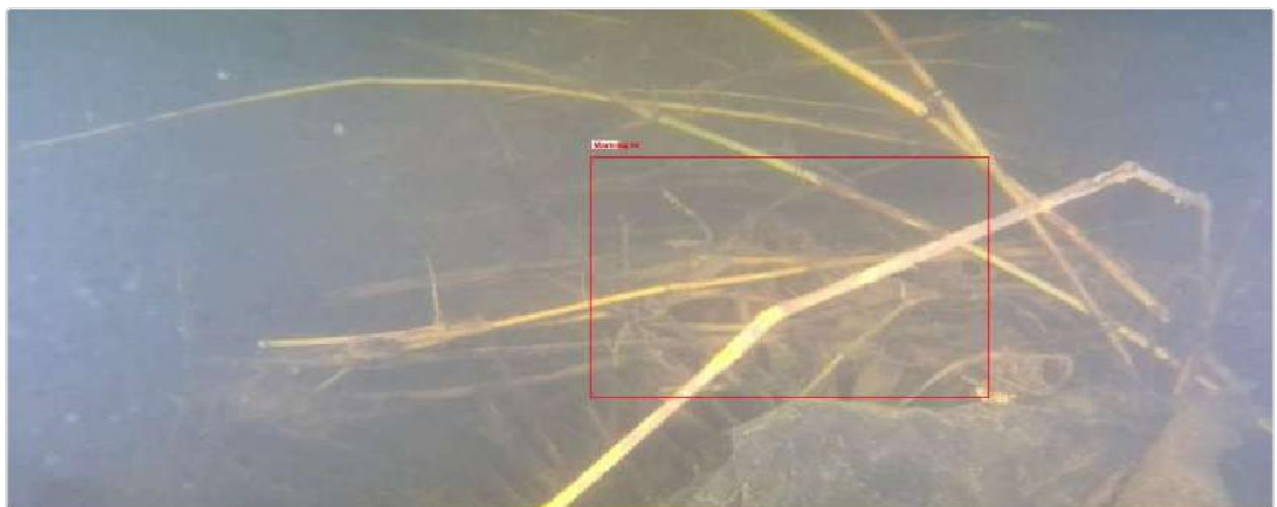
**Debris observed near and around the piles at bottom level.**
