Rehabilitation Measures of Distressed High Embankments

Four Laning of Sargaon - Bilaspur of NH-200 section (Package-III)
from km 91+026 to km 126+525 section of Raipur-Bilaspur in the
State of Chhattisgarh under NHDP-IV on EPC Mode

Project Director, PIU, Bilaspur

March 11, 2026

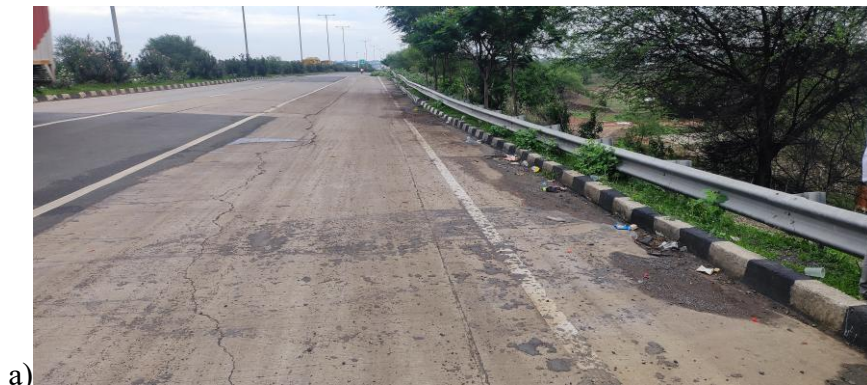
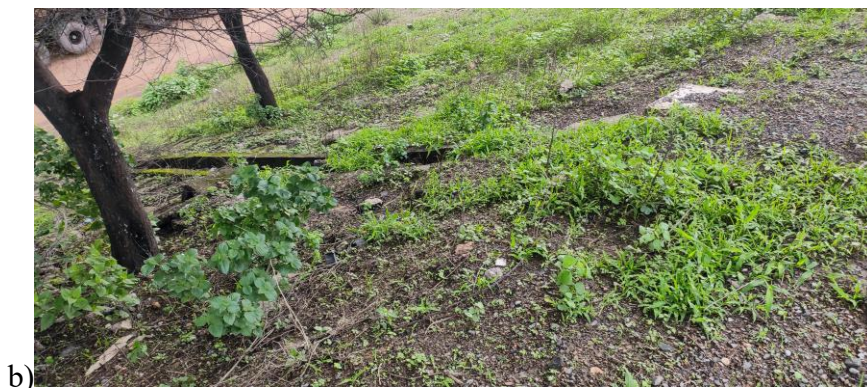
- Signs of settlement and cracking were observed at km 108+945 on A2 RHS and pavement on A2 LHS, indicating ongoing settlement and potential slope deformation.
- At km 118+650 (A2 LHS), a shallow slope failure with significant surficial slope movement, and the failed slope remains unrepaired.
- At km 123+050 (A1 LHS), settlement of concrete block pitching and a vertical crack indicate slope surficial movements; similar distress has reportedly occurred in nearby locations.

Figure 1 Observations: a-b) signs of settlement at embankment km 108+945; c-d) slope failure at embankment km 118+650; e-f) slope failure at embankment km 118+650; g) signs of surficial slope settlement and failure at embankment km 123+050

erosion protection measures using geocells (100 mm depth and specifications as per IS 17483 part-2) filled with concrete and sufficiently anchored, to prevent further erosion of the slope surface. All erosion protection measures should be continuous and extend up to the cement concrete (CC) pavement, ensuring that no gaps are left between the pavement edge and the slope protection system.

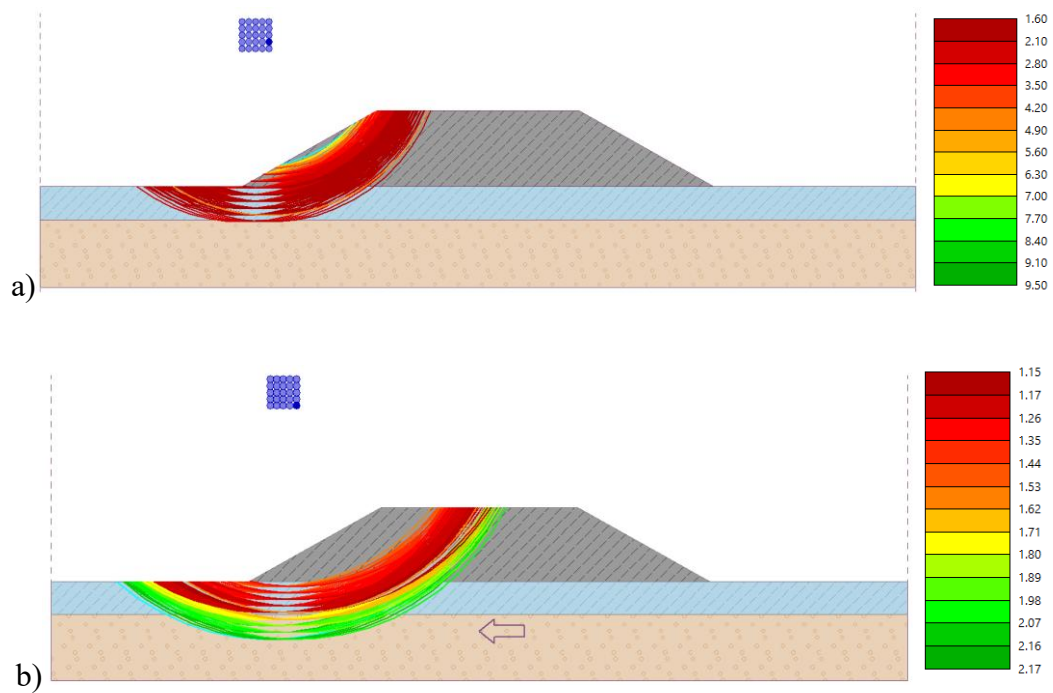
Figure 3 Results of slope stability analysis of maximum height (~11.5 m) embankment

- Stability analysis indicates that the overall stability of the embankment slopes remains within acceptable limits under both static and seismic conditions. However, the observed surficial failures and erosion-related distress require localized stabilization measures to prevent further progression.
