Report on  
Rehabilitation Measures of Distressed RE Walls  
of project

**Four Laning of Sargaon - Bilaspur of NH-200 section (Package-III)  
from km 91+026 to km 126+525 section of Raipur-Bilaspur in the  
State of Chhattisgarh under NHDP-IV on EPC Mode**

**Project Director, PIU, Bilaspur**

**National Highways Authority of India**

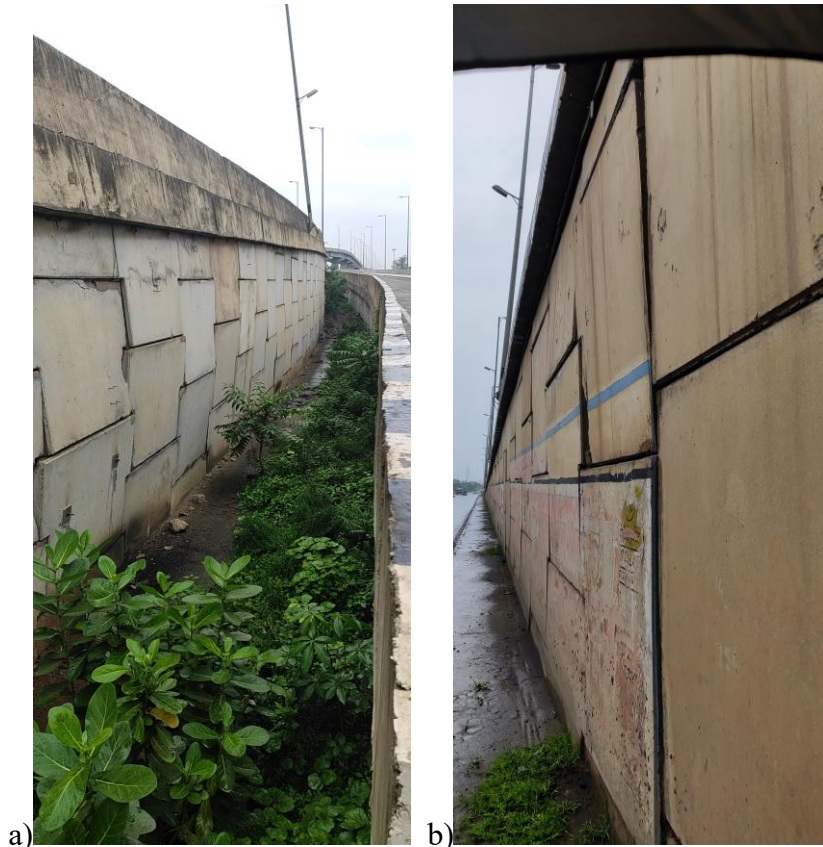
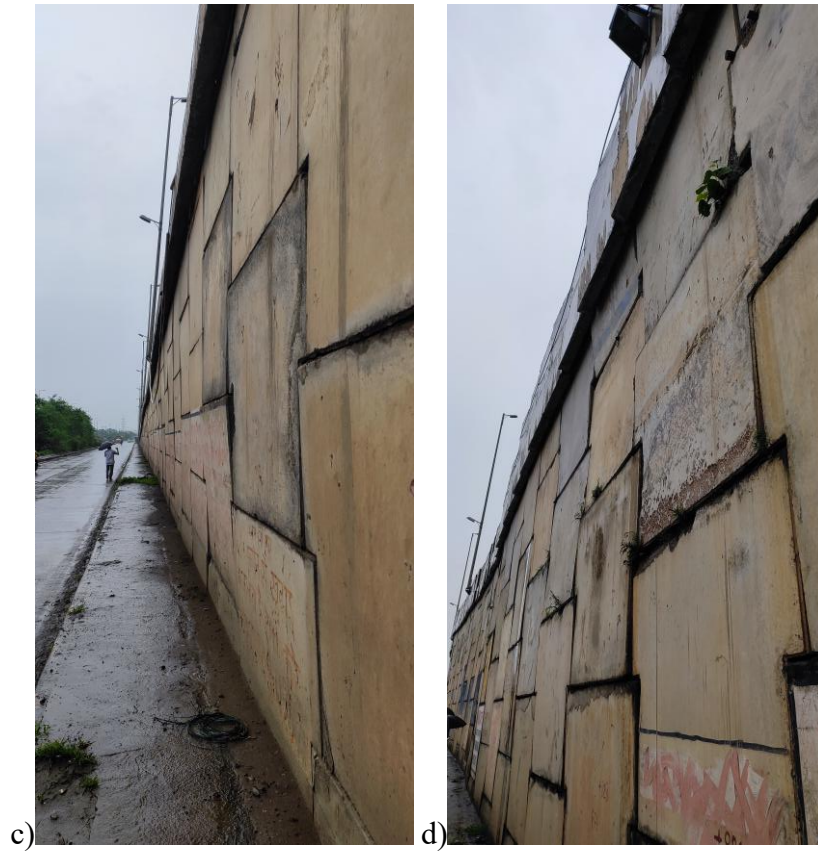
Figure 1 Photographs depicting bulging of RE wall at km 106+224

- Significant bulging of RE walls (km 106+224 (Figure 1); km 102+570 (Figure 2); km 96+426 (Figure 3); km 91+861 (Figure 4)) was observed across multiple chainages, with many locations displaying 10 m to 30 m stretches of distress. In multiple locations, panels were seen displaced 10 cm to 15 cm (relative to adjacent panels), indicating severe distress and critical condition of these walls.
- Soil nailing, wherever done, was found to be inadequate, with only one or two nails per panel in many locations.
- Cracks/crushing in panels and local surface settlement at several locations.
- Cracks and open joints in the CC pavement at the top of the wall were observed, allowing water to ingress into the wall system

**From investigations, bulging observed in the RE walls is predominantly attributed to the use of non-select, high fine-content plastic soil as backfill material. The relatively low shear strength and stiffness characteristics of the backfill soil have resulted in excessive lateral deformation, leading to pronounced bulging of the wall facings. This condition is further aggravated by settlement of the underlying clayey foundation soil.**

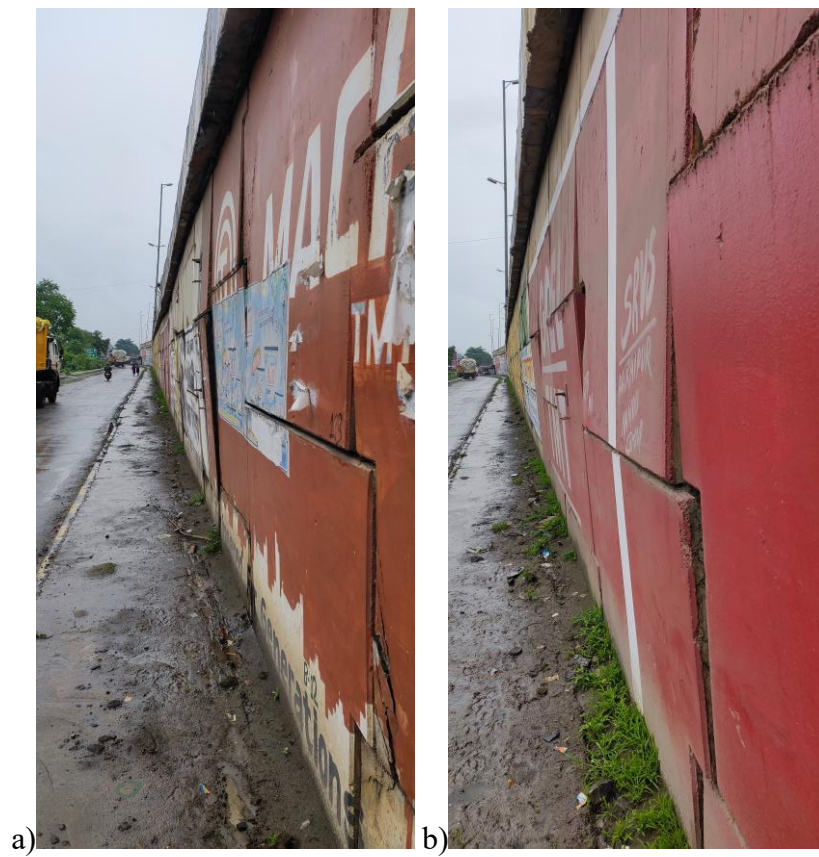
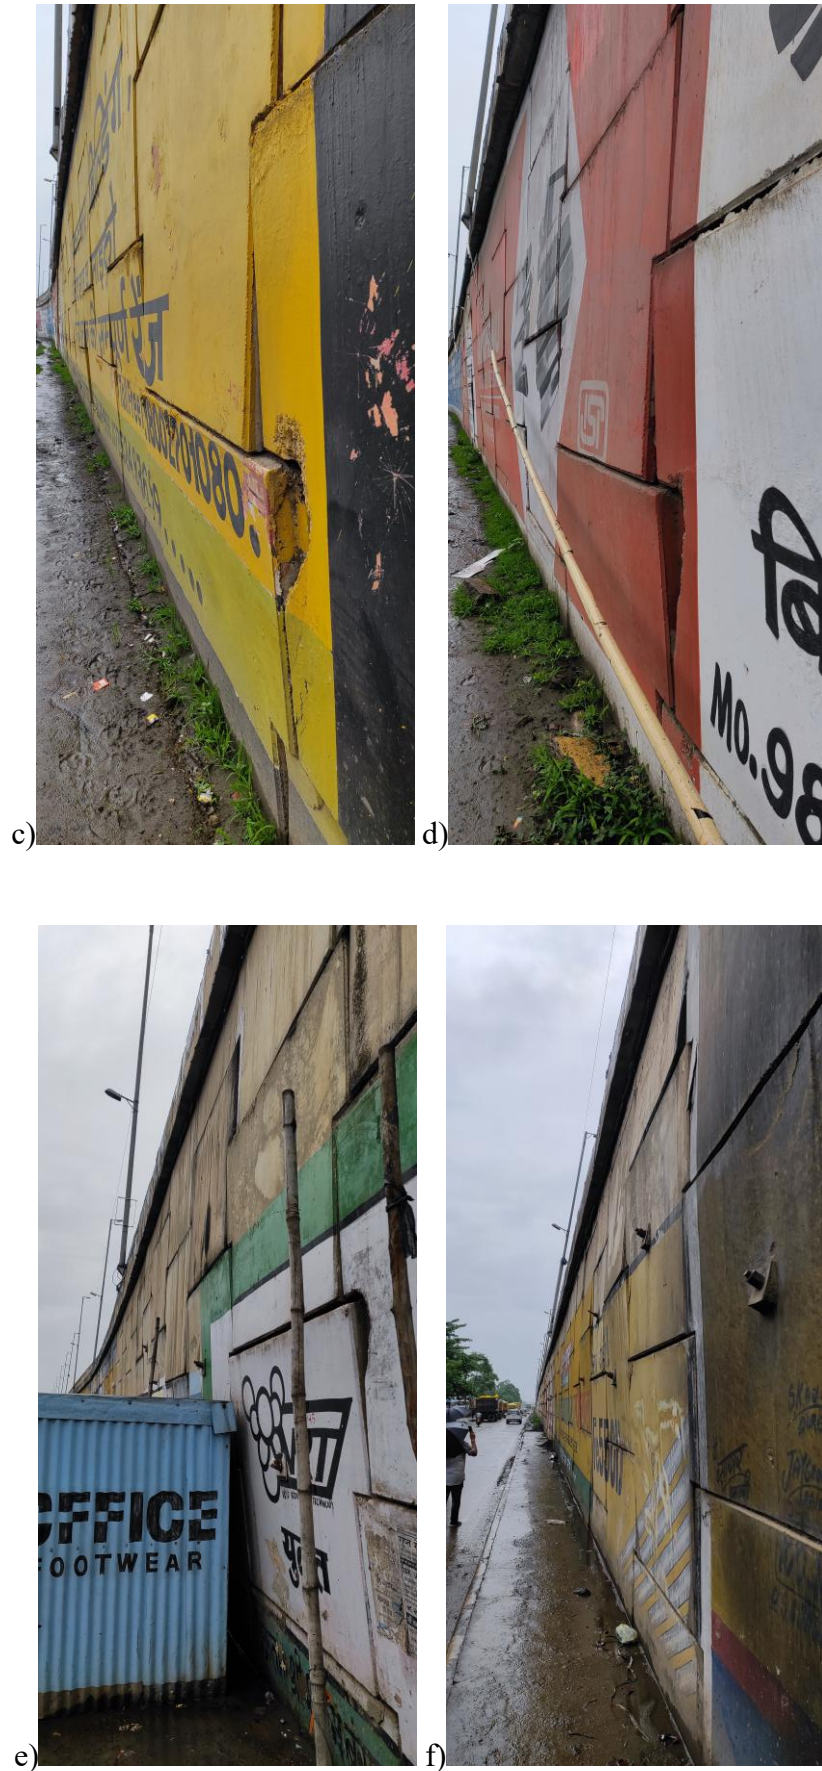
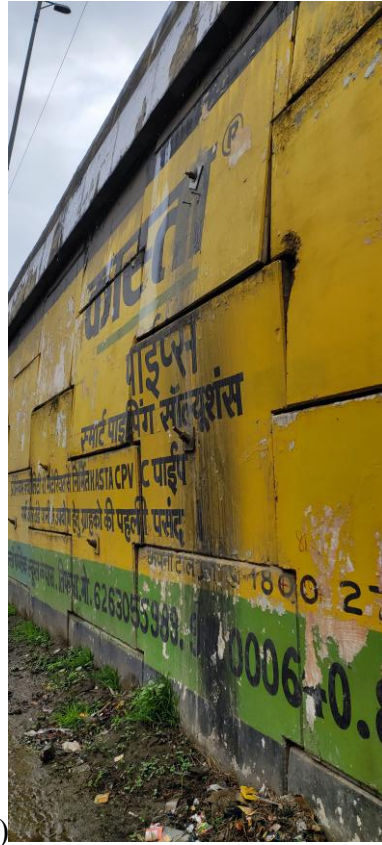
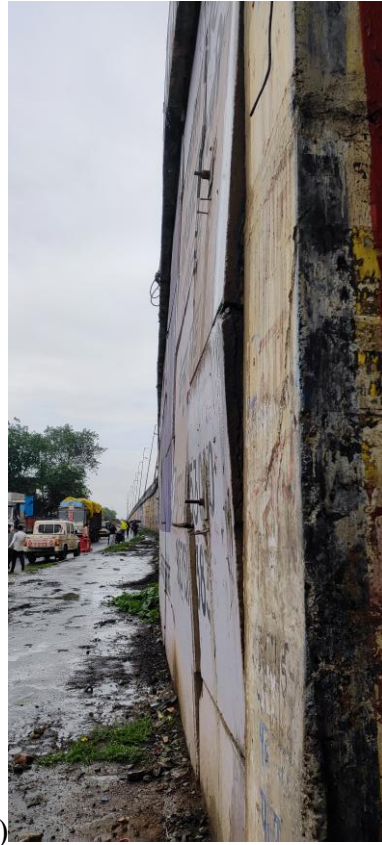
Figure 2 Photographs depicting bulging of RE wall at km 102+570

Figure 2 (Continued) Photographs depicting bulging of RE wall at km 102+570

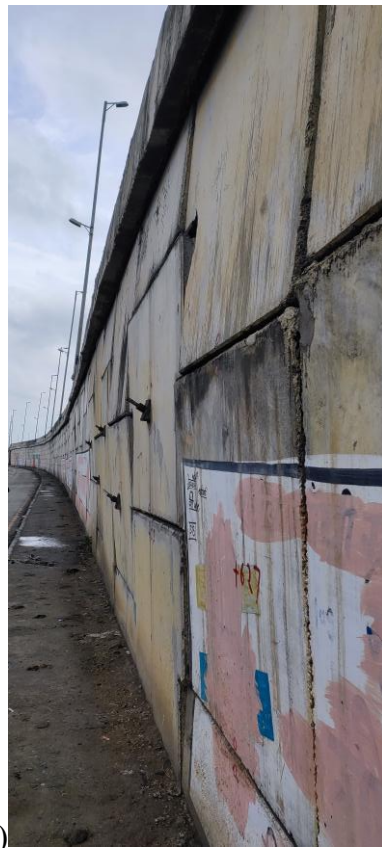
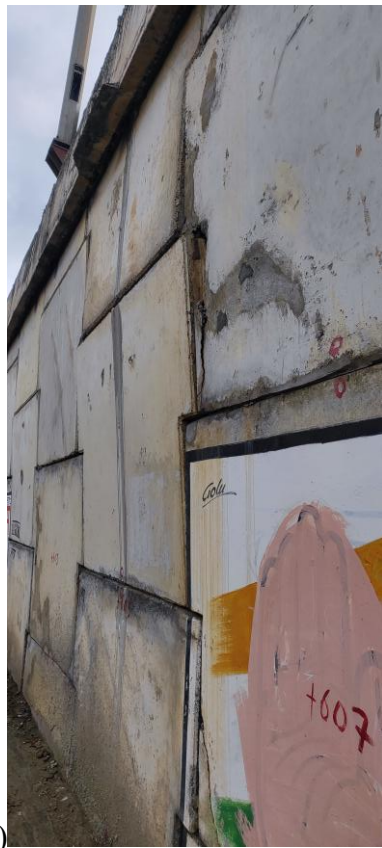
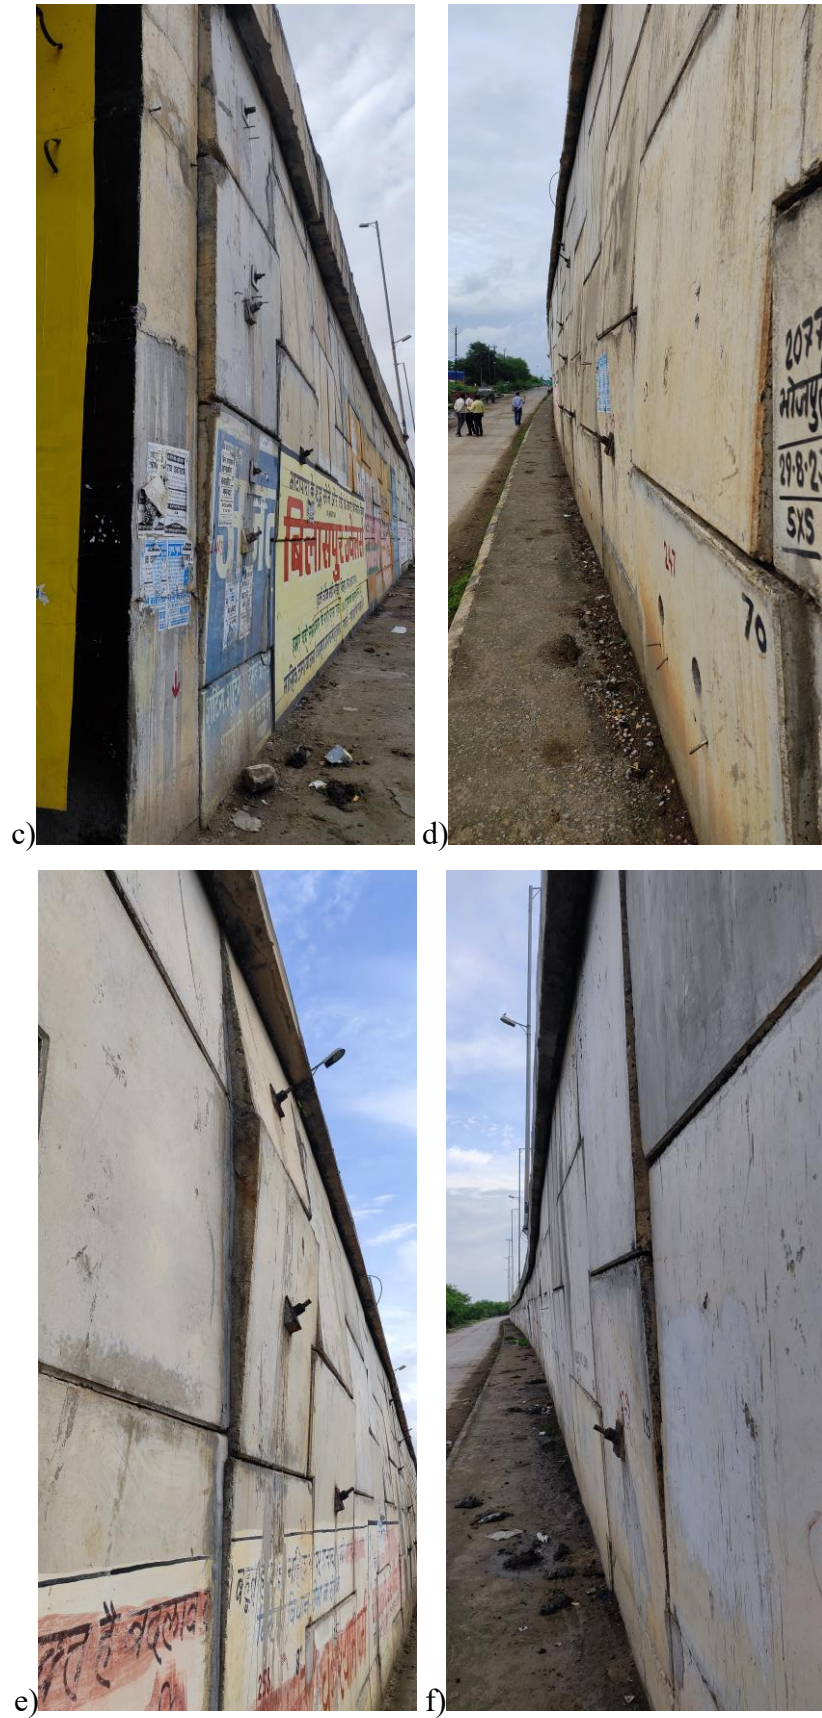
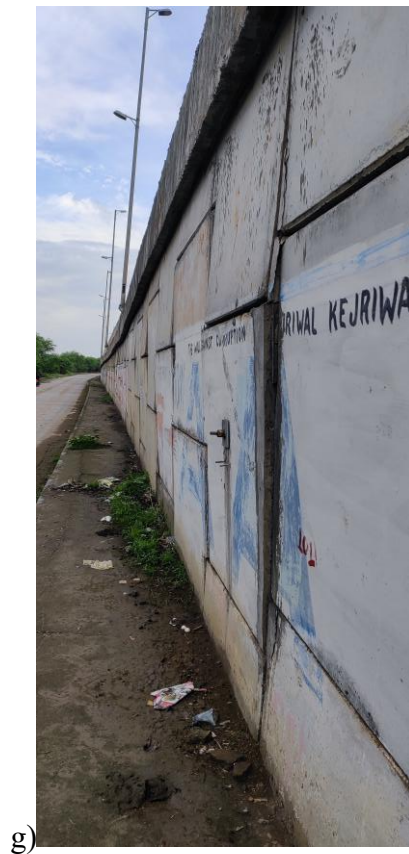
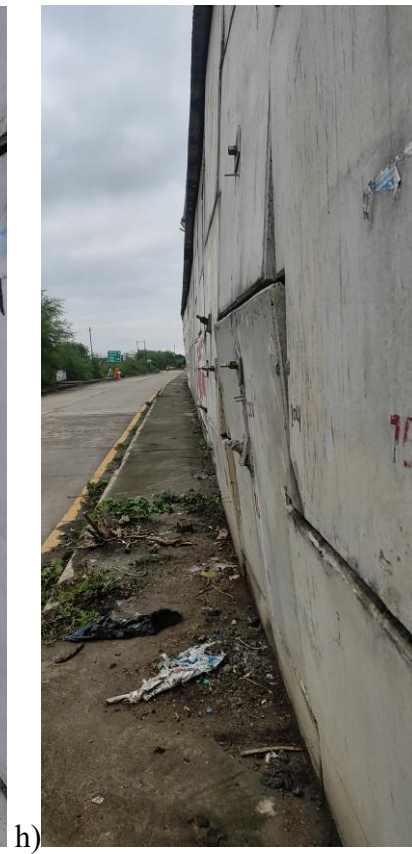
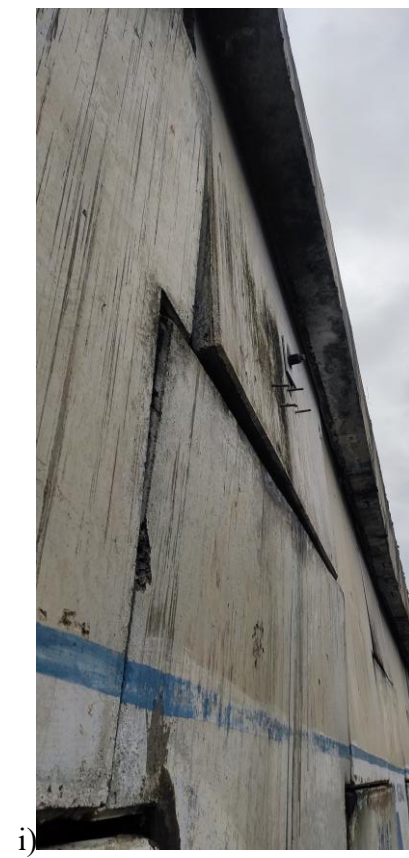
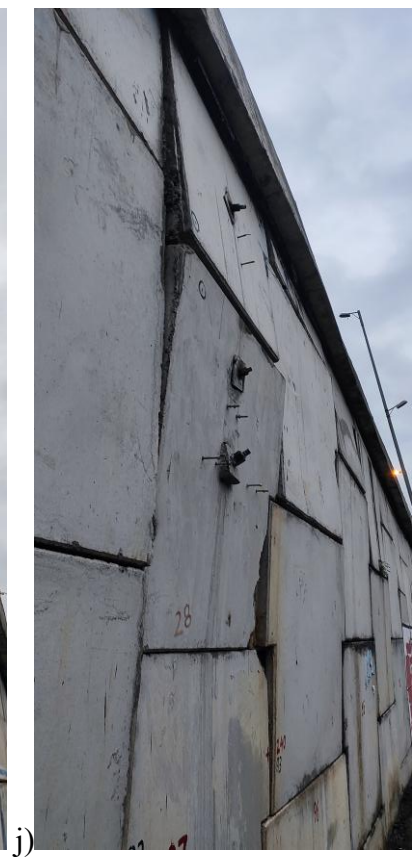
Figure 3 Photographs depicting bulging of RE wall at km 96+426

Figure 3 (continued) Photographs depicting bulging of RE wall at km 96+426

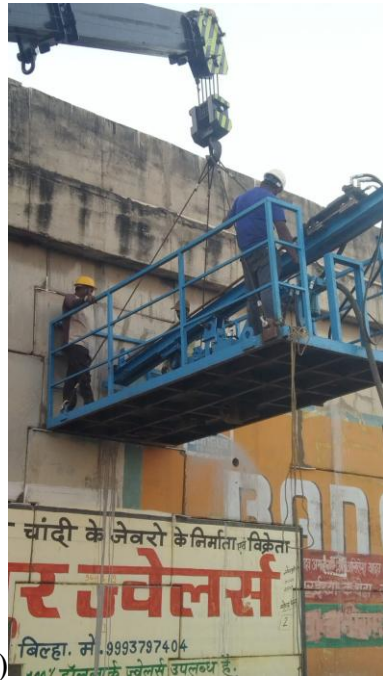
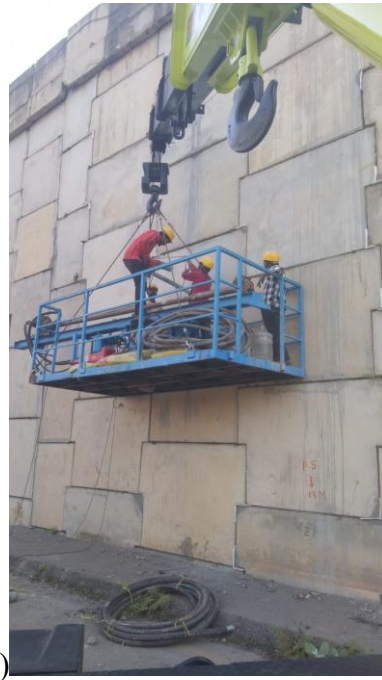
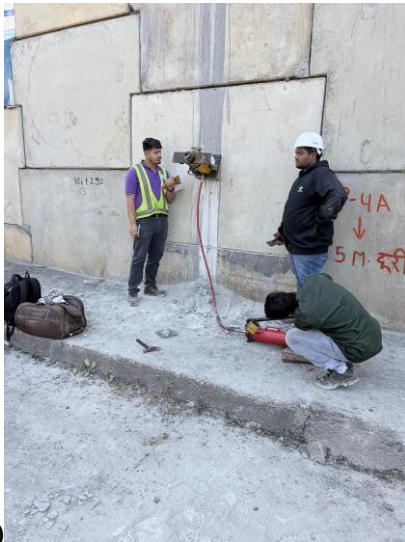
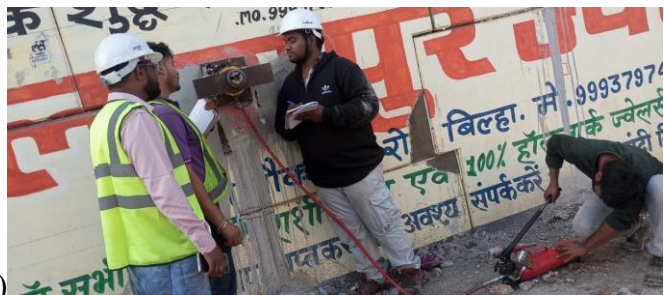
Figure 5 Photographs taken during trial nail installation and pullout testing

Eighteen trial nails – (9 solid nails and 9 SDA) were installed at km 106+224 and km 96+426 (Figure 3) for pullout testing to assess nail bond strength randomly. Subsequently, NHAI/contractor installed the trail nails. A brief installation procedure for solid nails is as follows:

The procedure involves initially application of an arbitrary load not more than ~5 kN to take up slack in the equipment. The load was applied uniformly but at a slow rate to avoid any jerk in the bar till the bar started coming out. The nail pullout test is carried out using a hydraulic pump, hydraulic jack, calibrated pressure gauge, dial gauges, and a reaction mechanism using suitable platform. The soil nail was tested by increasing the load in increments of 10 kN until failure. The failure criteria are defined as the load at which the nail cannot resist further load or total extension of 40 mm is reached or bolt yields or fractures, whichever is early. During the application of pressure, the dial gauge observation was recorded at regular load intervals after both load and extension were stabilized. The data collated after the test was used for calculating the bond strength and shown in Table 3. Pullout testing was performed on 29/12/2025-31/12/2025, and Figure 5 depicts a few photographs of testing. FHWA recommends minimum 7 days after installation to carryout testing, which is followed without fail.
