# DETAILED INSPECTION REPORT

## PARTIALLY EXECUTED WORK OF MAJOR BRIDGE

**KM 28+400 OVER MAHANADI ON NH-153 RAIGARH  
SARANGARH SARAIPALI IN THE DISTRICT SAKTI  
OF CHHATTISGARH UNDER THE PWD, NH  
DIVISION BILASPUR**

**IDDC ENGINEERS PVT. LTD.**

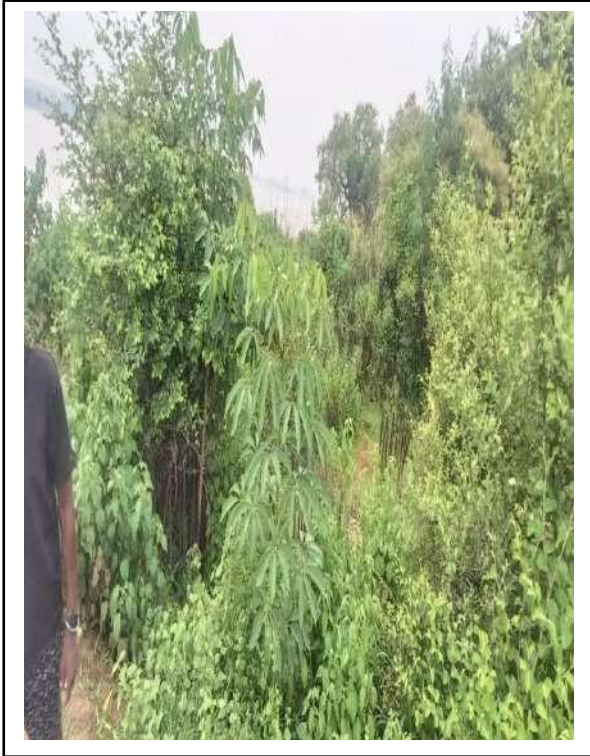
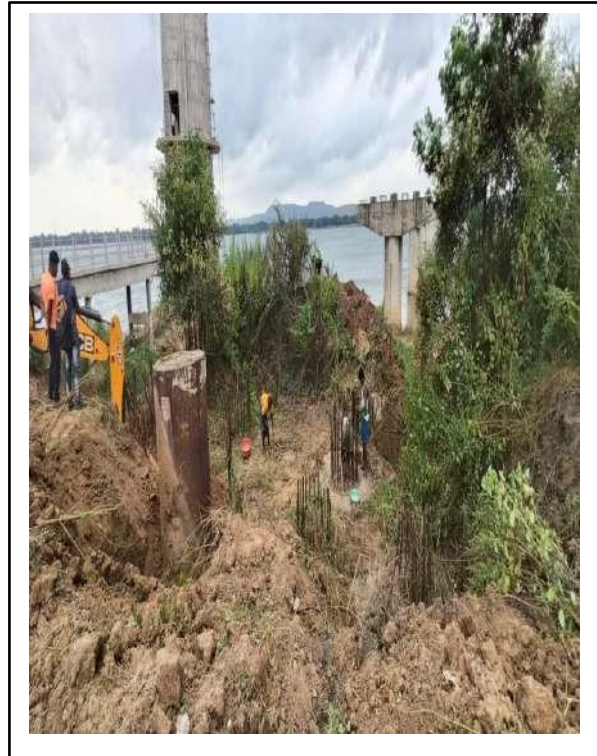
Picture-1 & 2: Abutment – 1 foundation view

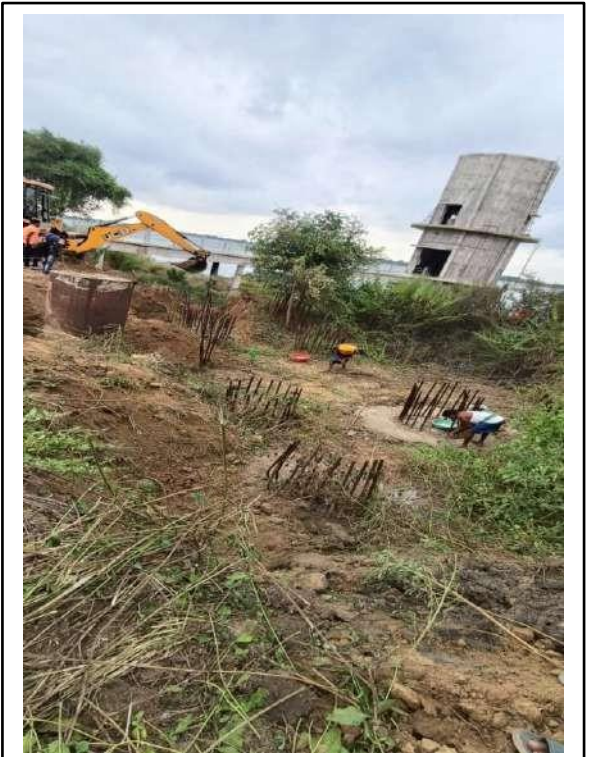
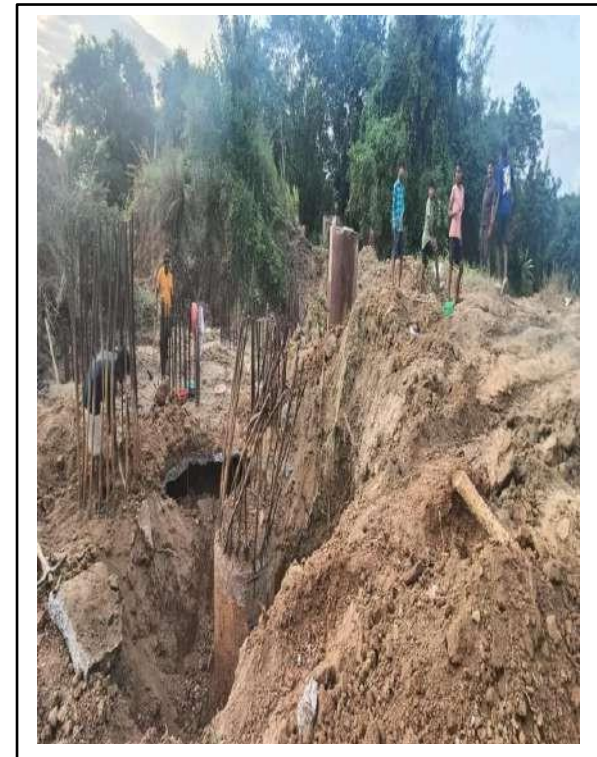
Picture-3 & 4: Abutment – 1 foundation view

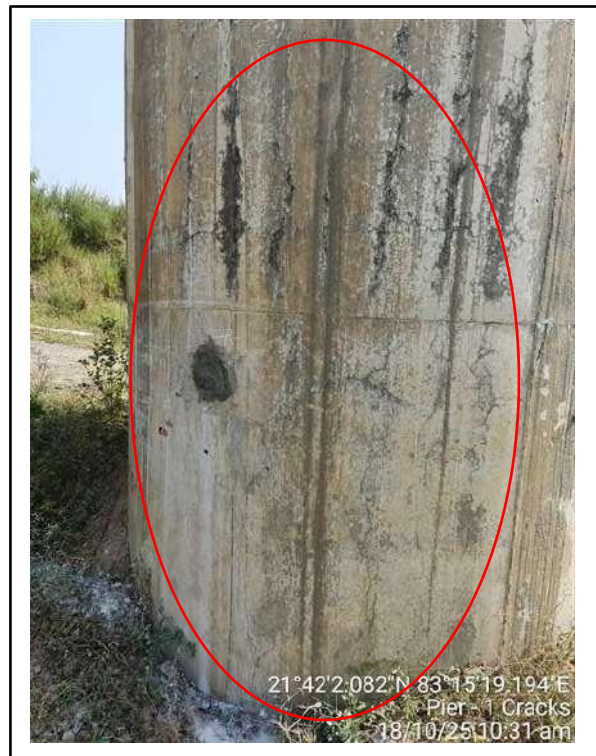
Element Name	Observation	Location of Distress
<b>Pier – 1</b>		
Pier cap	L	Leaching observed on pier cap top and all side faces at various locations.
	MC	Minor discontinues horizontal cracks observed on pier surface at various locations.
	R & SC	Rust & Steel corrosion observed on pedestal reinforcement over pier cap
Pier	C	Vertical cracks observed on pier surface from bottom to top level at various locations.
	MC	Minor cracks observed on pier surface at all faces along the main reinforcement direction.

Picture-2: Cracks on pier surface.

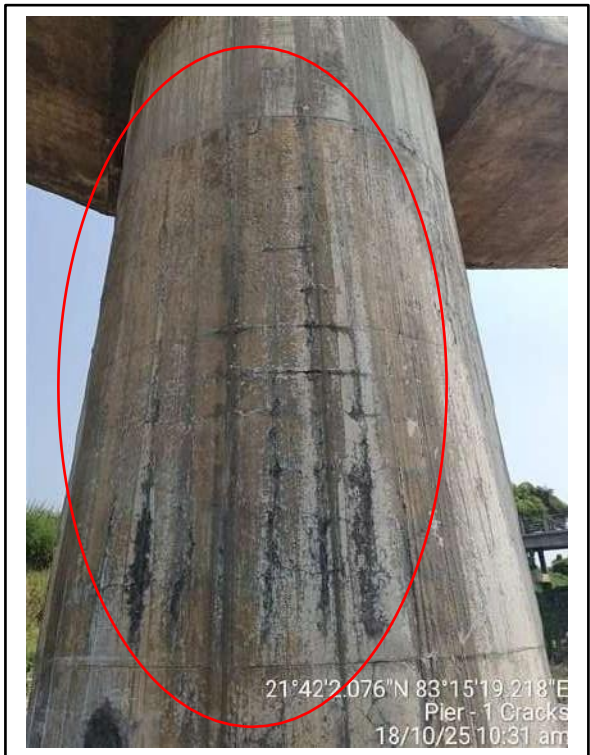
Picture-3: Cracks on pier surface.

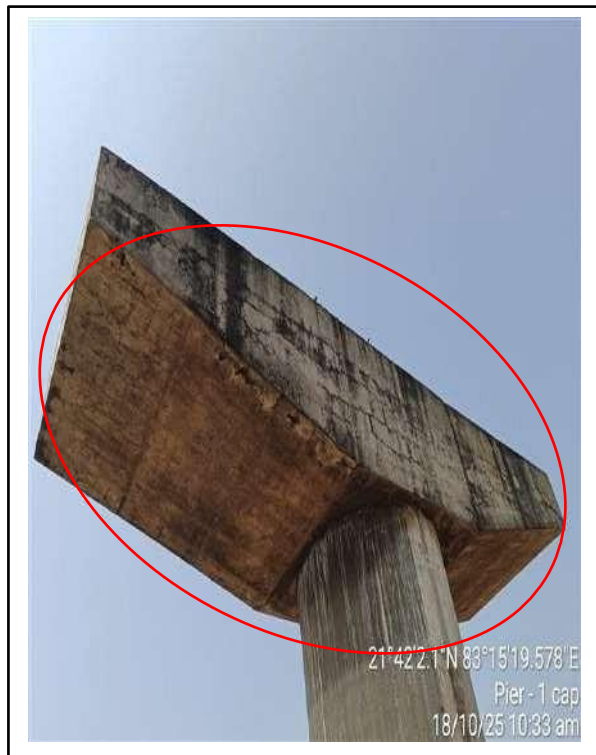
Picture-4: Leaching & Minor cracks on pier cap.

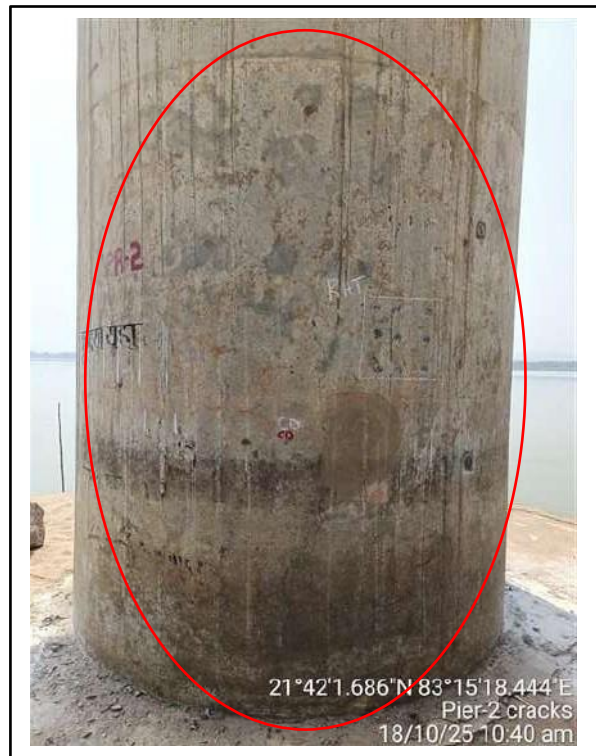
Picture-2: Cracks on pier surface.

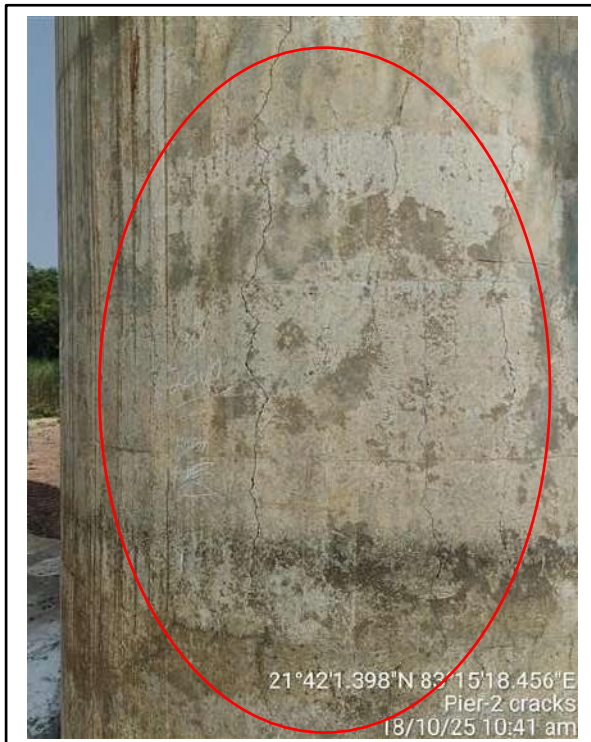
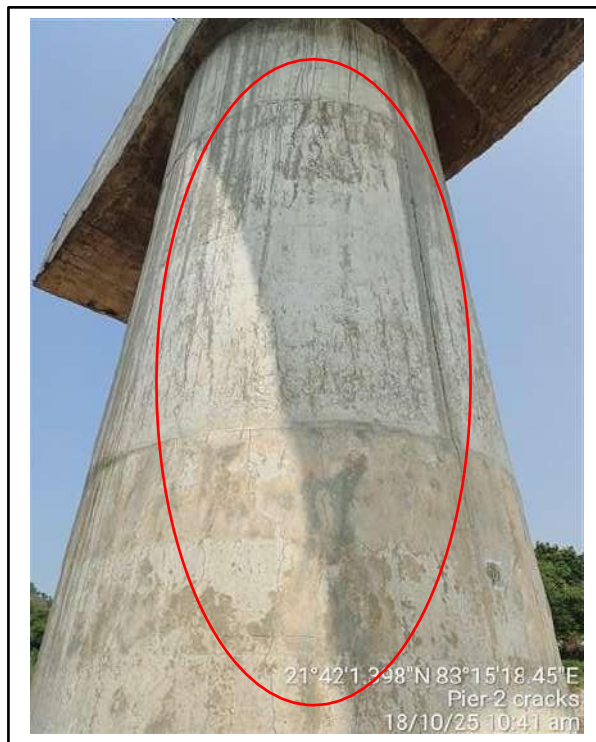
Picture-3 & 4: Cracks on pier surface

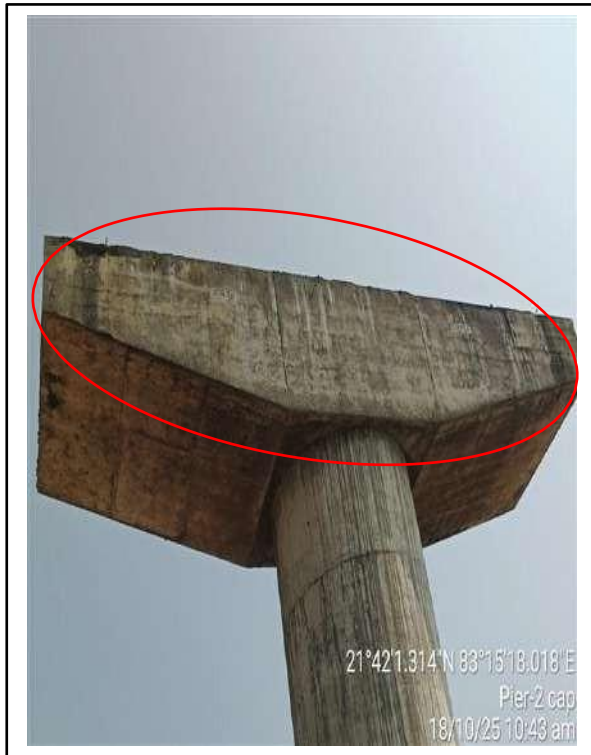
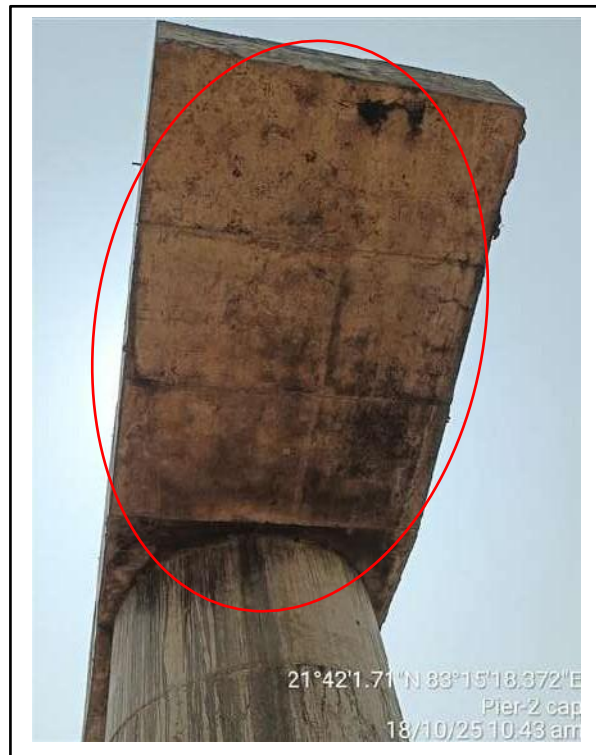
Element Name	Observation	Location of Distress
<b>Pier – 2</b>		
Pier cap	MC	Minor cracks observed on pier cap surface at all faces along the main reinforcement direction.
	L	Leaching observed on pier cap top and all side faces at various locations.
	R	Rust observed on pedestal reinforcement over pier cap.
Pier	C	Vertical cracks observed on pier surface from bottom to top level at various locations.
	MC	Minor discontinues horizontal cracks observed on pier surface at various locations.
Pile cap	MC	Minor cracks observed on pile cap all faces at various locations.

Picture-5 & 6: Surface cracks on pier cap.

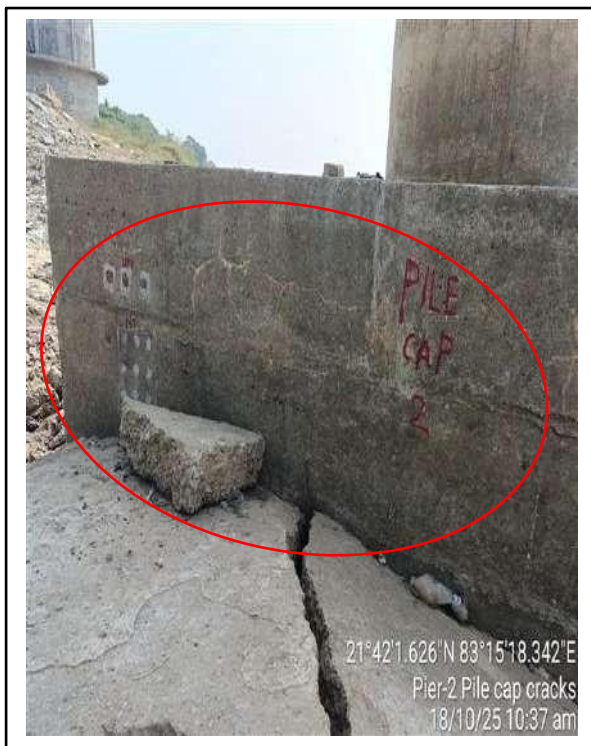
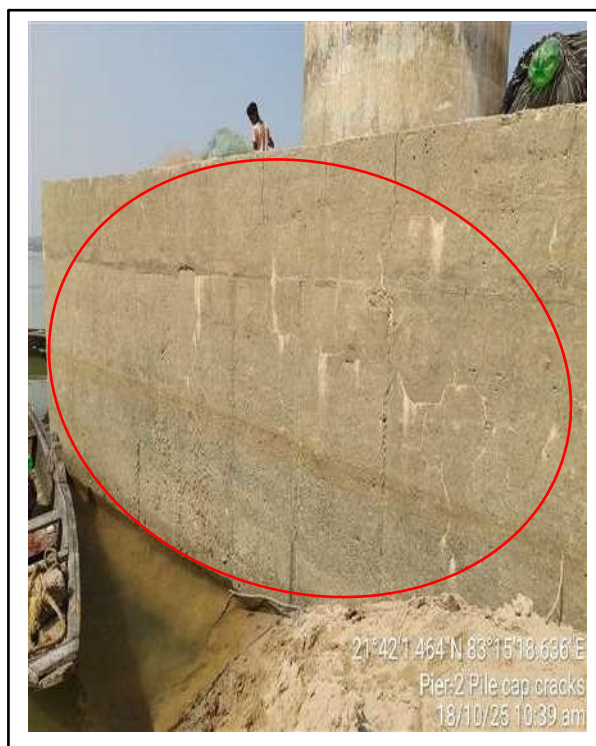
Picture-7 & 8: Cracks on pile cap surface

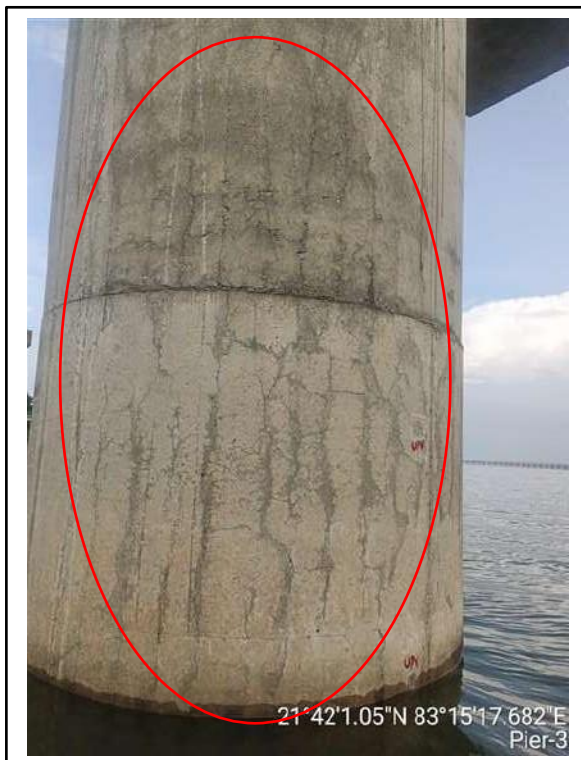
Picture-3 & 4: Cracks on pier surface

S.No	Location		Crack Width In mm
1	Pier -3	Pile cap	0.1 to 0.5
2		Pier	0.1 to 1.5
3		Pier Cap	0.1 to 0.3

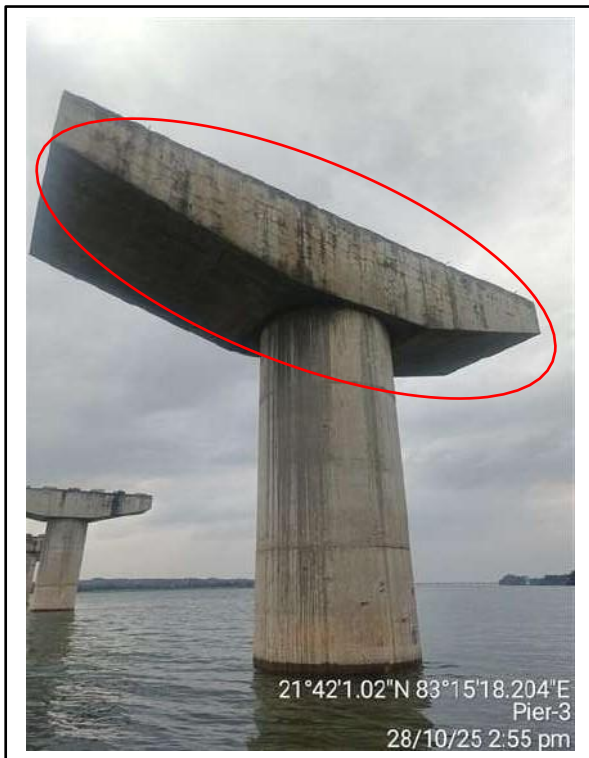
Element Name	Observation	Location of Distress
Pier – 3		
Pier cap	MC	Minor cracks observed on pier cap surface at all faces along the main reinforcement direction.
	L	Leaching observed on pier cap top and all side faces at various locations.
	R	Rust observed on pedestal reinforcement over pier cap.
Pier	C	Vertical cracks observed on pier surface from bottom to top level at various locations.
	MC	Minor discontinues horizontal cracks observed on pier surface at various locations.
Pile cap	MC	Minor cracks observed on pile cap all faces at various locations.

**Picture- 5 & 6: Minor cracks & leaching on pier cap.**

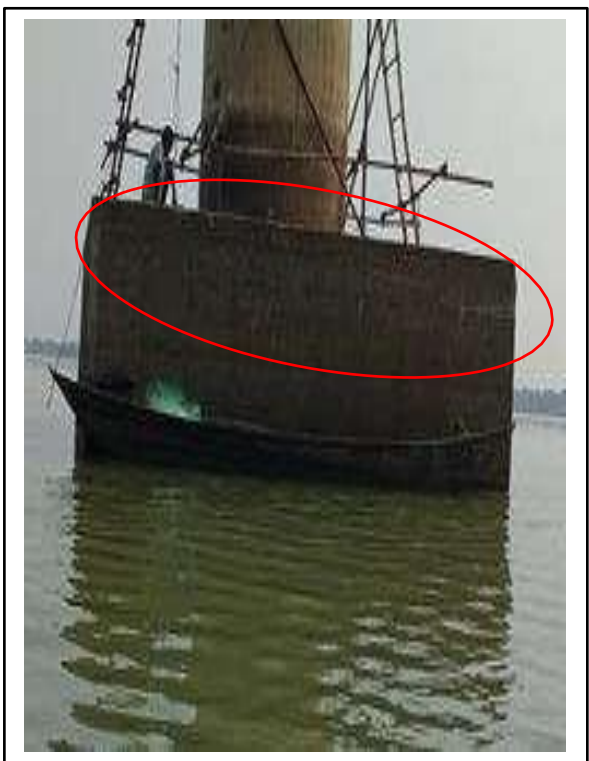
**Picture-7 & 8: Cracks on pile cap surface**

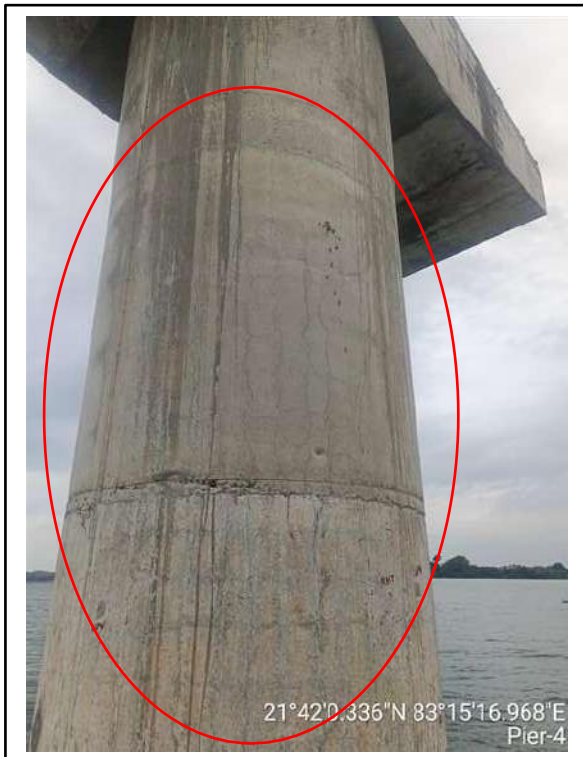
Picture-3 & 4: Cracks on pier surface

S.NO	LOCATION		CRACK WIDTH IN MM
1	Pier -4	Pile cap	0.1 to 0.5
2		Pier	0.2 to 1.5
3		Pier Cap	0.1 to 0.4

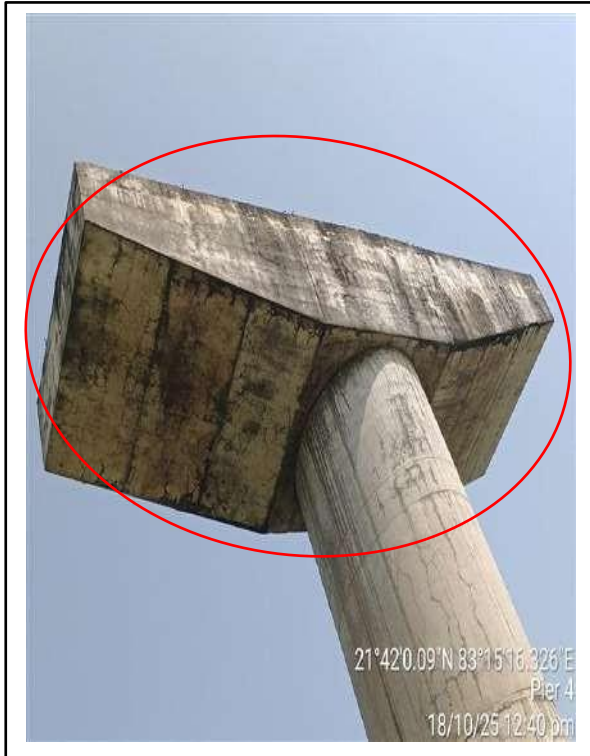
Element Name	Observation	Location of Distress
<b>Pier – 4</b>		
Pier cap	MC	Minor cracks observed on pier cap surface at all faces along the main reinforcement direction.
	L	Leaching observed on pier cap top and all side faces at various locations.
	R	Rust observed on pedestal reinforcement over pier cap.
Pier	C	Vertical cracks observed on pier surface from bottom to top level at various locations.
	MC	Minor discontinues horizontal cracks observed on pier surface at various locations.
Pile cap	MC	Minor cracks observed on pile cap all faces at various locations.

Picture- 5 & 6: Minor cracks & leaching on pier cap.

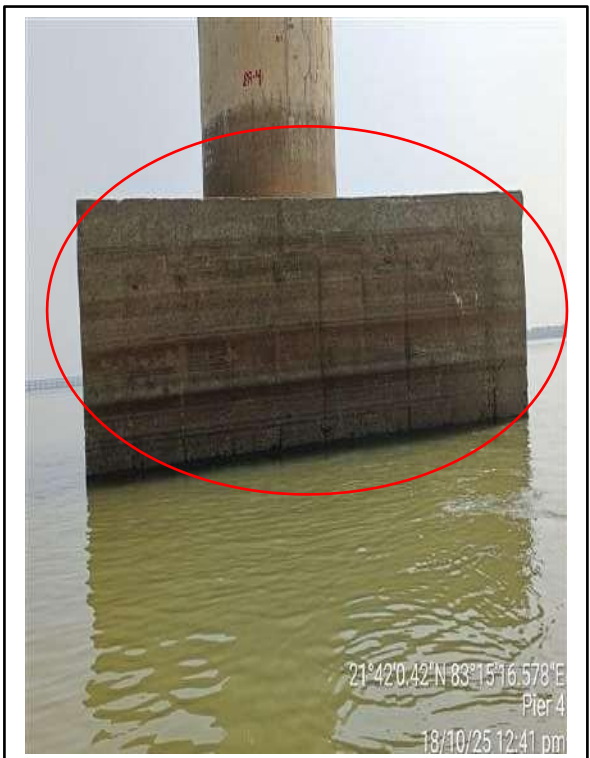
Picture-7 & 8: Cracks on pile cap surface

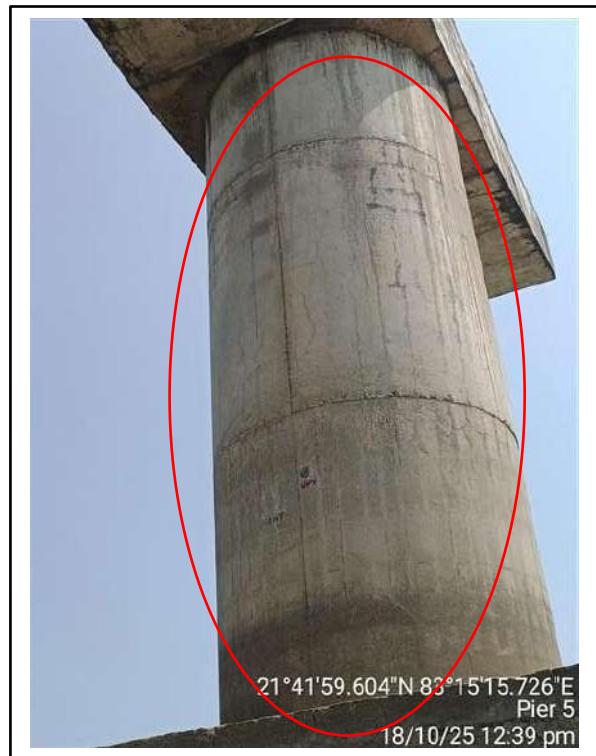
Picture-2: Cracks on pier surface

S.No	Location		Crack Width In mm
1	Pier -5	Pile cap	0.1 to 0.5
2		Pier	0.1 to 1
3		Pier Cap	0.1 to 0.4

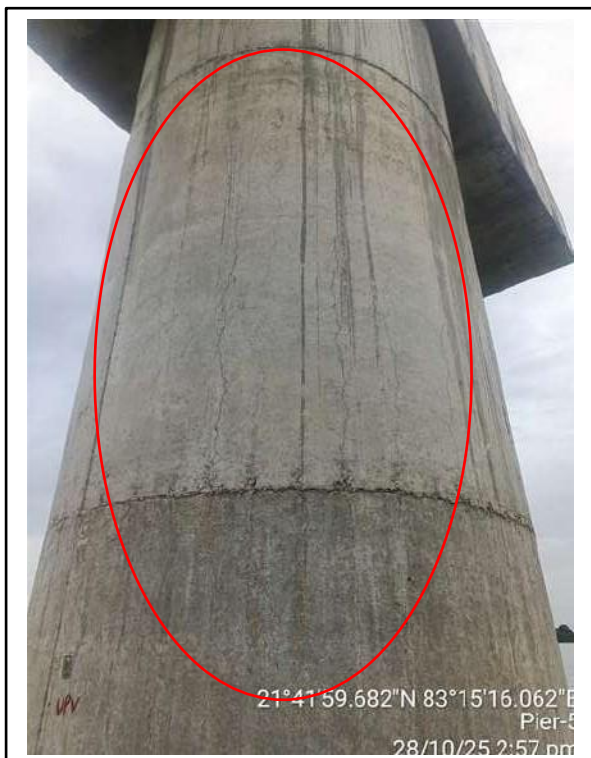
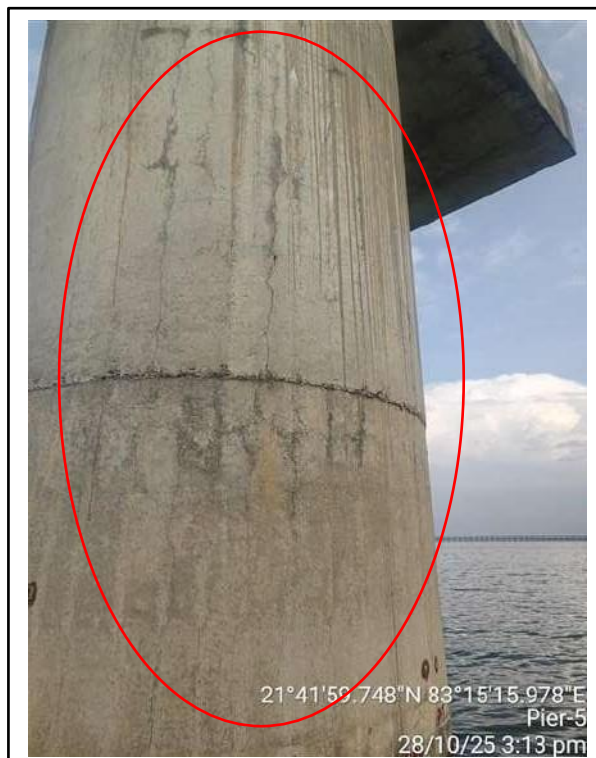
Picture-3 & 4: Cracks on pier surface

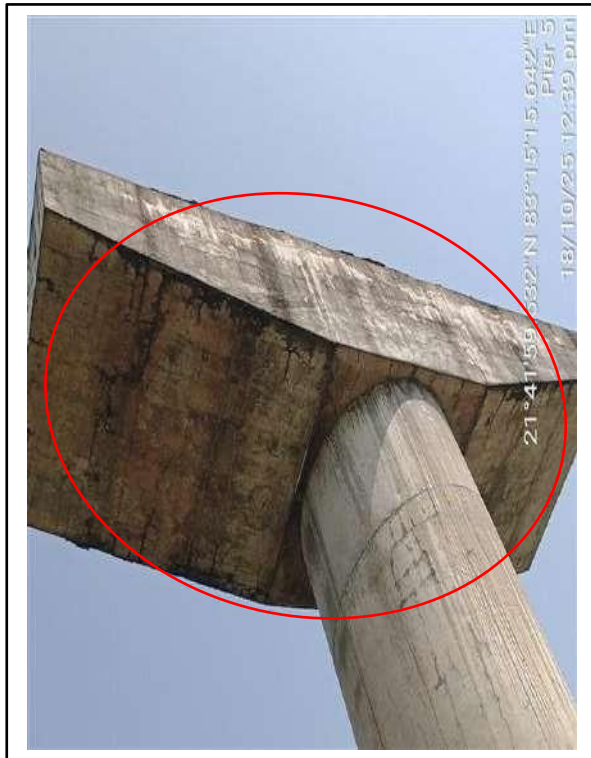
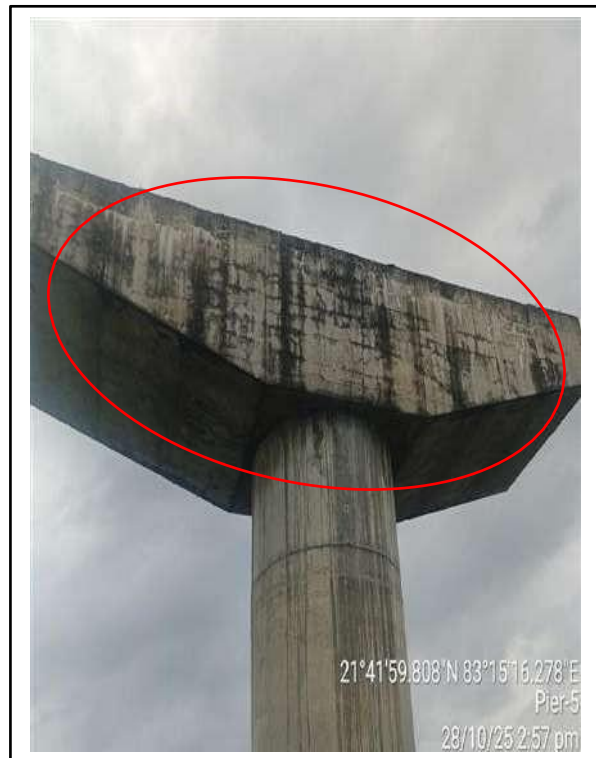
Element Name	Observation	Location of Distress
<b>Pier – 5</b>		
Pier cap	MC	Minor cracks observed on pier cap surface at all faces along the main reinforcement direction.
	L	Leaching observed on pier cap top and all side faces at various locations.
	EFF	Efflorescence observed on side faces of the pier cap.
	R	Rust observed on pedestal reinforcement over pier cap.
Pier	C	Vertical cracks observed on pier surface from bottom to top level at various locations.
	MC	Minor discontinues horizontal cracks observed on pier surface at various locations.
Pile cap	MC	Minor cracks observed on pile cap all faces at various locations.

Picture- 5 & 6: Minor cracks, leaching & efflorescence on pier cap.

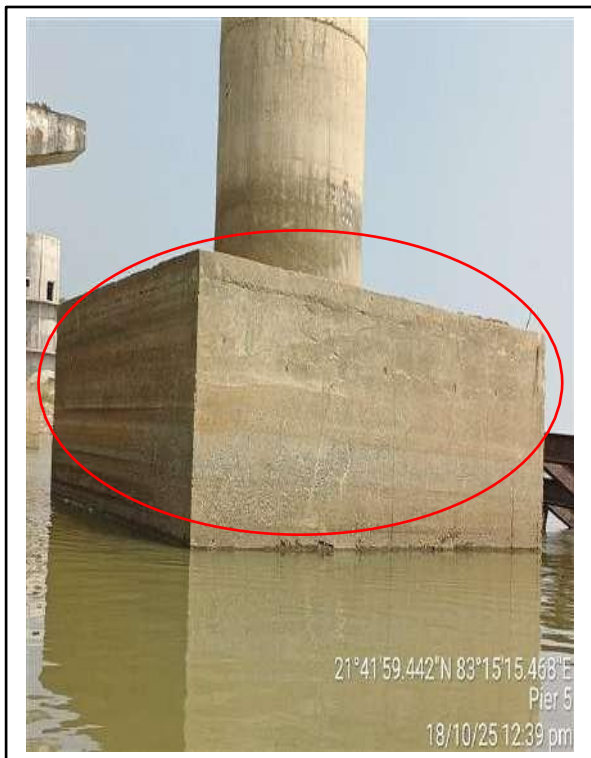
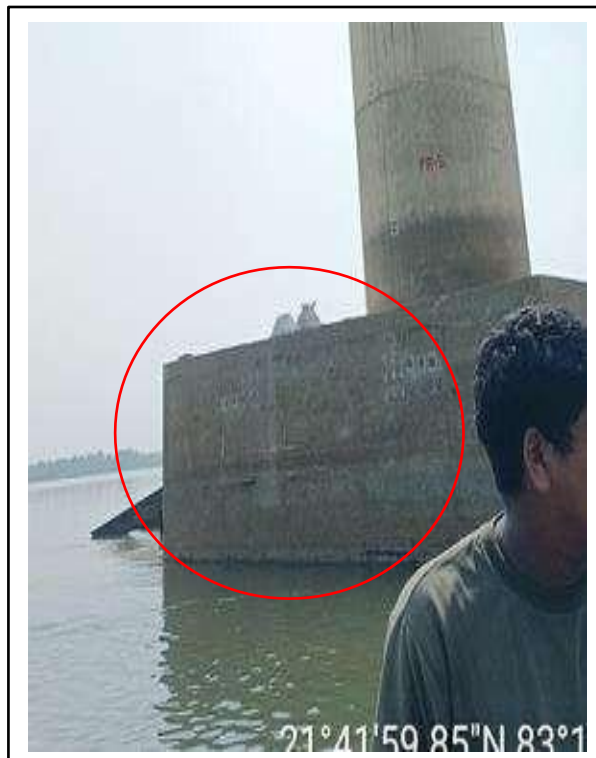
Picture-7 & 8: Cracks on pile cap surface

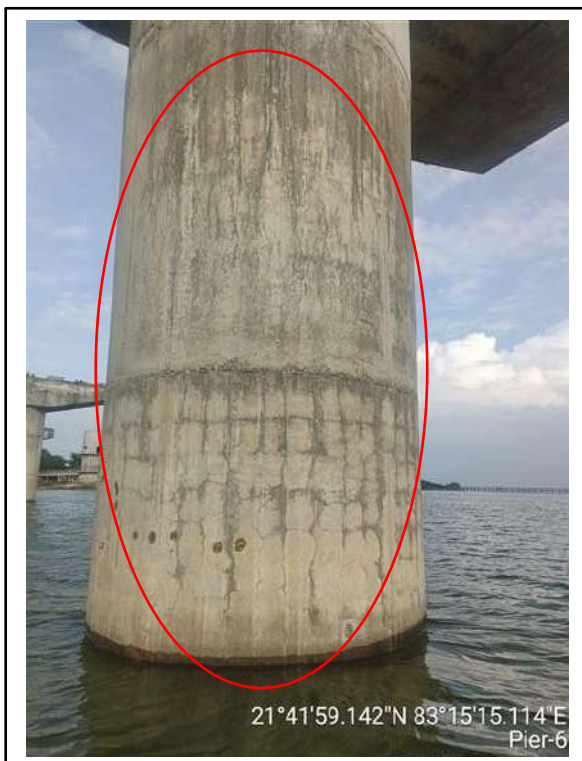
Picture-3 & 4: Cracks on pier surface

S.NO	LOCATION		CRACK WIDTH IN MM
1	Pier -6	Pile cap	0.1 to 0.4
2		Pier	0.1 to 1
3		Pier Cap	0.1 to 0.3

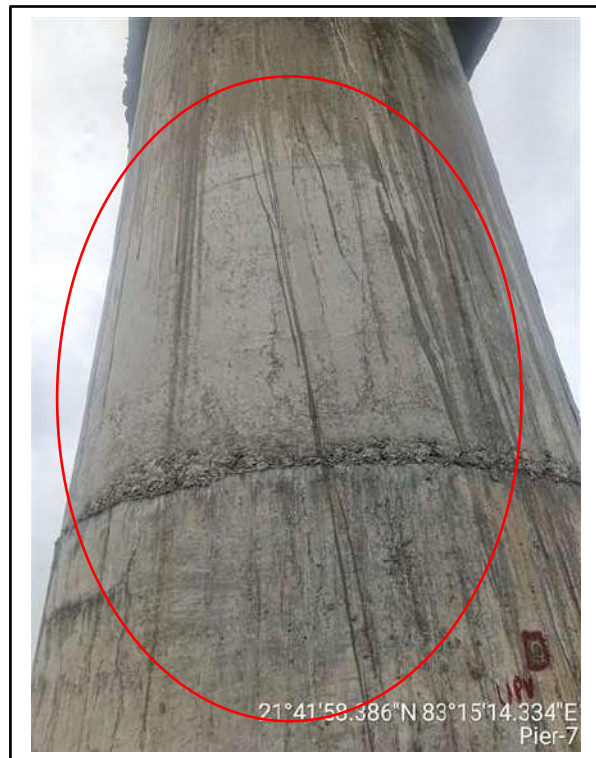
Picture-2: Cracks on pier surface

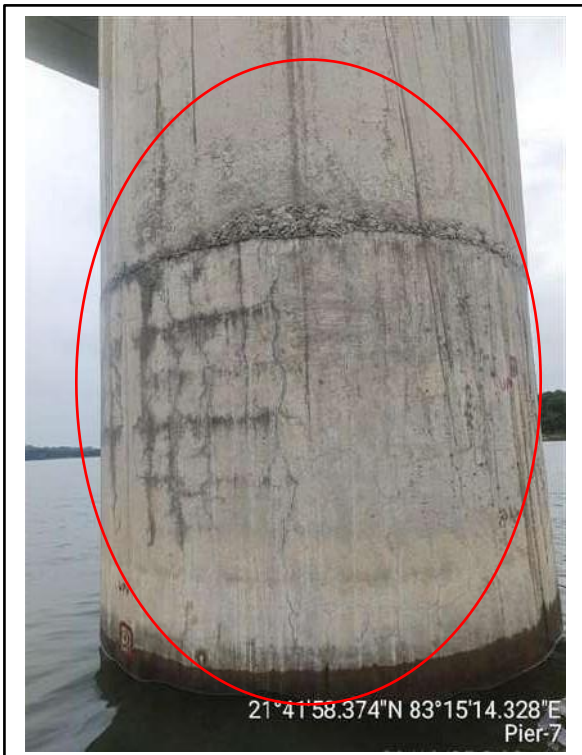
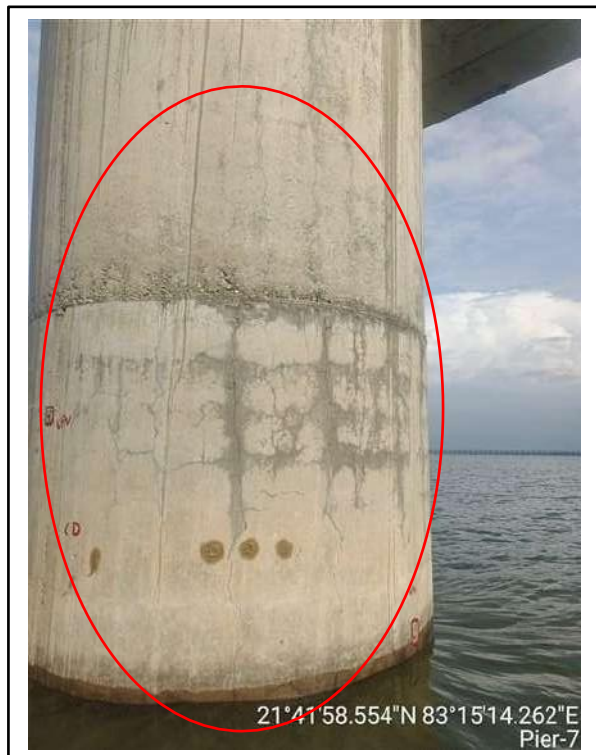
Picture-3 & 4: Cracks on pier surface

S.No	Location		Crack Width In mm
1	Pier -7	Pile cap	0.1 to 0.6
2		Pier	0.1 to 1.5
3		Pier Cap	0.1 to 0.6

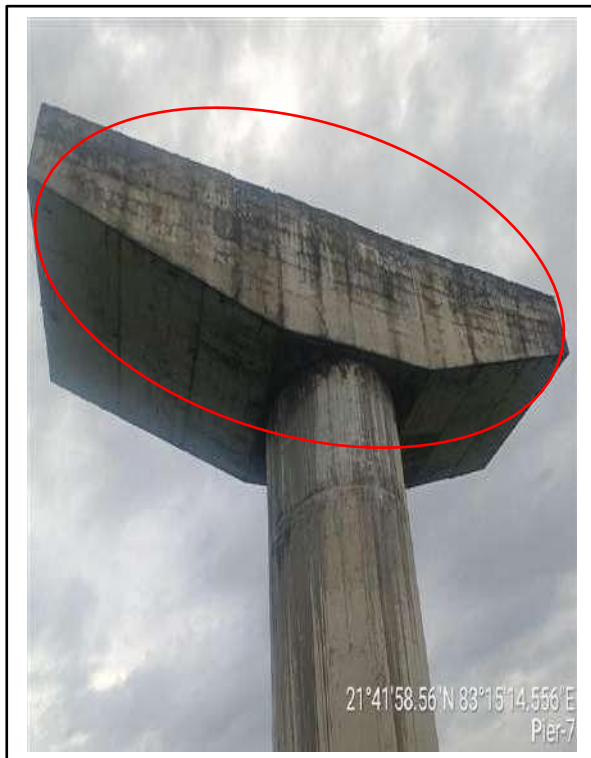
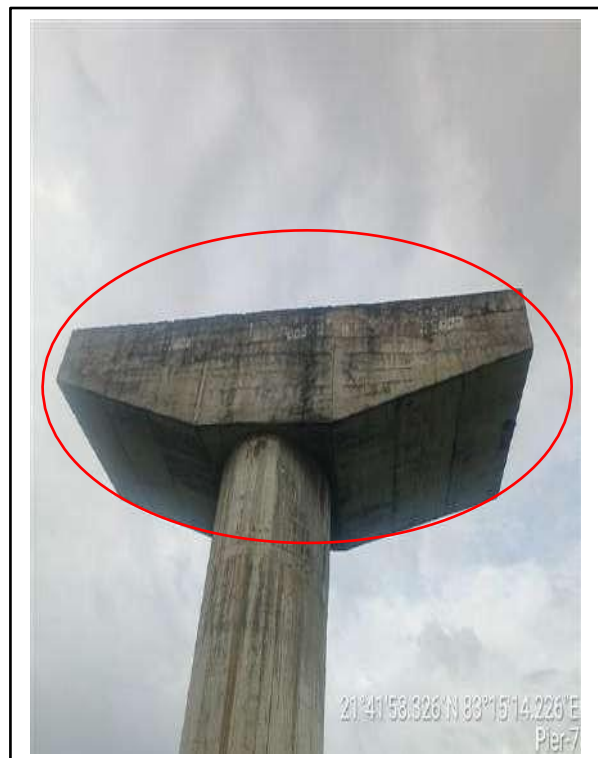
Element Name	Observation	Location of Distress
<b>Pier – 7</b>		
Pier cap	MC	Minor cracks observed on pier cap surface at all faces along the main reinforcement direction.
	L	Leaching observed on pier cap top and all side faces at various locations.
	EFF	Efflorescence observed on all side faces of the pier cap.
	R	Rust observed on pedestal reinforcement over pier cap.
Pier	C	Vertical cracks observed on pier surface from bottom to top level at various locations.
	MC	Minor discontinues horizontal cracks observed on pier surface at various locations.
Pile cap	MC	Minor cracks observed on pile cap all faces at various locations.

Picture- 5 & 6: Minor cracks, leaching & efflorescence on pier cap.

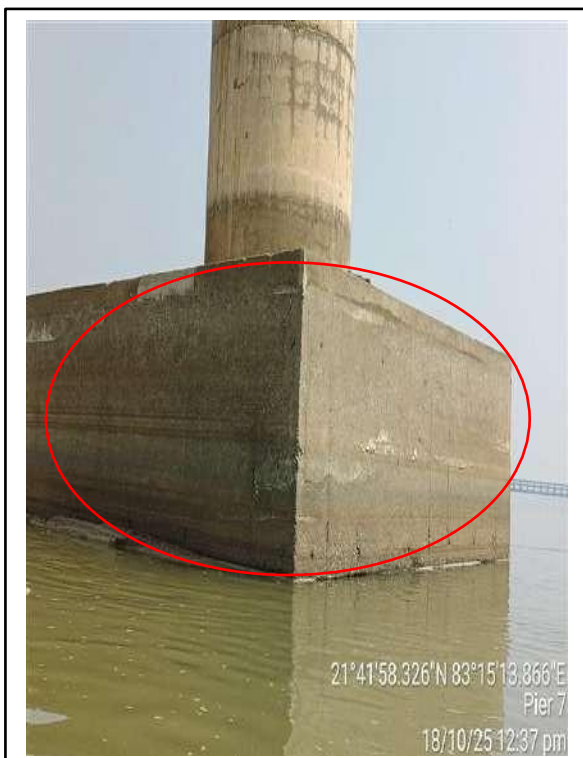
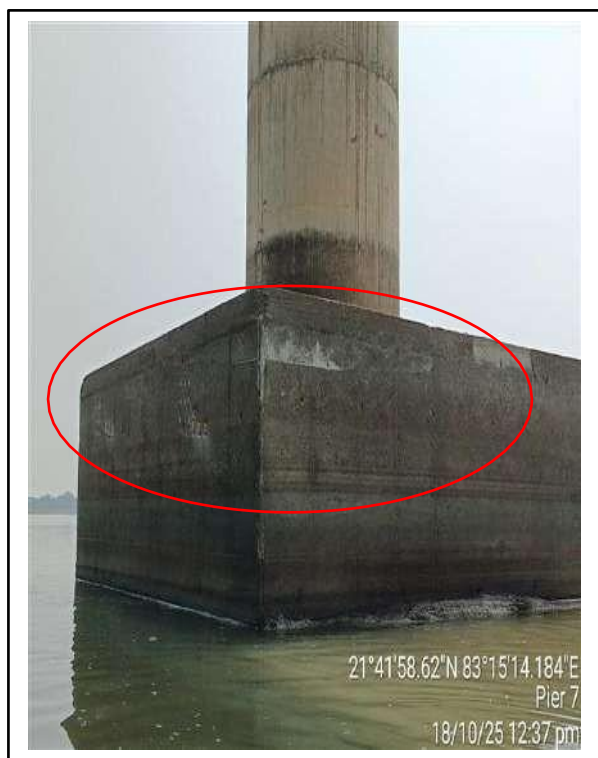
Picture-7 & 8: Cracks on pile cap surface

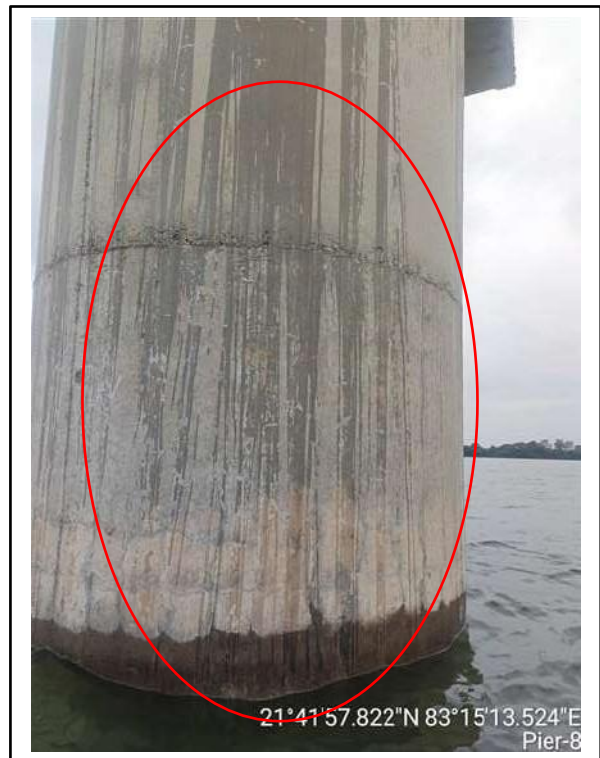
Picture-2: Cracks on pier surface

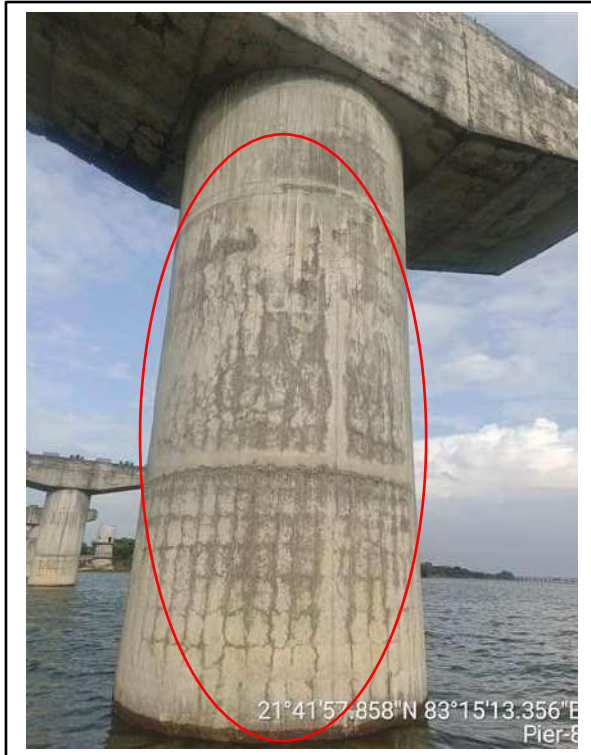
Picture-3 & 4: Cracks on pier surface

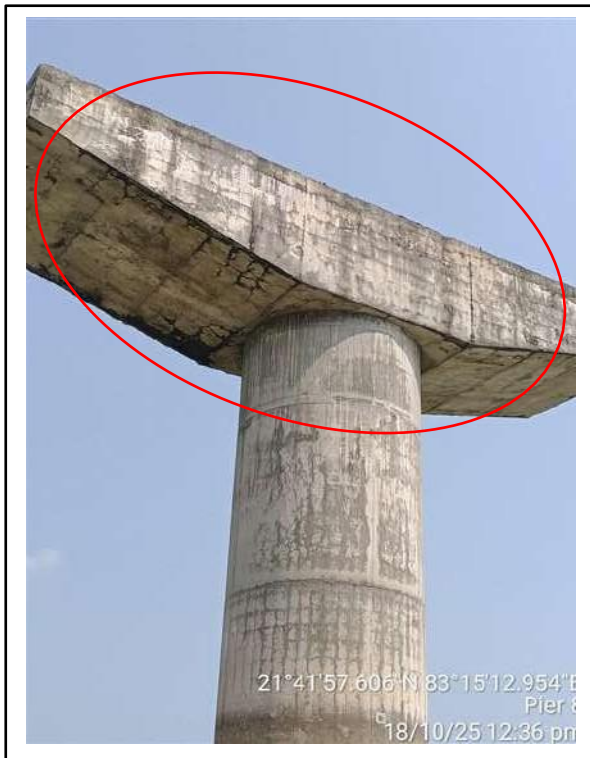
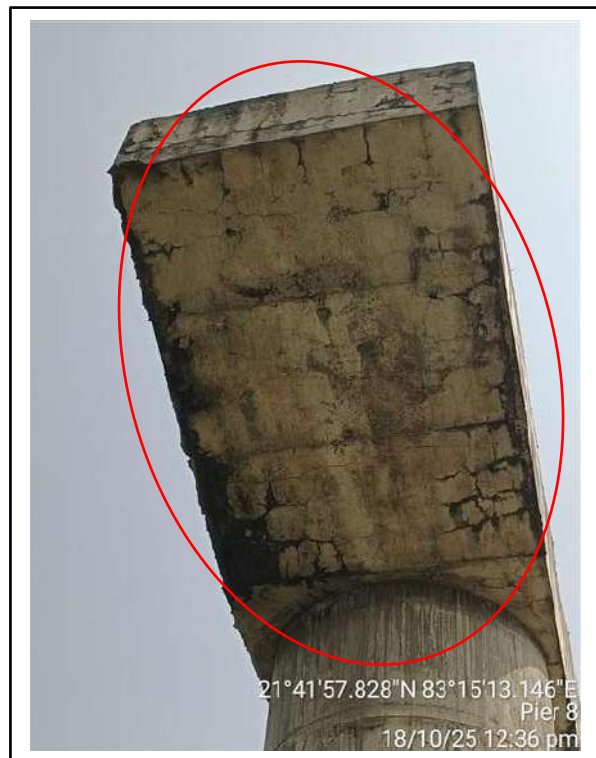
Element Name	Observation	Location of Distress
<b>Pier – 8</b>		
Pier cap	MC	Minor cracks observed on pier cap surface at all faces along the main reinforcement direction.
	L	Leaching observed on pier cap top and all side faces at various locations.
	EFF	Efflorescence observed on all side faces of the pier cap.
	R	Rust observed on pedestal reinforcement over pier cap.
Pier	C	Vertical cracks observed on pier surface from bottom to top level at various locations.
	MC	Minor discontinues horizontal cracks observed on pier surface at various locations.
Pile cap	MC	Minor cracks observed on pile cap all faces at various locations.

Picture- 5 & 6: Minor cracks, leaching & efflorescence on pier cap.

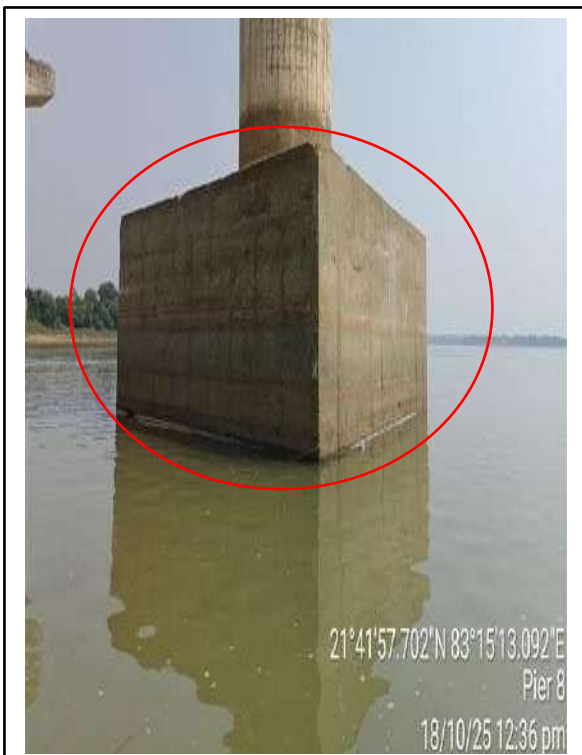
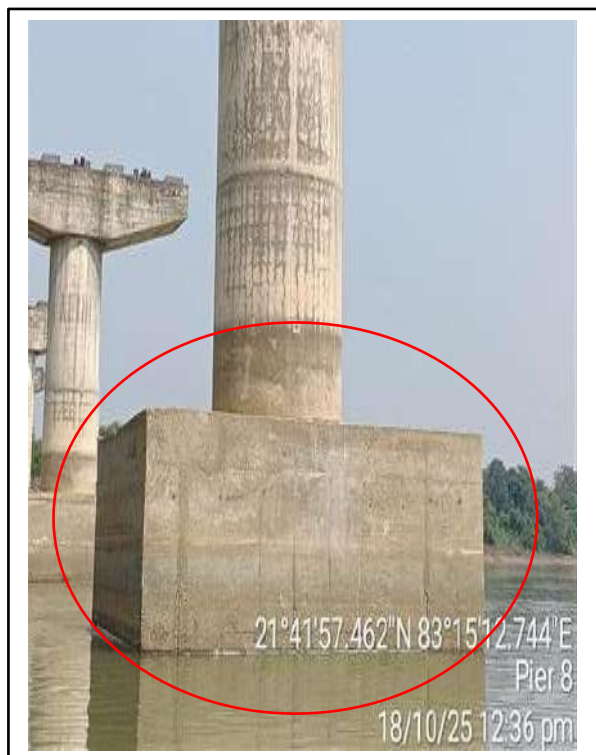
Picture-7 & 8: Cracks on pile cap surface

S.NO	LOCATION		CRACK WIDTH IN MM
1	Pier -8	Pile cap	0.1 to 0.8
2		Pier	0.1 to 0.8
3		Pier Cap	0.1 to 0.4

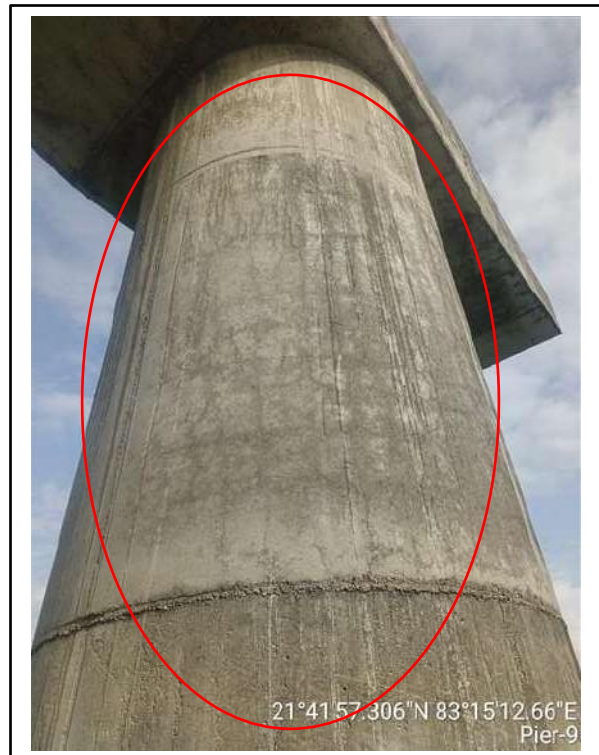
Picture-2: Cracks on pier surface

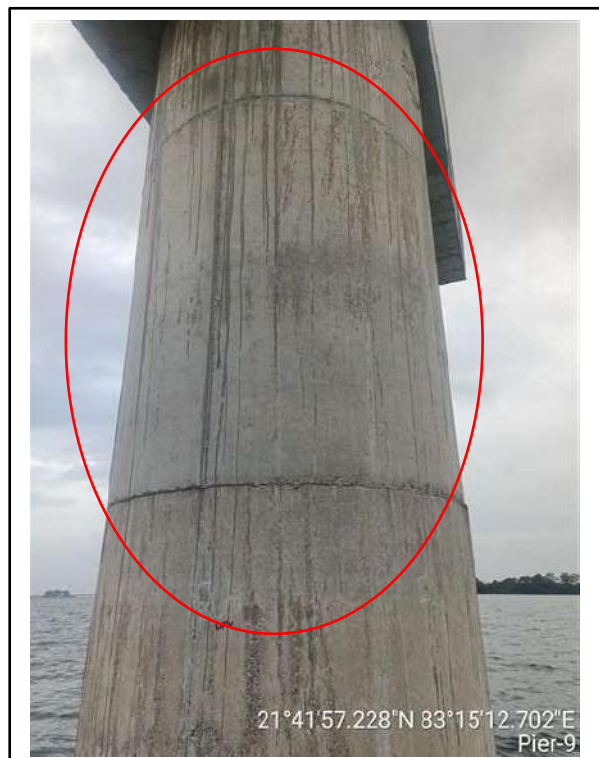
Picture-3 & 4: Cracks on pier surface

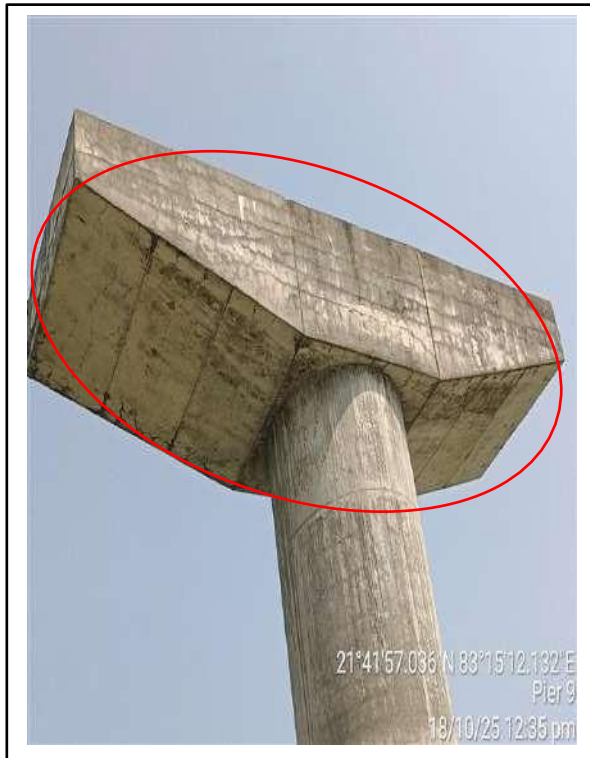
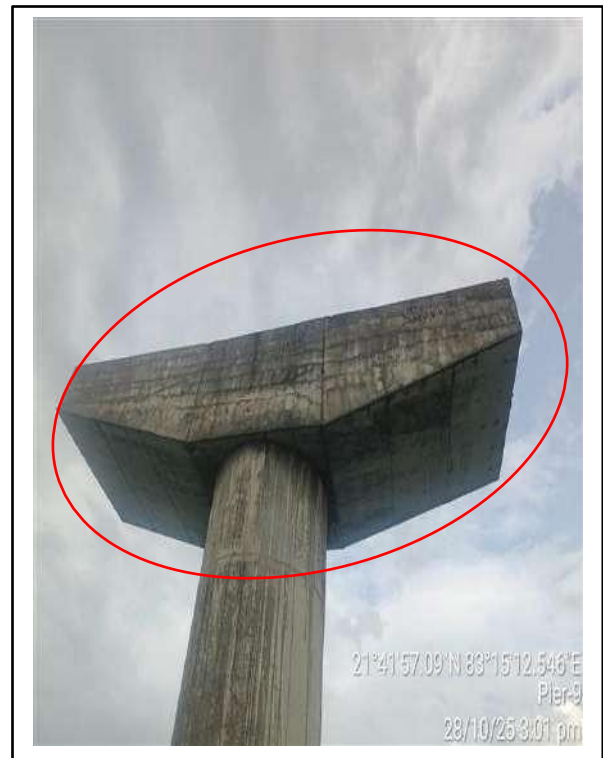
Element Name	Observation	Location of Distress
<b>Pier – 9</b>		
Pier cap	MC	Minor cracks observed on pier cap surface at all faces along the main reinforcement direction.
	L	Leaching observed on pier cap top and all side faces at various locations.
	EFF	Efflorescence observed on all side faces of the pier cap.
	R	Rust observed on pedestal reinforcement over pier cap.
Pier	C	Vertical cracks observed on pier surface from bottom to top level at various locations.
	MC	Minor discontinues horizontal cracks observed on pier surface at various locations.
Pile cap	MC	Minor cracks observed on pile cap all faces at various locations.

**Picture- 5 & 6: Minor cracks, leaching & efflorescence on pier cap.**

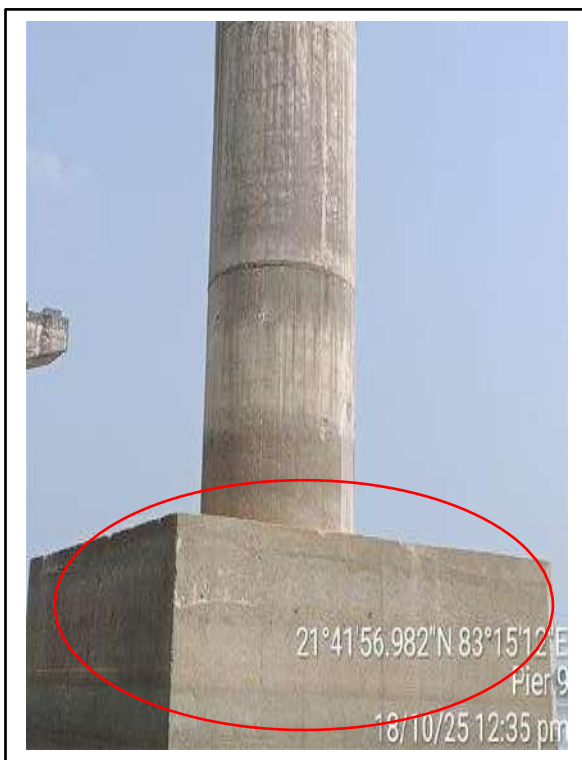
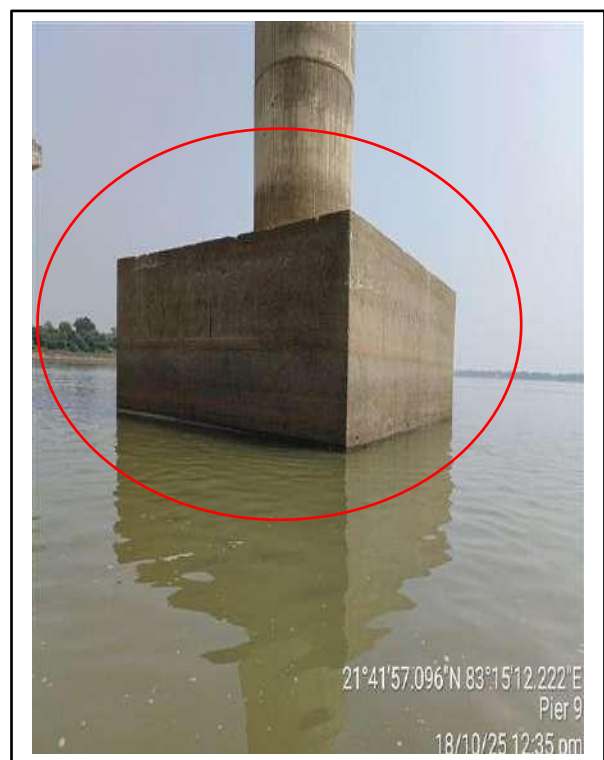
**Picture-7 & 8: Cracks on pile cap surface**

S.No	Location		Crack Width In mm
1	Pier -9	Pile cap	0.1 to 0.3
2		Pier	0.1 to 0.9
3		Pier Cap	0.1 to 0.3
