# DETAILED INSPECTION REPORT

## PARTIALLY EXECUTED WORK OF MAJOR BRIDGE

**KM 28+400 OVER MAHANADI ON NH-153 RAIGARH  
SARANGARH SARAIPALI IN THE DISTRICT SAKTI  
OF CHHATTISGARH UNDER THE PWD, NH  
DIVISION BILASPUR**

**IDDC ENGINEERS PVT. LTD.**

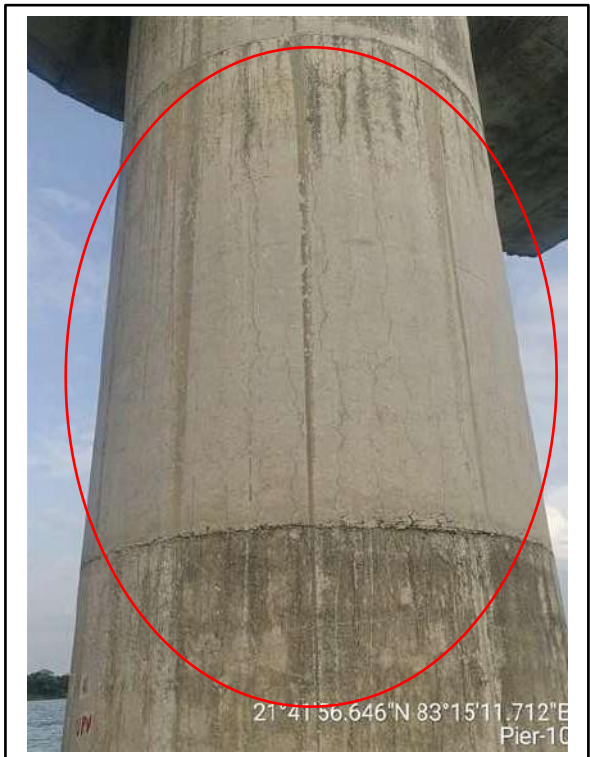
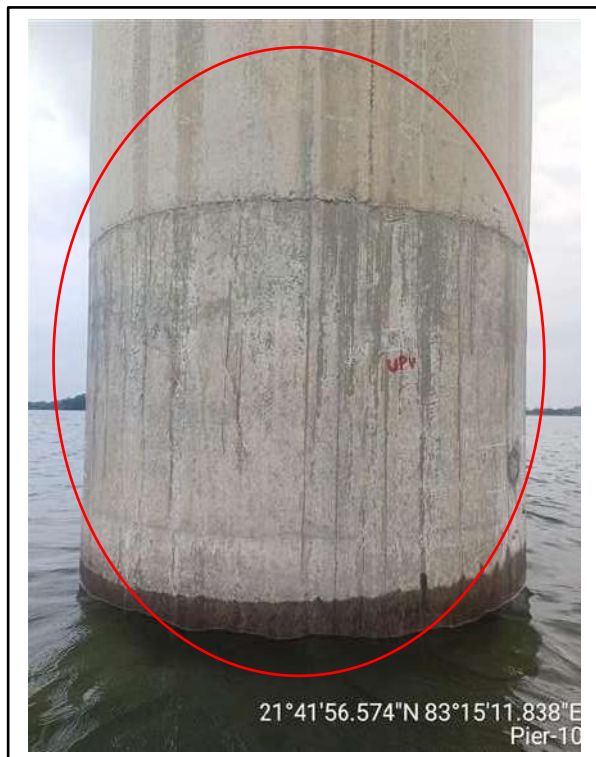
Picture-3 & 4: Cracks on pier surface

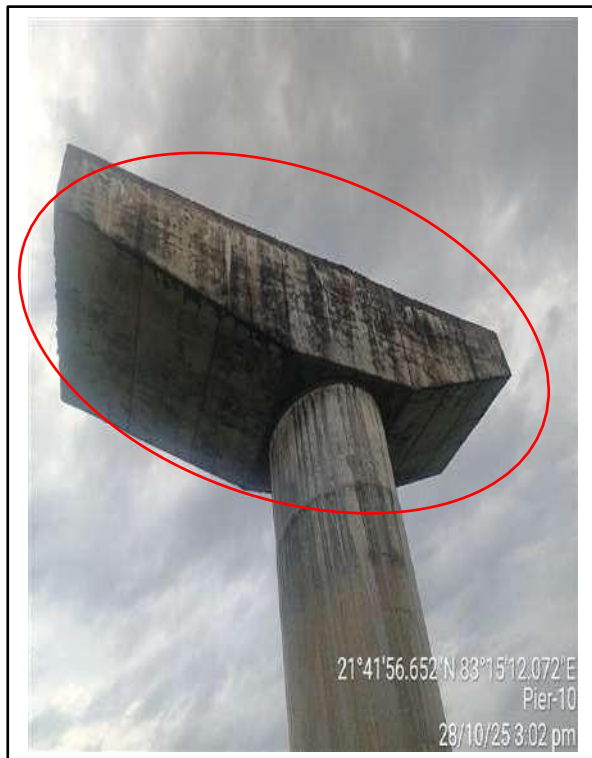
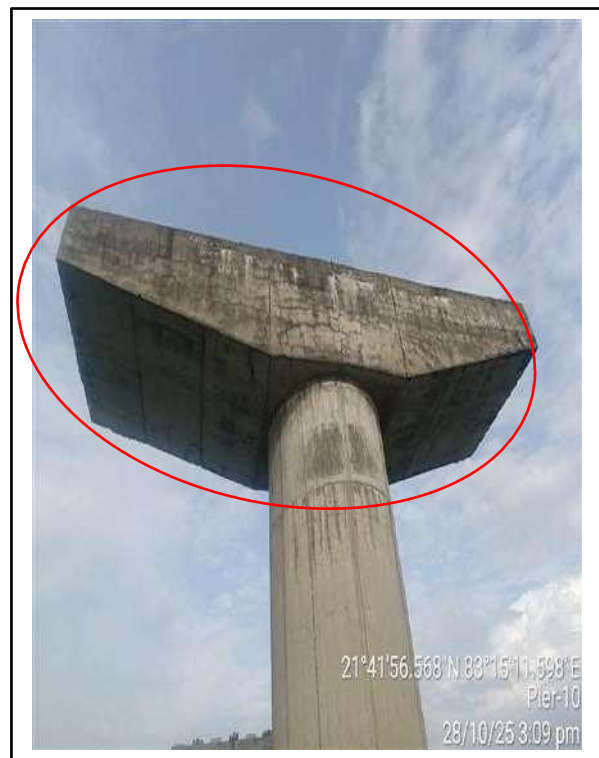
Element Name	Observation	Location of Distress
<b>Pier – 10</b>		
Pier cap	MC	Minor cracks observed on pier cap surface at all faces along the main reinforcement direction.
	L	Leaching observed on pier cap top and all side faces at various locations.
	EFF	Efflorescence observed on all side faces of the pier cap.
	R	Rust observed on pedestal reinforcement over pier cap.
Pier	C	Vertical cracks observed on pier surface from bottom to top level at numerous locations.
	MC	Minor discontinues horizontal cracks observed on pier surface at numerous locations.
Pile cap	MC	Minor cracks observed on pile cap all faces at various locations.

**Picture- 5 & 6: Minor cracks, leaching & efflorescence on pier cap.**

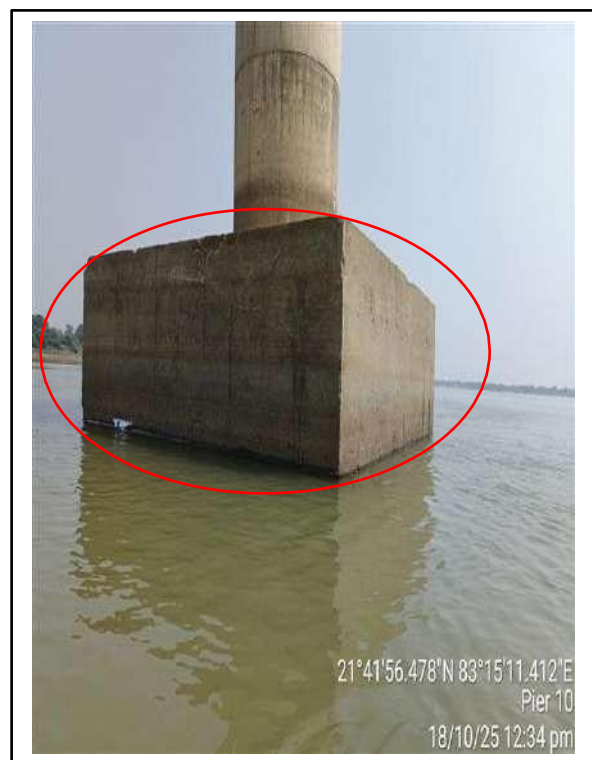
**Picture-7 & 8: Cracks on pile cap surface**

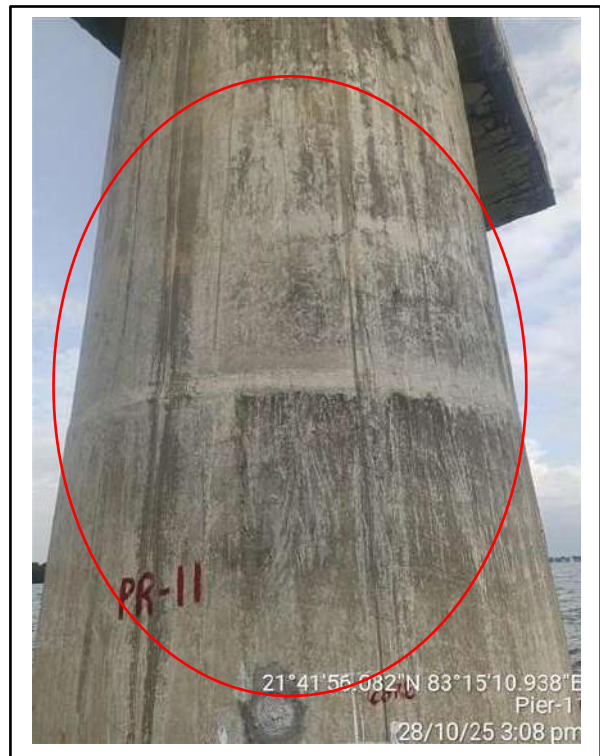
Picture-2: Cracks on pier surface

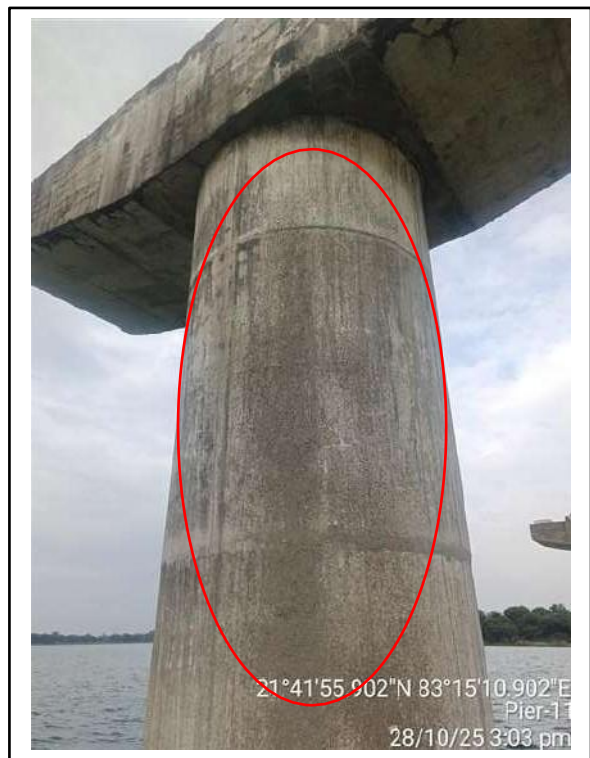
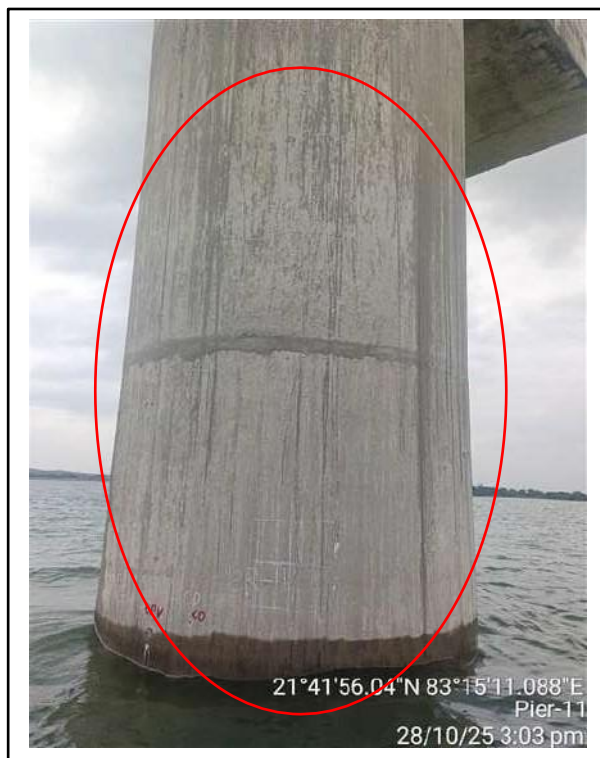
Picture-3 & 4: Cracks on pier surface

S.No	Location		Crack Width In mm
1	Pier -11	Pile cap	0.1 to 0.3
2		Pier	0.1 to 1
3		Pier Cap	0.1 to 0.5

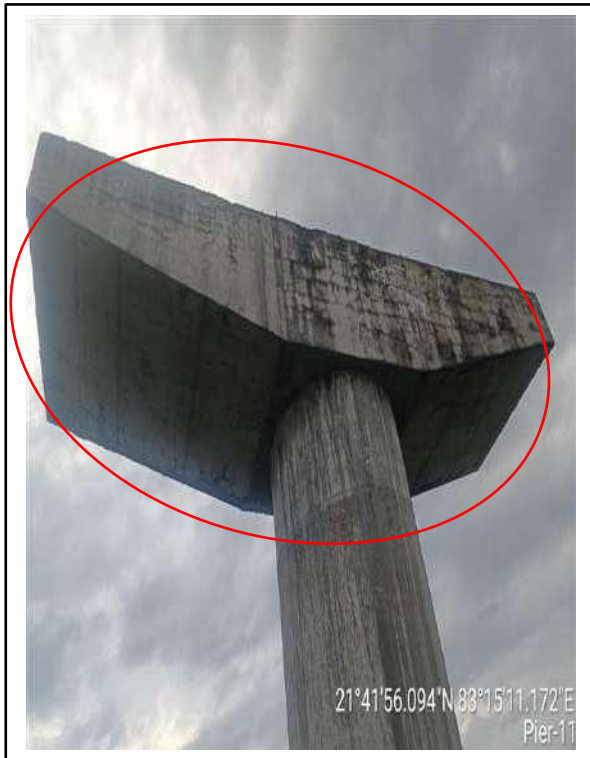
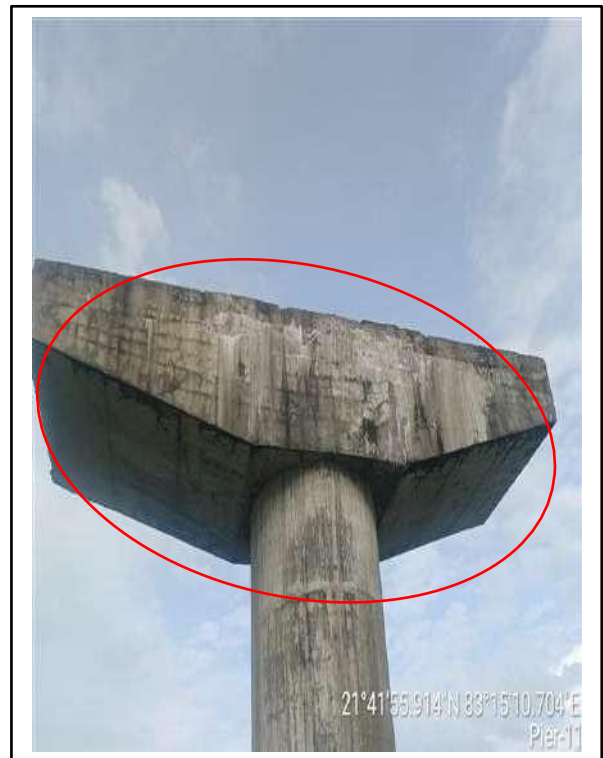
Element Name	Observation	Location of Distress
<b>Pier – 11</b>		
Pier cap	MC	Minor cracks observed on pier cap surface at all faces along the main reinforcement direction.
	L	Leaching observed on pier cap top and all side faces at various locations.
	EFF	Efflorescence observed on all side faces of the pier cap.
	R	Rust observed on pedestal reinforcement over pier cap.
Pier	C	Vertical cracks observed on pier surface from bottom to top level at various locations.
	MC	Minor discontinues horizontal cracks observed on pier surface at various locations.
Pile cap	MC	Minor cracks observed on pile cap all faces at various locations.

Picture- 5 & 6: Minor cracks, leaching & efflorescence on pier cap.

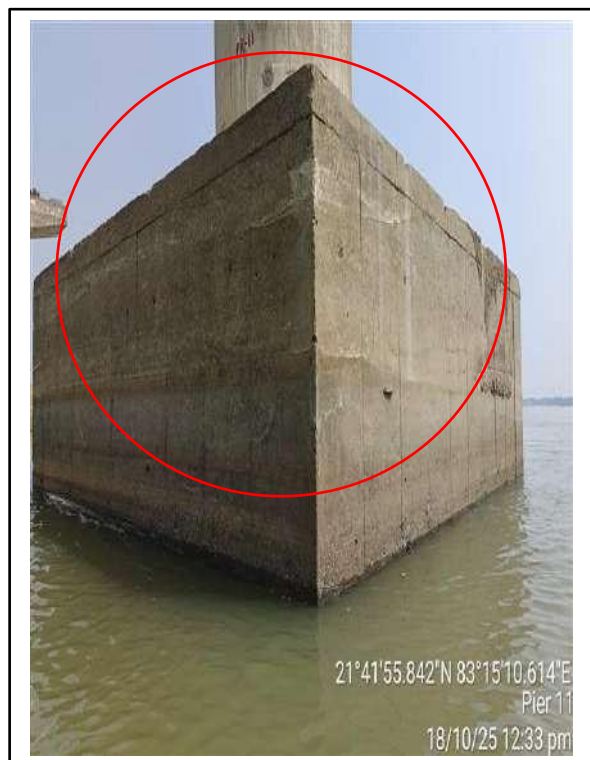
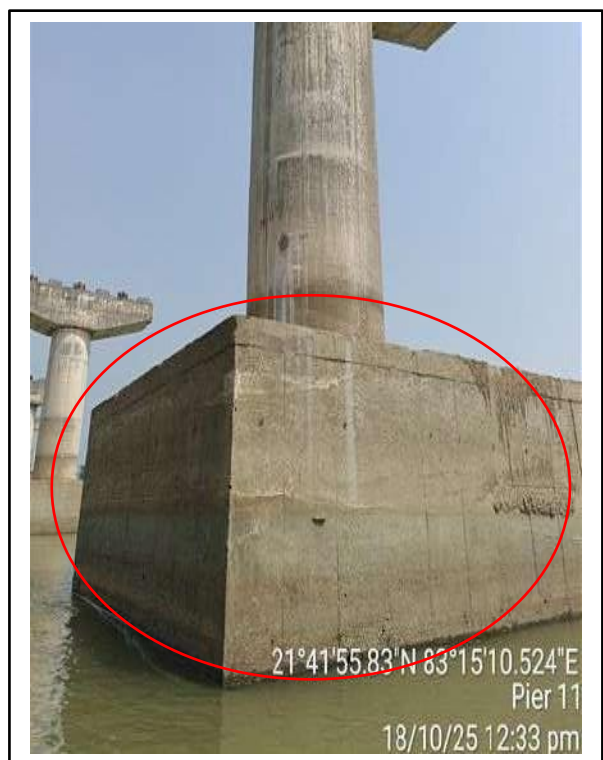
Picture-7 & 8: Cracks on pile cap surface

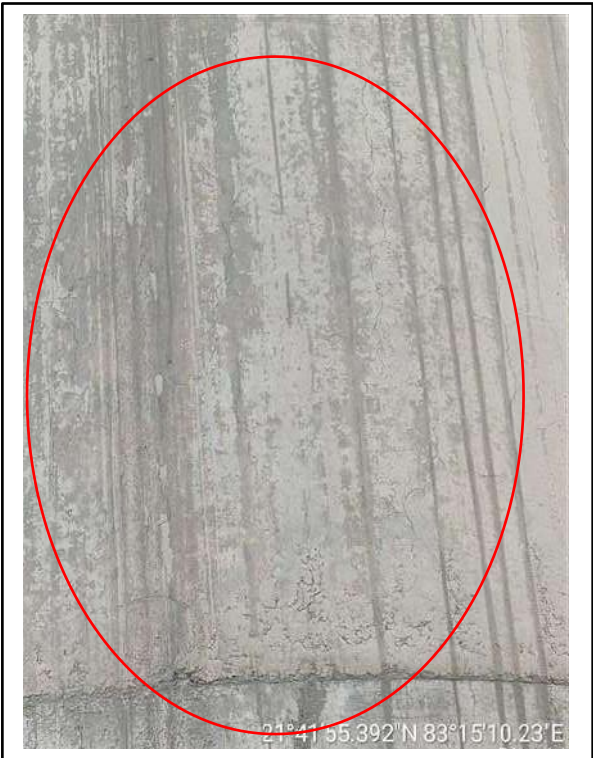
**Picture-2: Cracks on pier surface**

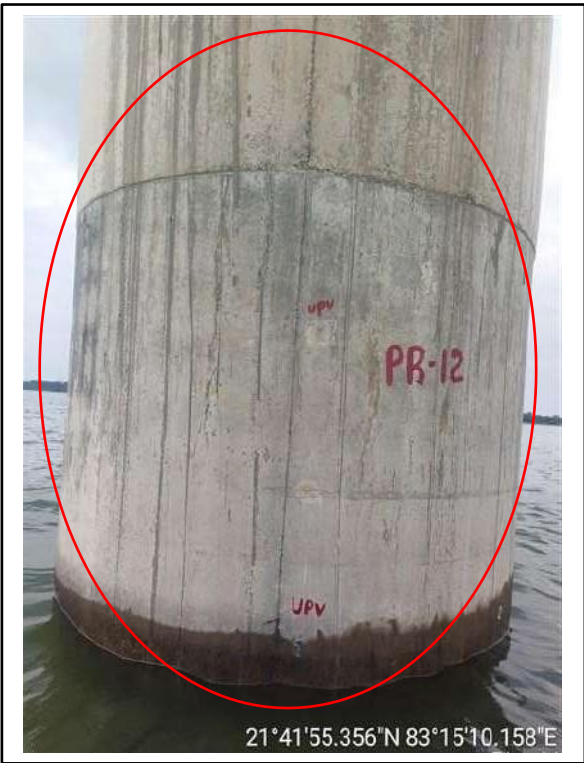
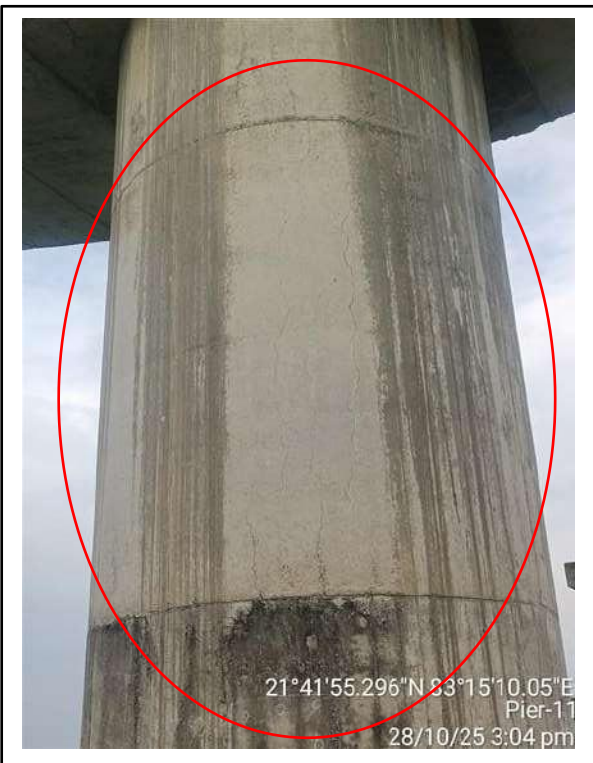
**Picture-3 & 4: Cracks on pier surface**

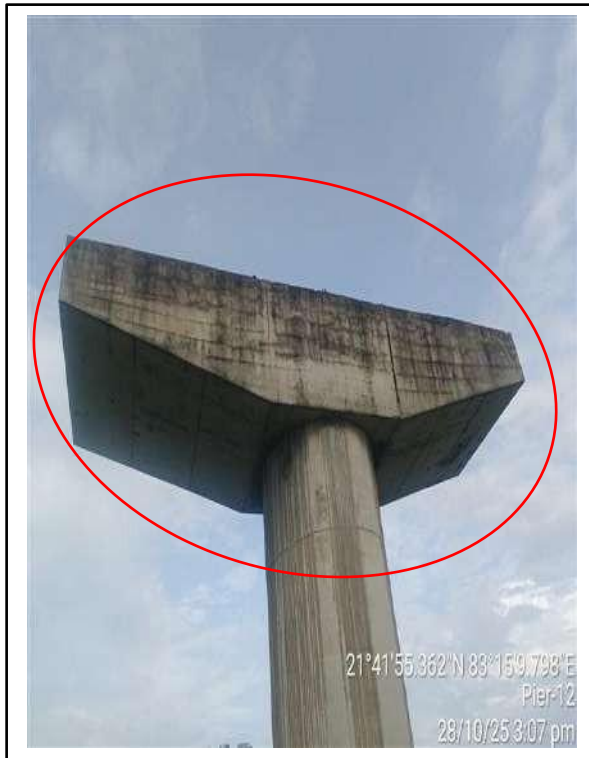
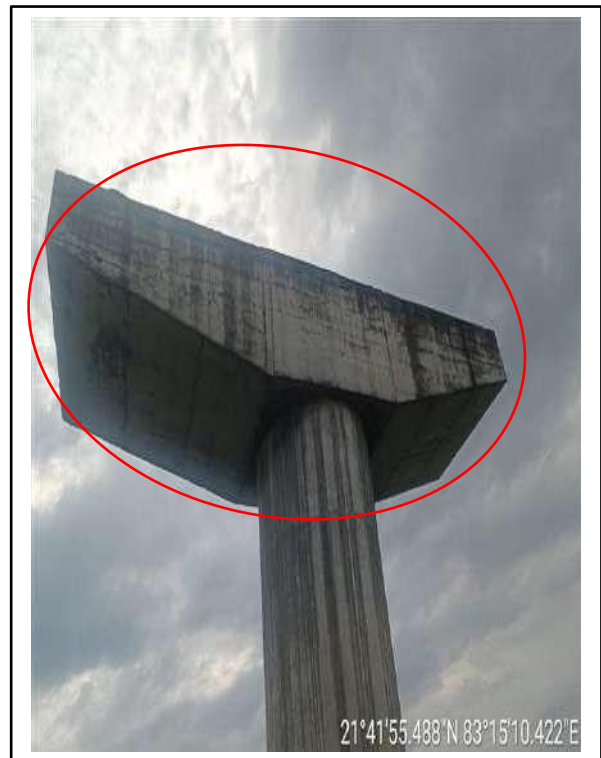
**Picture- 5 & 6: Minor cracks, leaching & efflorescence on pier cap.**

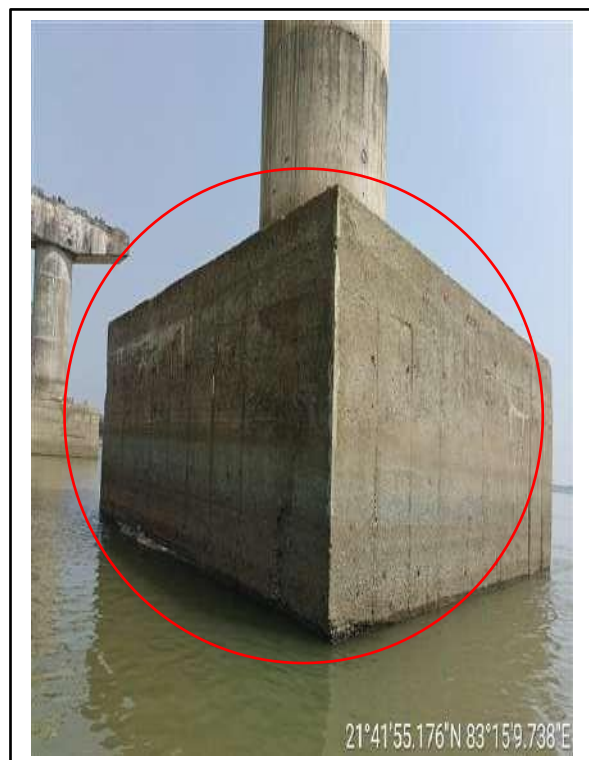
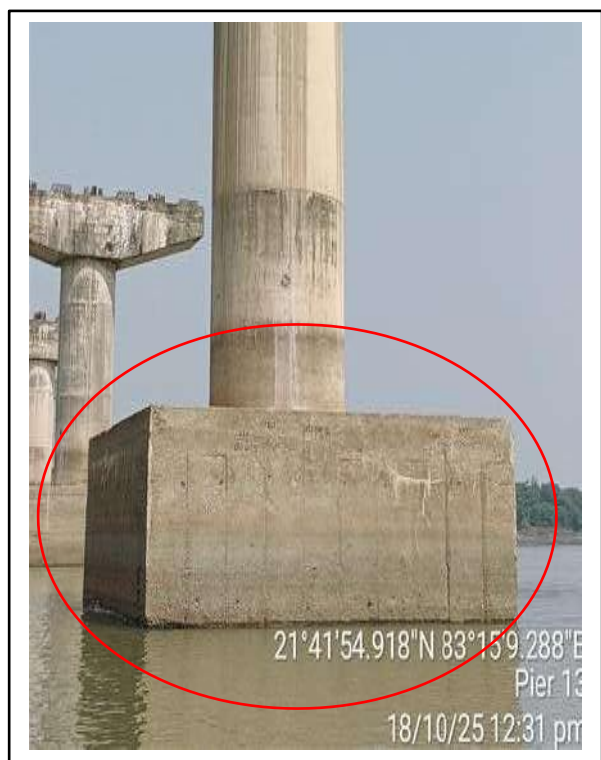
**Picture-7 & 8: Cracks on pile cap surface**

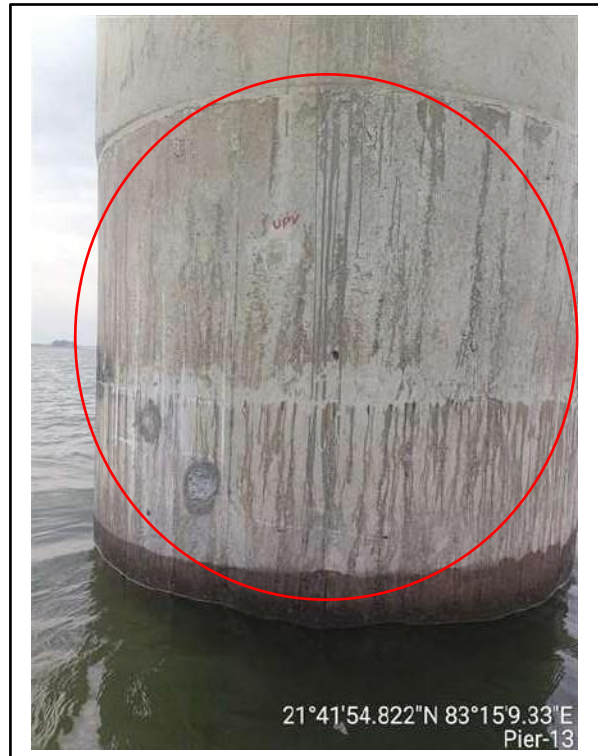
Picture-2: Minor cracks on pier surface

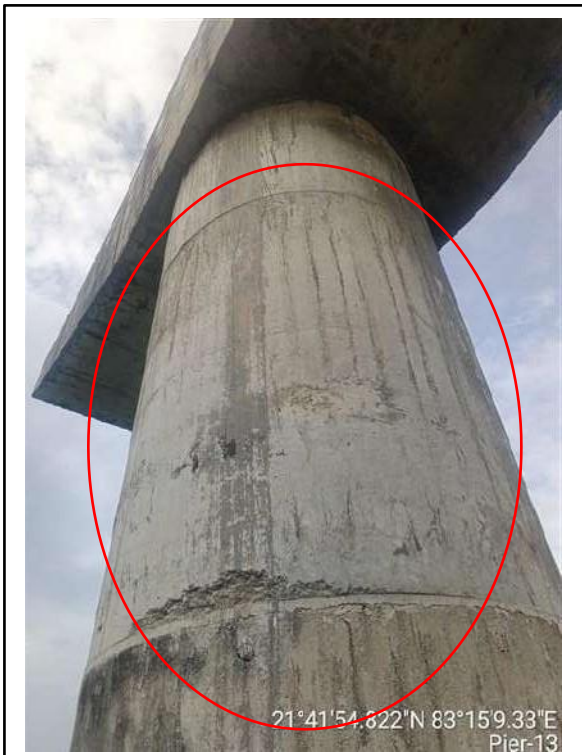
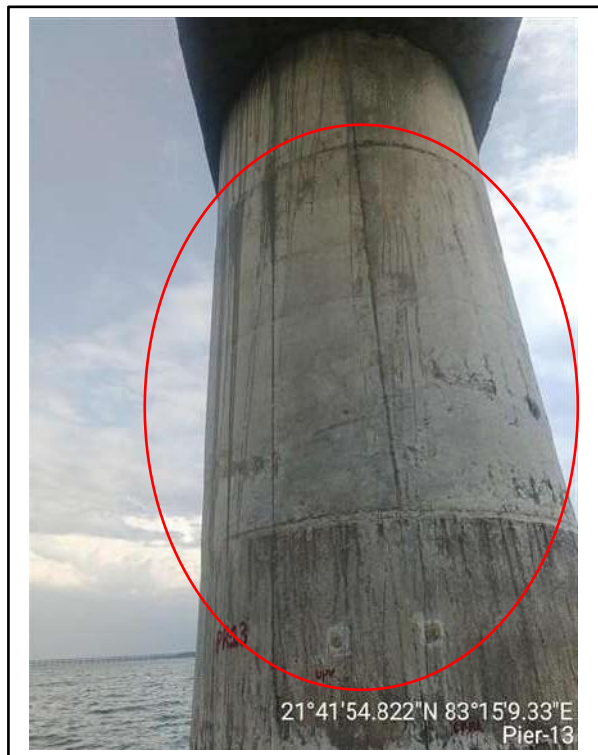
Picture-3 & 4: Minor cracks on pier surface

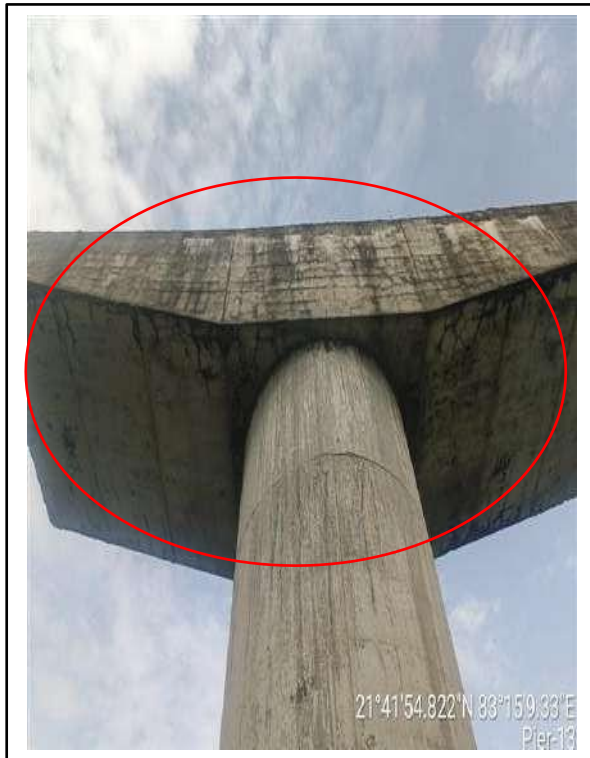
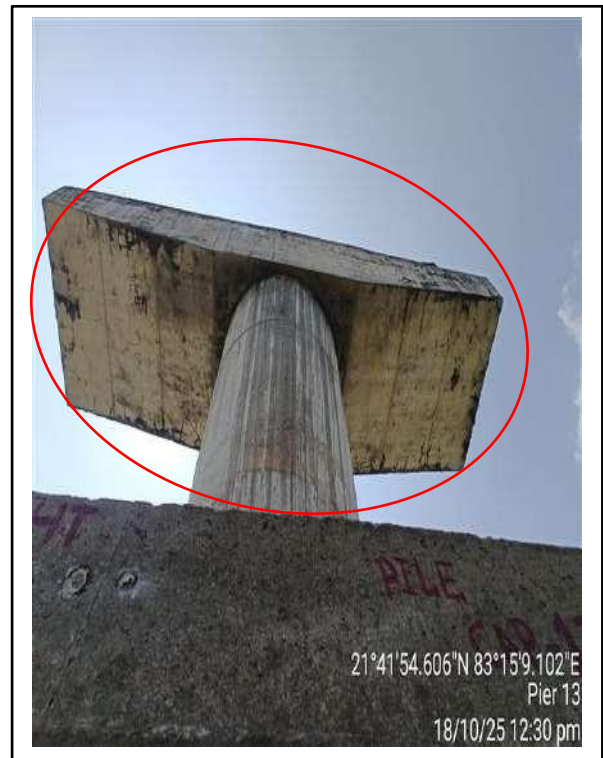
Picture- 5 & 6: Minor cracks, leaching & efflorescence on pier cap.

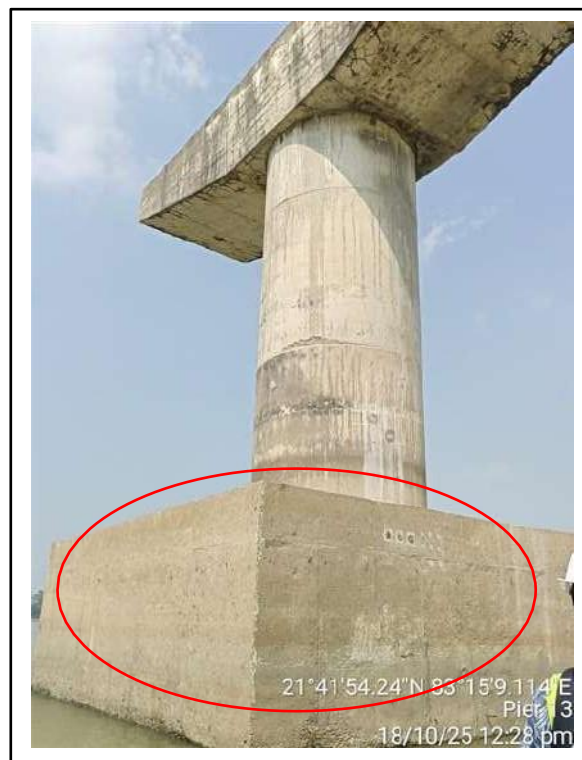
Picture-7 & 8: Cracks on pile cap surface

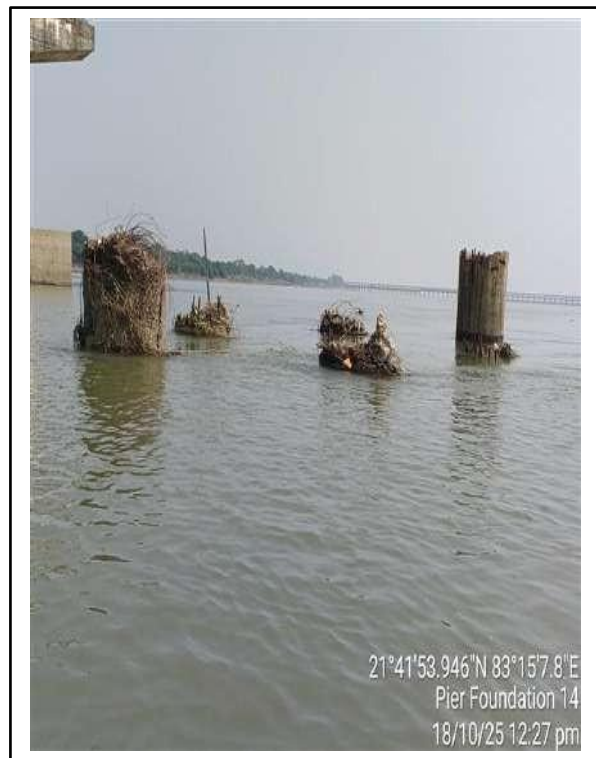
1. Pier – 14 is not constructed and its pile foundation is partially executed up to pile level only.
2. Total 6 Nos piles are observed in this pile foundation and no other structural members are not constructed.
3. Damages observed on 2 piles concrete above the water level.
4. Debris observed near the piles.

Picture-2: Debris near piles.

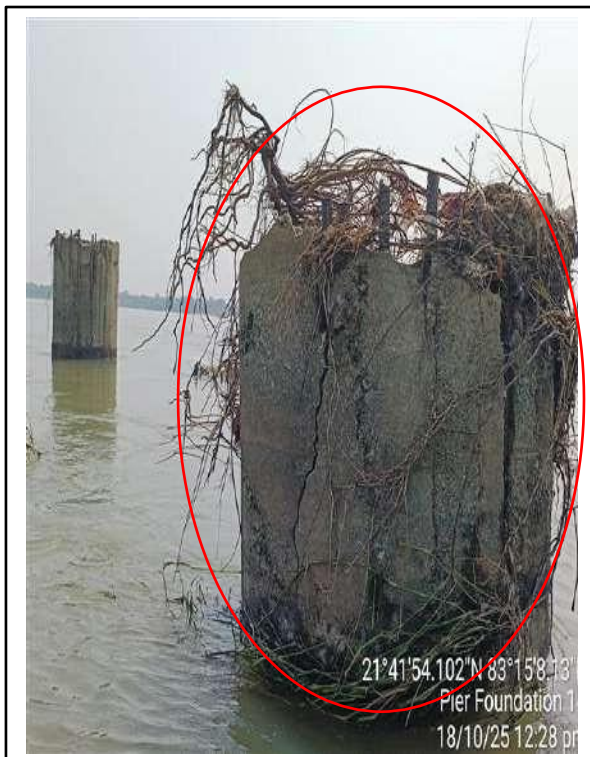
Picture-3: Pile concrete damage.

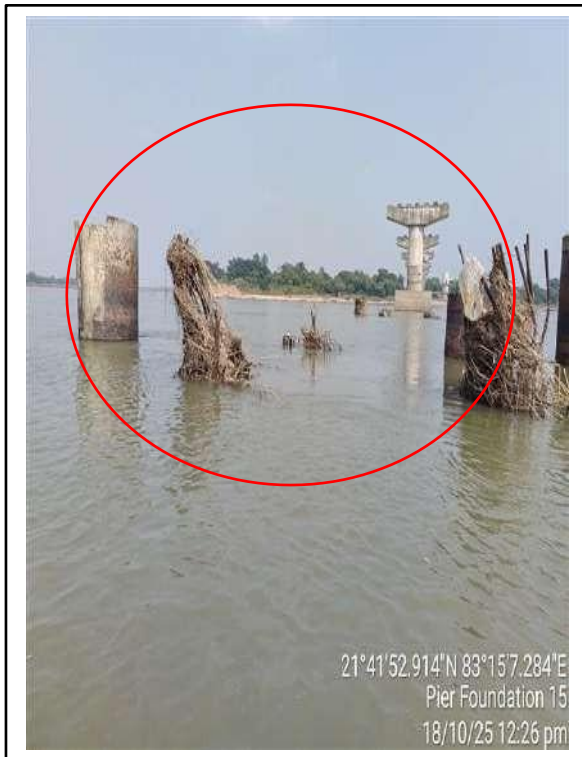
1. Pier – 15 is not constructed and its pile foundation is partially executed up to pile level only.
2. Total 6 Nos piles are observed in this pile foundation and no other structural members are not constructed.
3. Severe crack observed on pile concrete above the water level.
4. Damages observed on pile liners above the water level.
5. Debris observed near the piles.

Picture-3: Debris near piles.

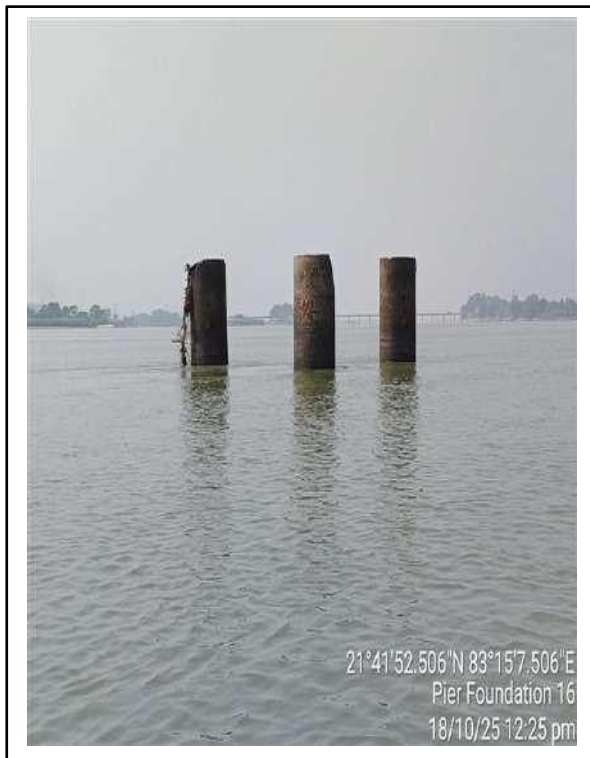
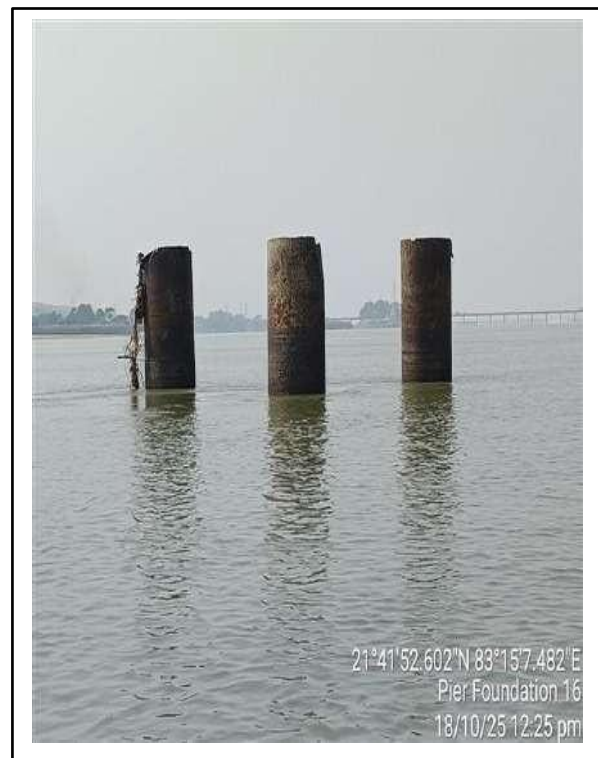
Picture-1 & 2: Piles foundation – 16 view

1. Pier – 16 is not constructed and its pile foundation is partially executed up to pile level only.
2. Total 3 Nos piles are observed in this pile foundation and no other structural members are not constructed.
3. Steel liner observed for 3 piles.

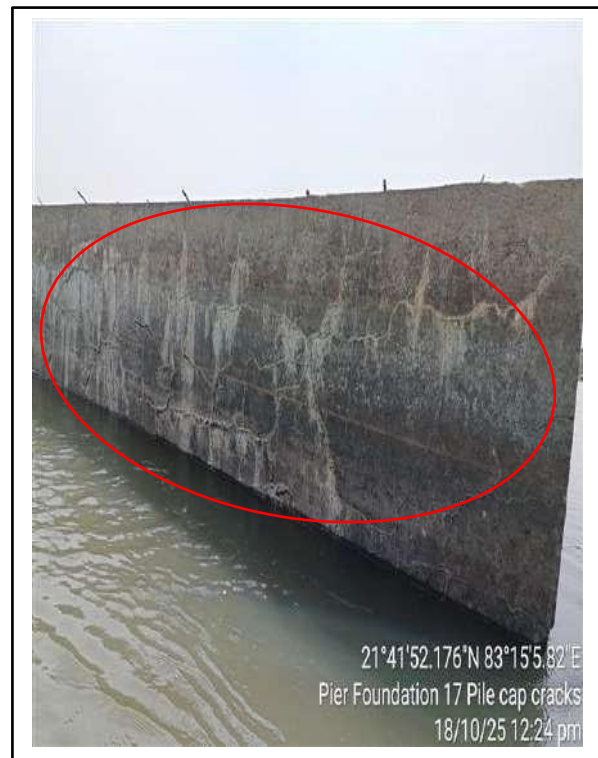
1. Pier – 17 is not constructed and its pile foundation is executed up to pile cap level.
2. Several minor and major cracks observed on cap all faces and on cap top level.
3. Efflorescence observed on pile cap side faces at all crack locations.

Picture-2: Cracks on Pile cap side face.

S.NO	LOCATION		CRACK WIDTH IN MM
1	Pile cap-17	Pile cap	0.1 to 1.5

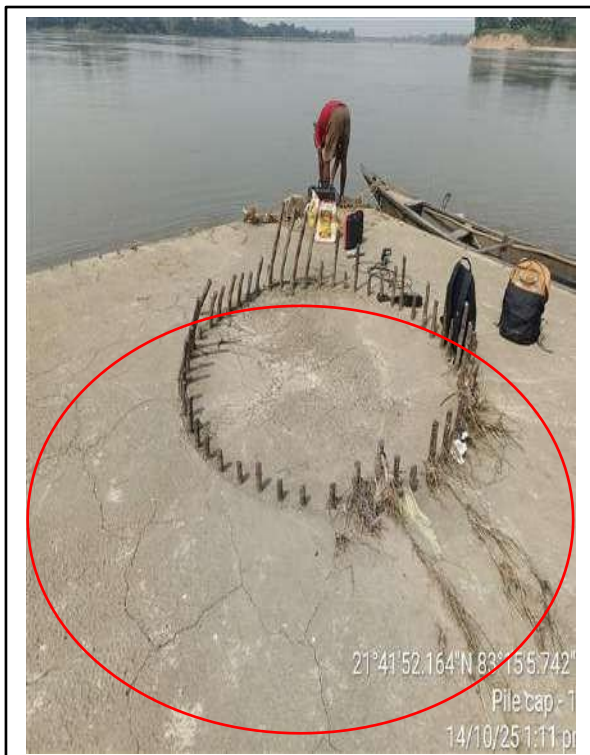
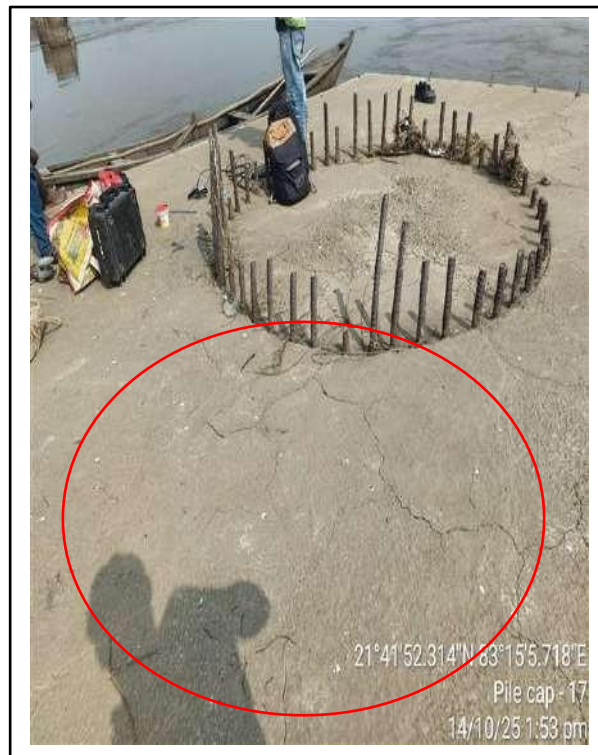
Picture-3 & 4: Cracks on pile cap top face

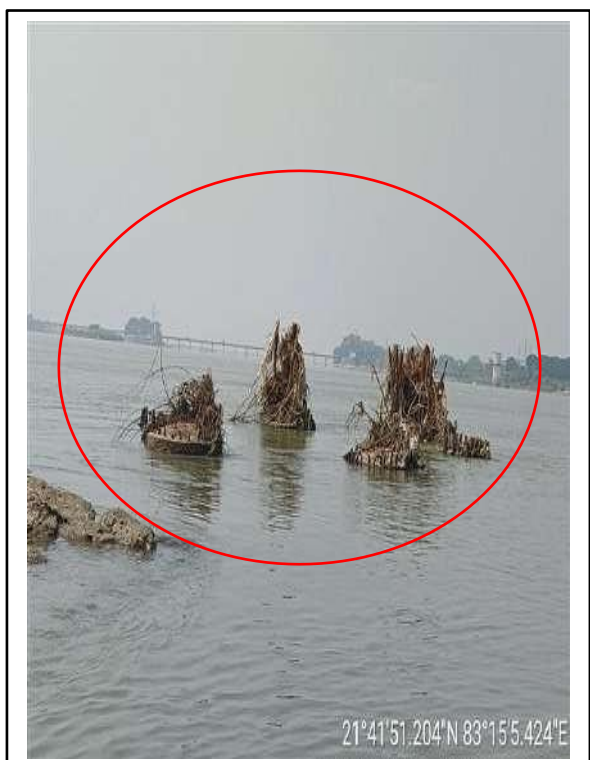
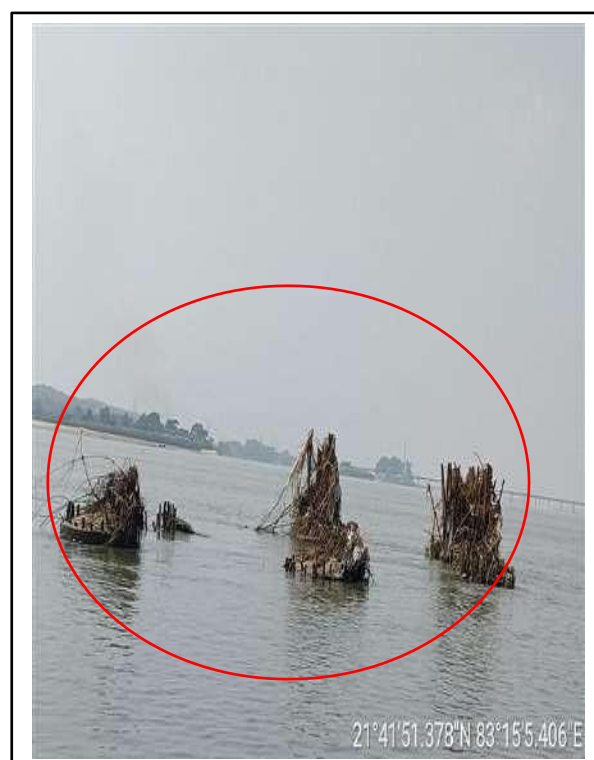
1. Pier – 18 is not constructed and its pile foundation is partially executed up to pile level only.
2. Total 6 Nos piles are observed in this pile foundation and no other structural members are not constructed.
3. Debris observed near all piles.

Picture-3 & 4: Debris near all piles.

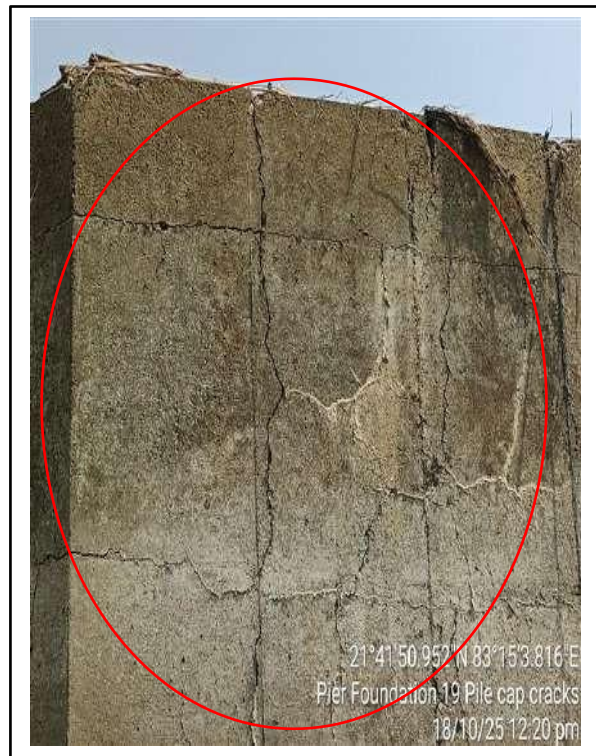
1. Pier – 19 is not constructed and its pile foundation is executed up to pile cap level.
2. Several minor and major cracks observed on cap all faces and on cap top level.
3. Efflorescence observed on pile cap side faces at all crack locations.

Picture-2: Cracks on pile cap.

S.NO	LOCATION		CRACK WIDTH IN MM
1	Pile cap-19	Pile cap	0.1 to 1.5

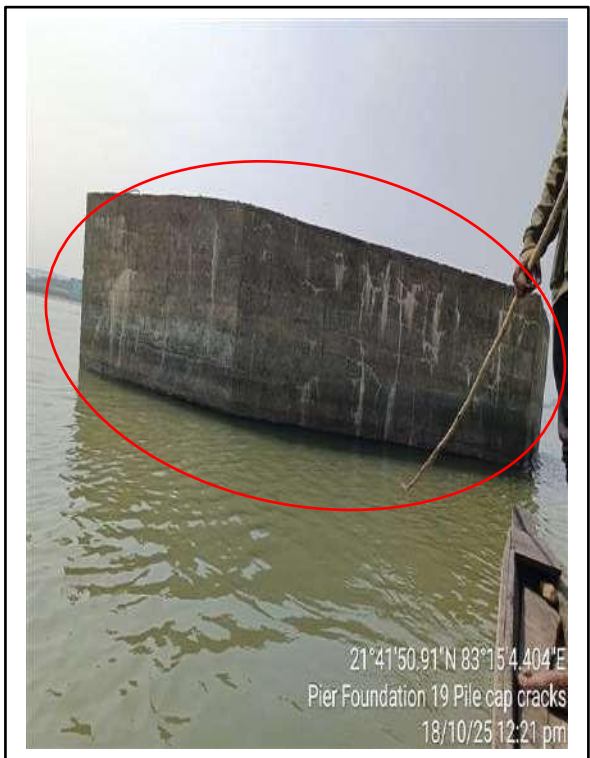
Picture-3: Cracks on pile cap.

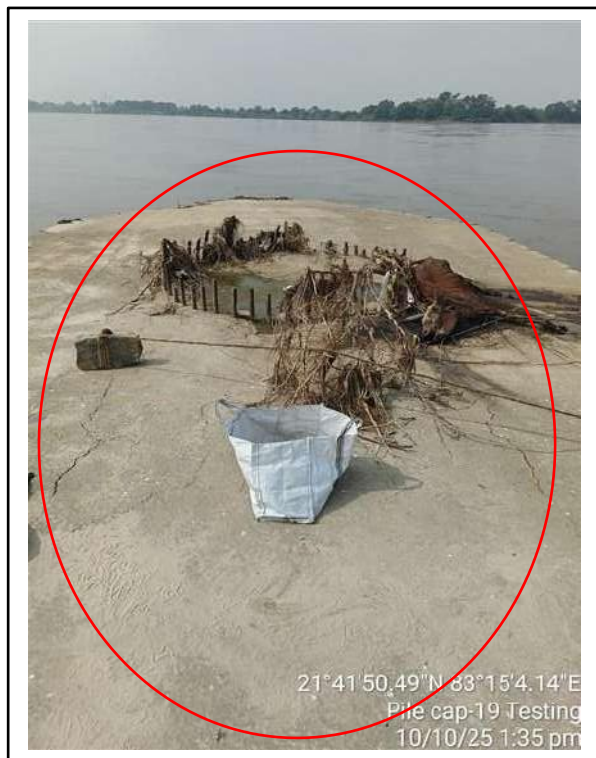
Picture-4: Cracks & Debris on cap.

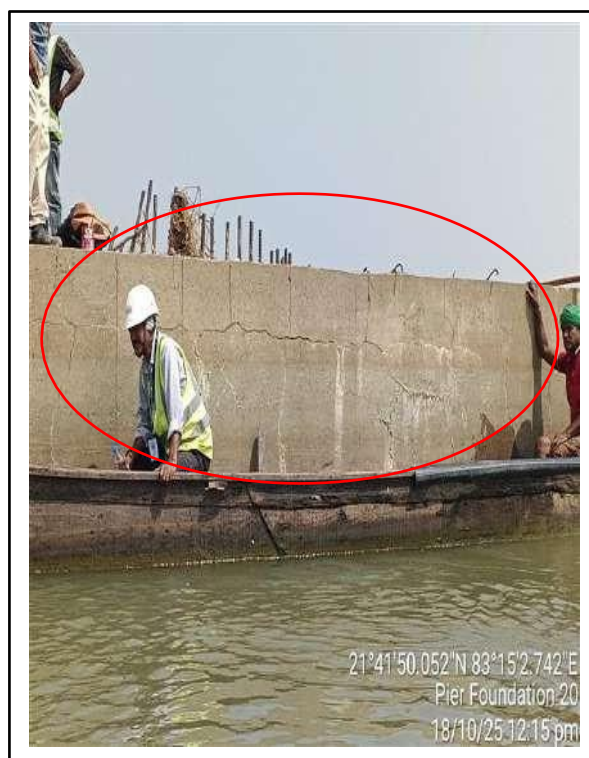
1. Pier – 20 is not constructed and its pile foundation is executed up to pile cap level.
2. Several minor and major cracks observed on pile cap all faces and on cap top level.
3. Efflorescence observed on pile cap side faces at all crack locations.

Picture-2: Cracks on pile side face.

S.NO	LOCATION		CRACK WIDTH IN MM
1	Pile cap-20	Pile cap	0.1 to 1.5

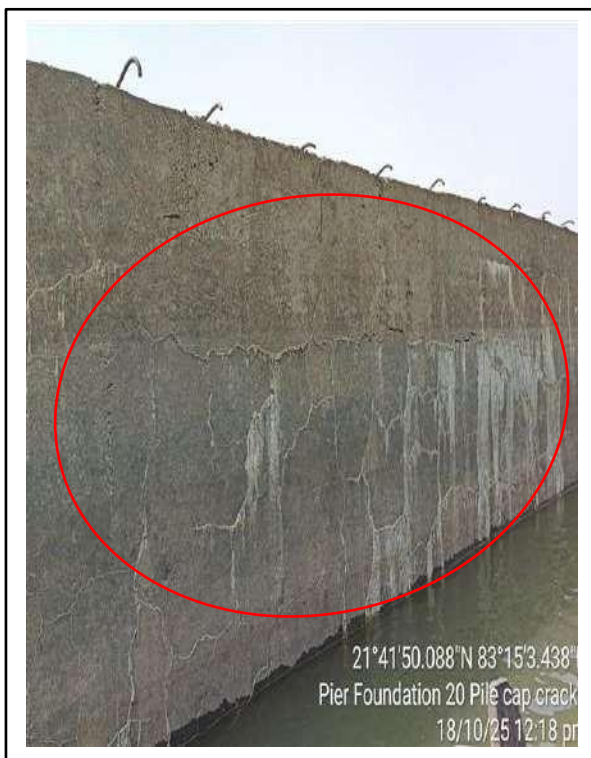
Picture-3: Cracks & Efflorescence on pile side face.

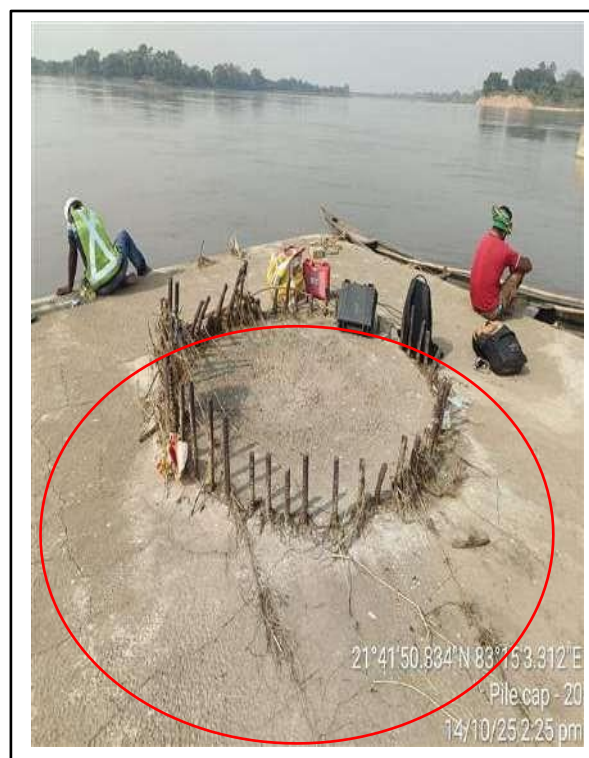
Picture-4: Cracks on pile cap top level.

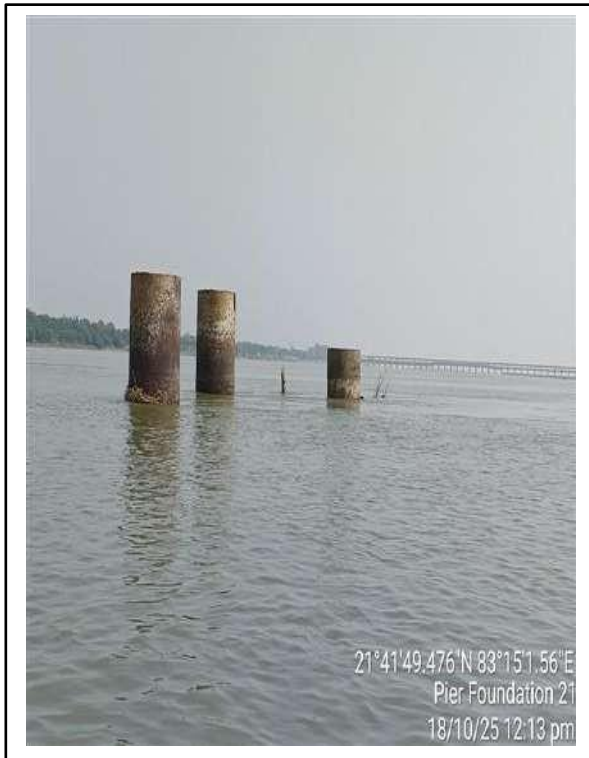
**Picture-1: Piles foundation – 21 view**

1. Pier – 21 is not constructed and its pile foundation is partially executed up to pile level only.
2. Total 3 Nos piles are observed in this pile foundation and no other structural members are not constructed.
3. Debris observed near piles.

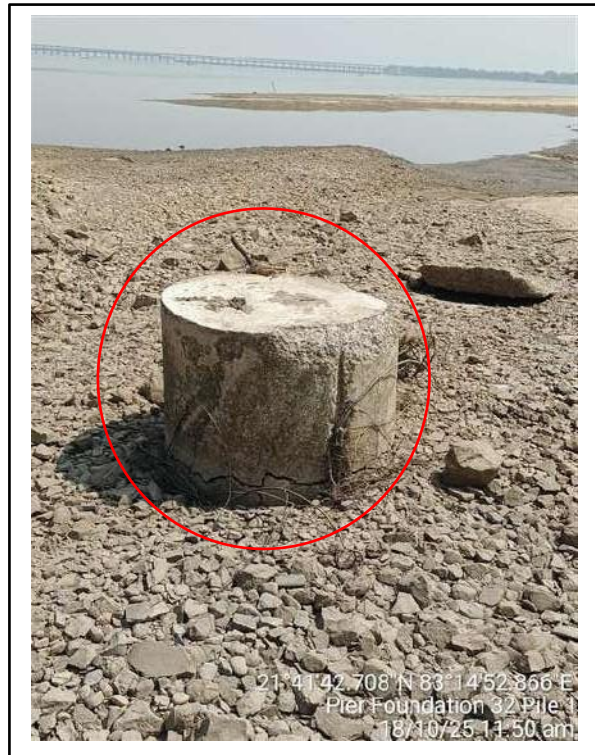
1. Pier – 32 is not constructed and its pile foundation is partially executed up to pile level only.
2. Total 4 Nos piles are observed in this pile foundation and no other structural members are not constructed.
3. Pile concrete damages are observed above the ground level.

Picture-2: Cracks on pile concrete.

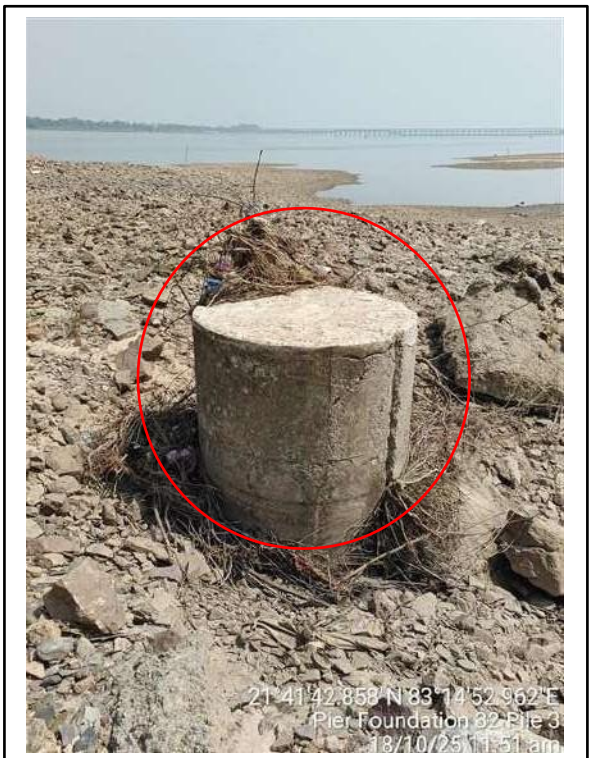
Picture-3: Cracks on pile concrete.

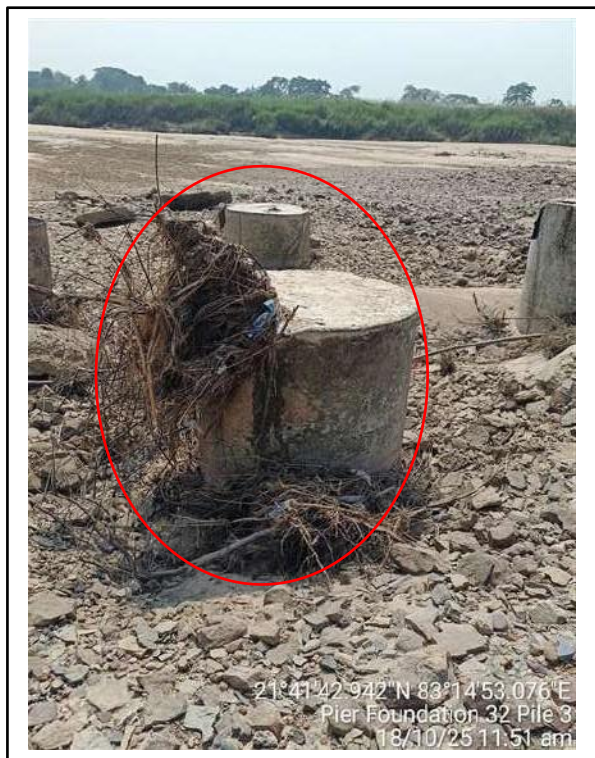
Picture-4: Debris near pile.

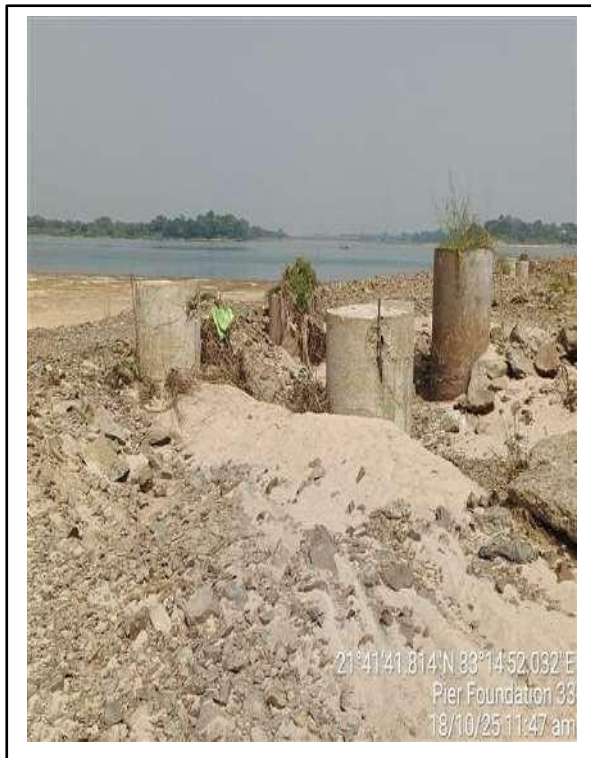
Picture-1: Piles foundation – 33 view

1. Pier – 33 is not constructed and its pile foundation is partially executed up to pile level only.
2. Total 4 Nos piles are observed in this pile foundation and no other structural members are not constructed.
3. Pile concrete damages are observed above the ground level.

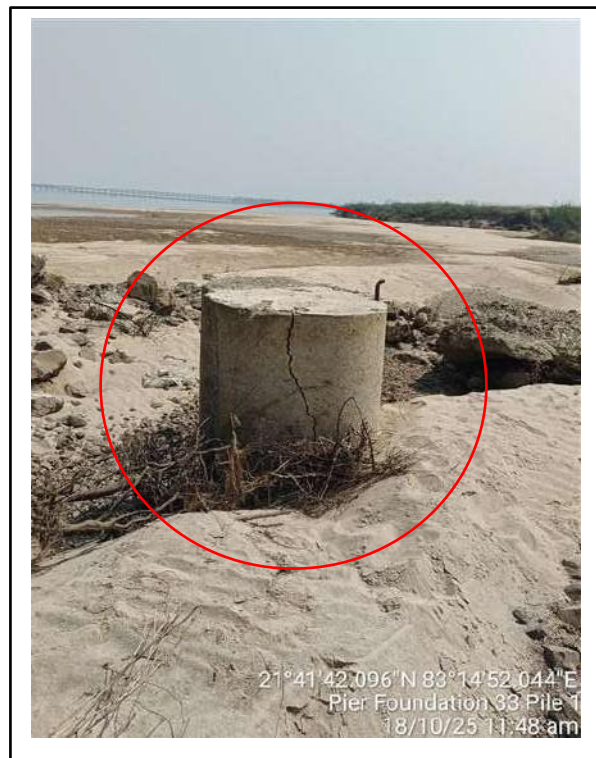
Picture-2: Cracks on pile concrete.
