# DETAILED INSPECTION REPORT

## PARTIALLY EXECUTED WORK OF MAJOR BRIDGE

**KM 28+400 OVER MAHANADI ON NH-153 RAIGARH  
SARANGARH SARAIPALI IN THE DISTRICT SAKTI  
OF CHHATTISGARH UNDER THE PWD, NH  
DIVISION BILASPUR**

**IDDC ENGINEERS PVT. LTD.**

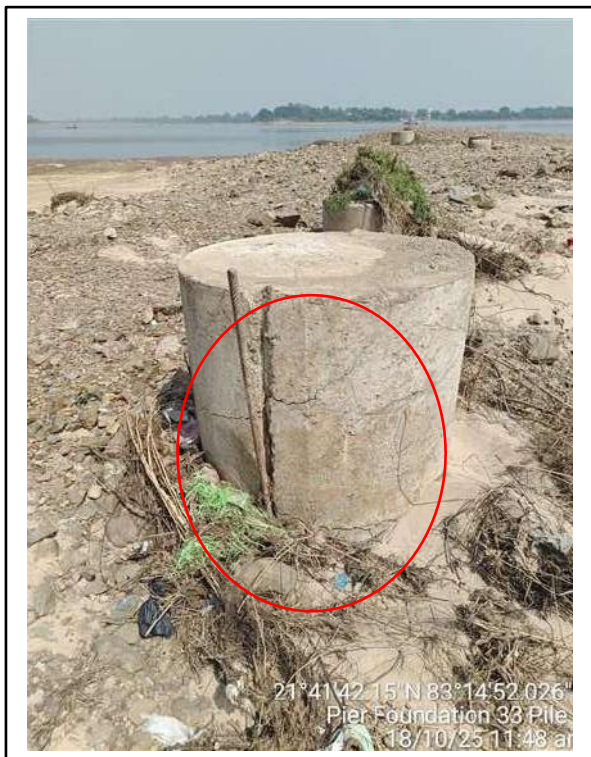
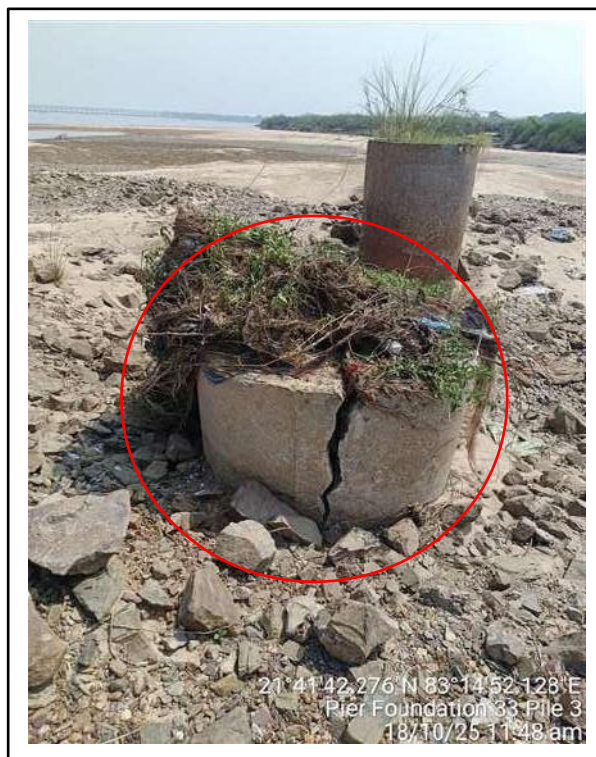
Picture-3 & 4: Cracks and debris on pile concrete

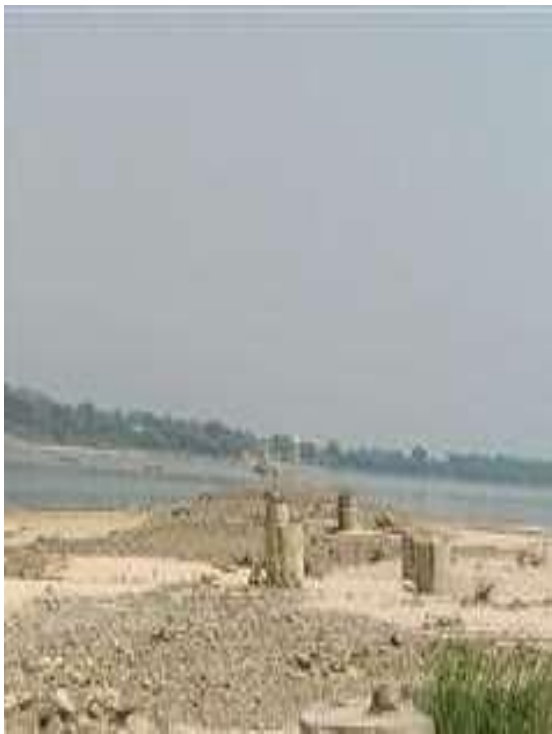
Picture-1: Piles foundation – 34 view

1. Pier – 34 is not constructed and its pile foundation is partially executed up to pile level only.
2. Total 4 Nos piles are observed in this pile foundation and no other structural members are not constructed.
3. Pile concrete damages are observed above the ground level

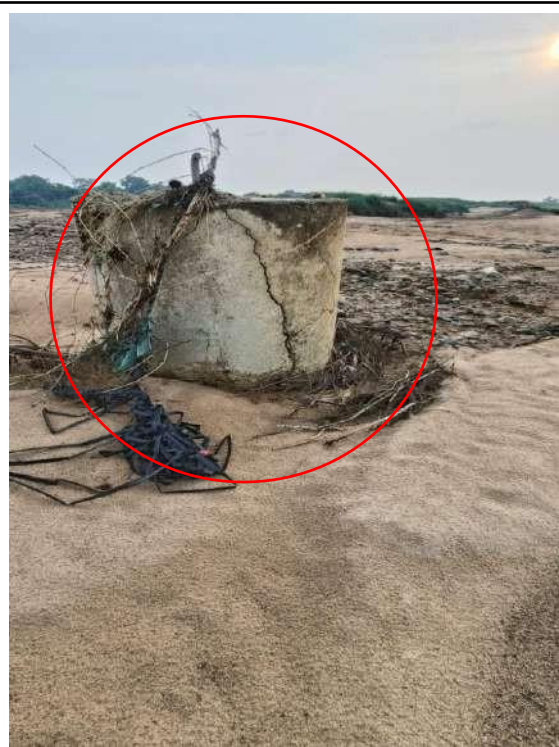
Picture-2: Crack on pile concrete.

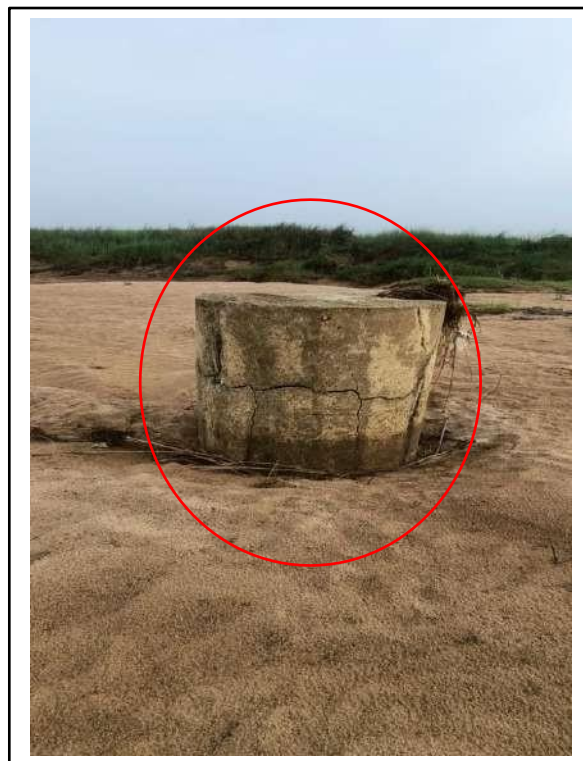
Picture-3: Crack on pile concrete.

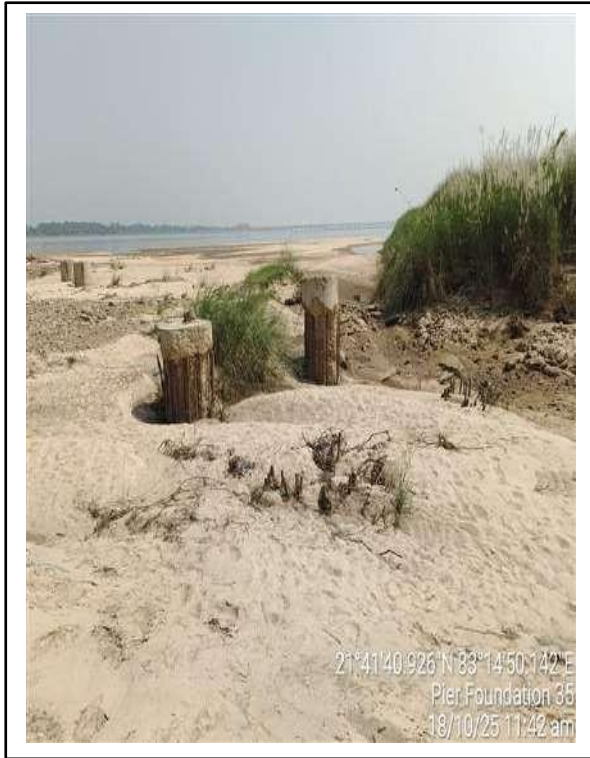
Picture-1: Piles foundation – 35 view

1. Pier – 35 is not constructed and its pile foundation is partially executed up to pile level only.
2. Total 4 Nos piles are observed in this pile foundation and no other structural members are not constructed.
3. Pile concrete damages and reinforcement corrosion are observed above the ground level.

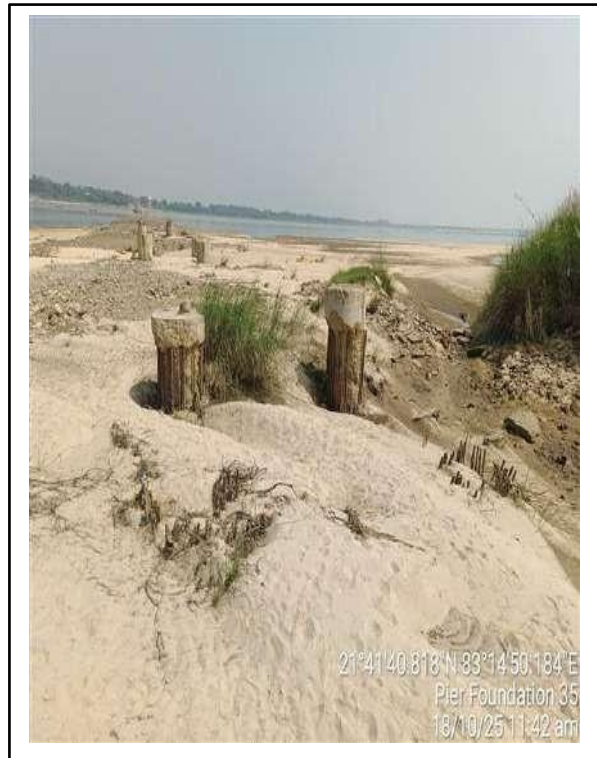
Picture-2: Concrete damage on piles

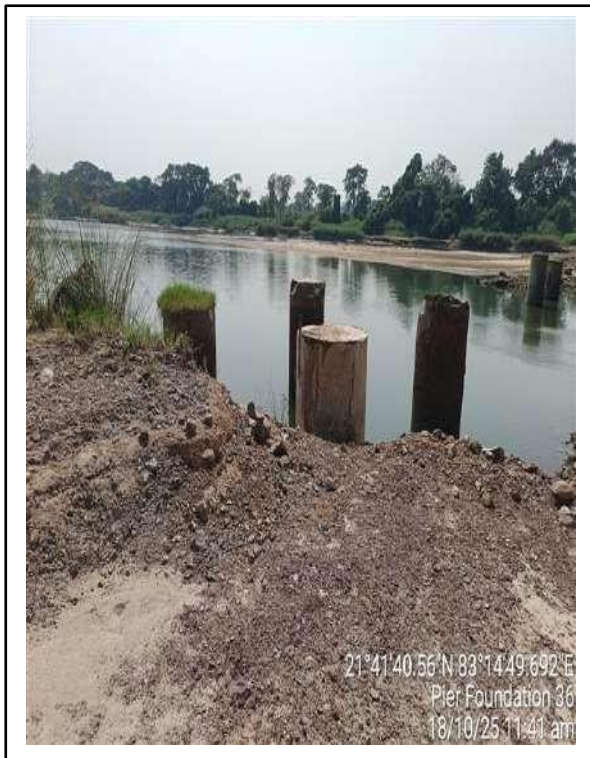
Picture-1: Piles foundation – 36 view

1. Pier – 36 is not constructed and its pile foundation is partially executed up to pile level only.
2. Total 4 Nos piles are observed in this pile foundation and no other structural members are not constructed.
3. Pile concrete crack on 1 pile and other 3 piles are covered by steel liners above the ground level.

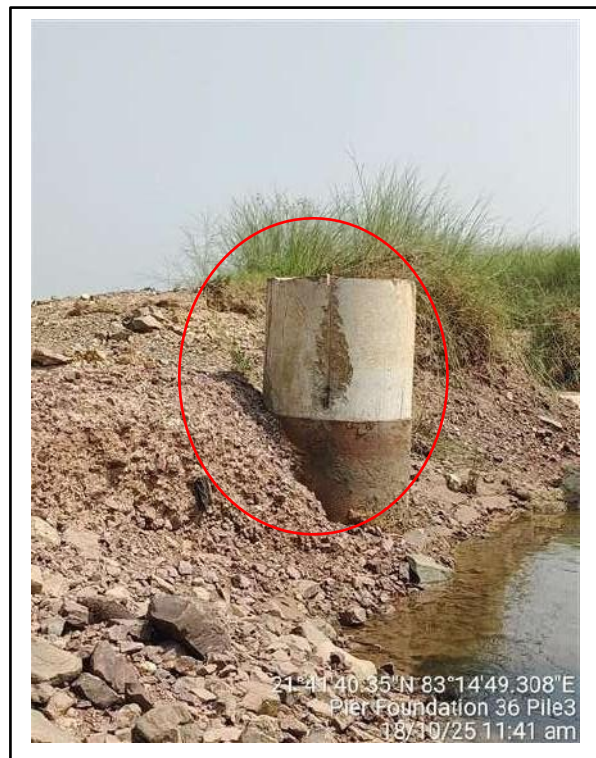
Picture-2: Damage on pile concrete.

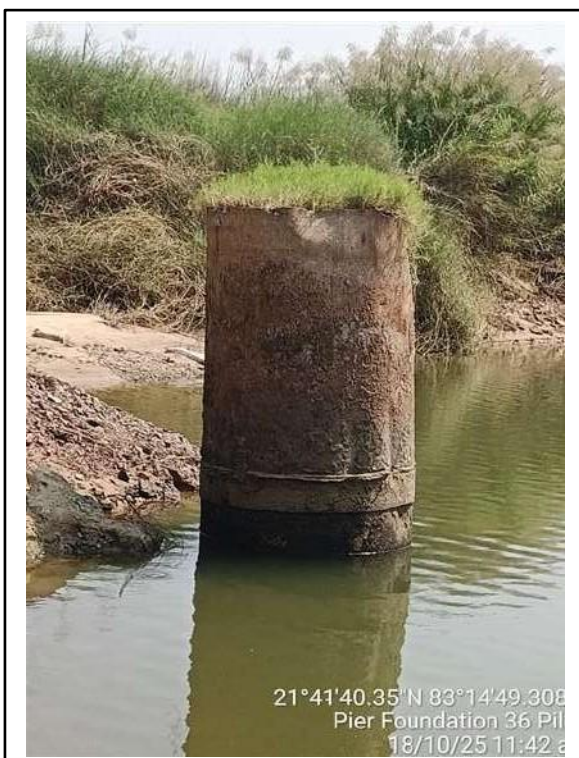
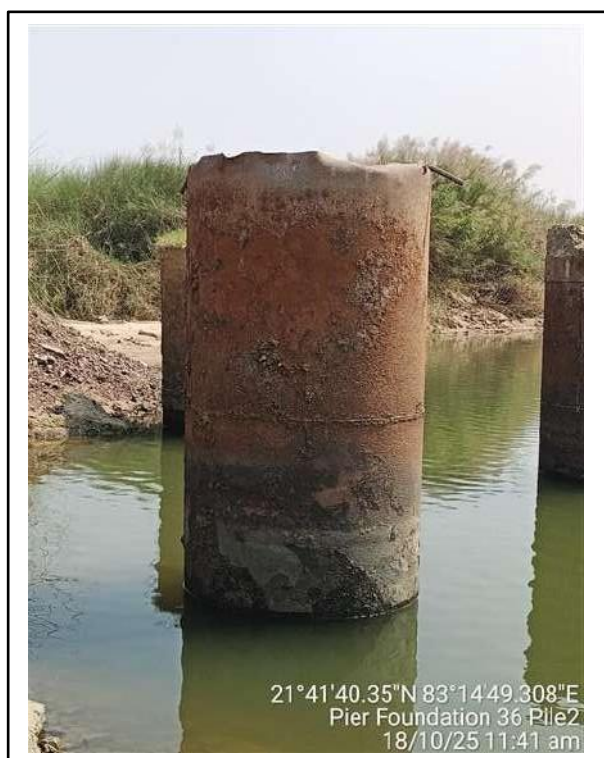
Picture-3: Steel liners for piles above the ground level

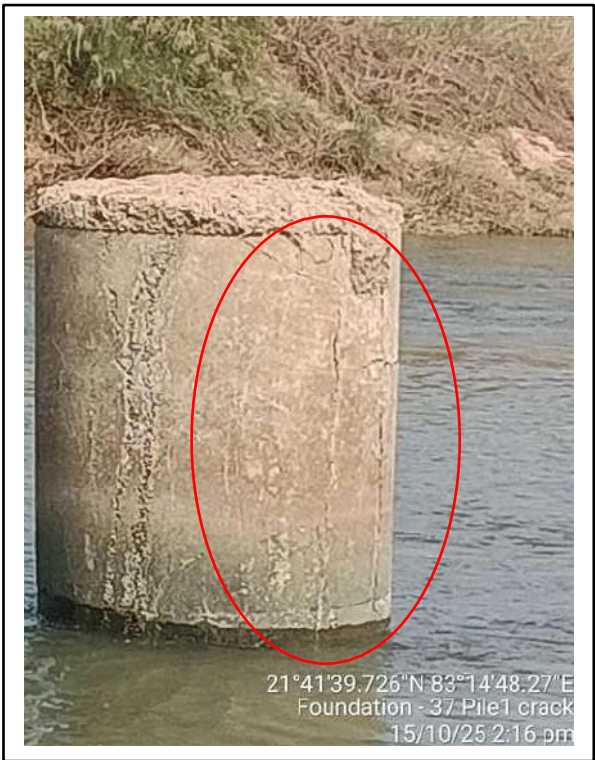
Picture-2: Cracks on pile concrete

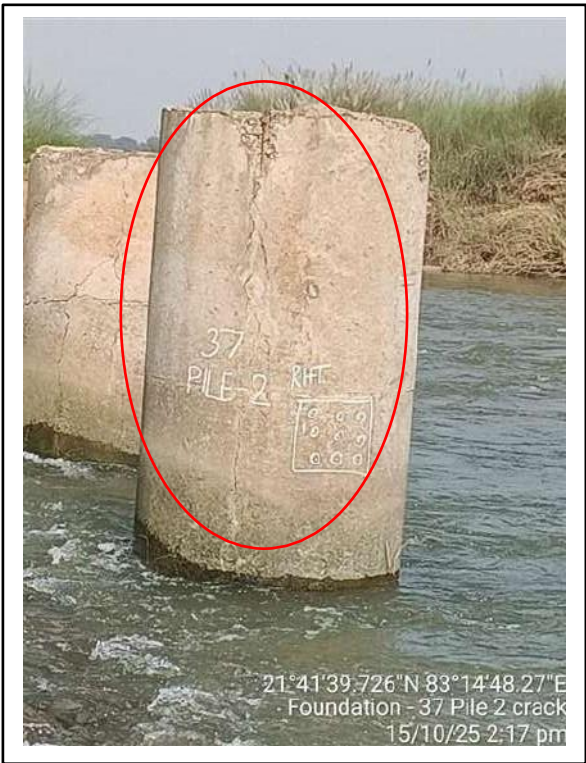
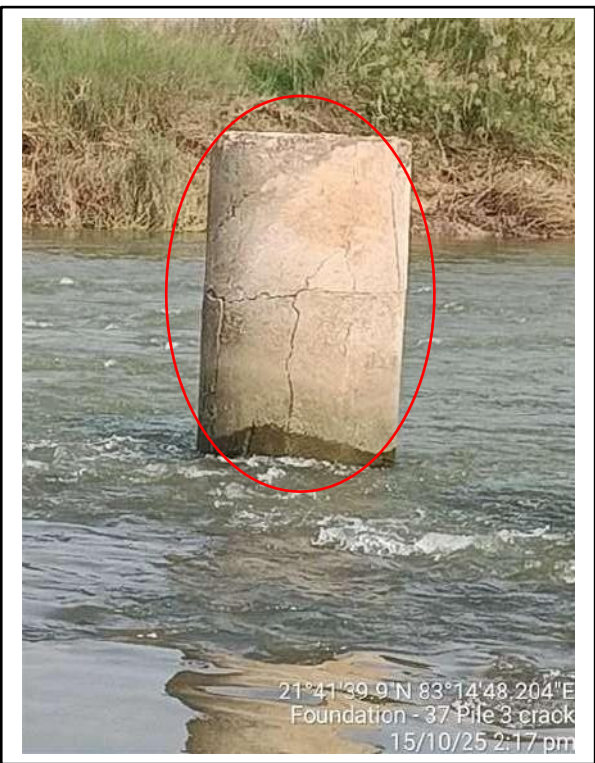
Picture-3 & 4: Cracks on pile concrete

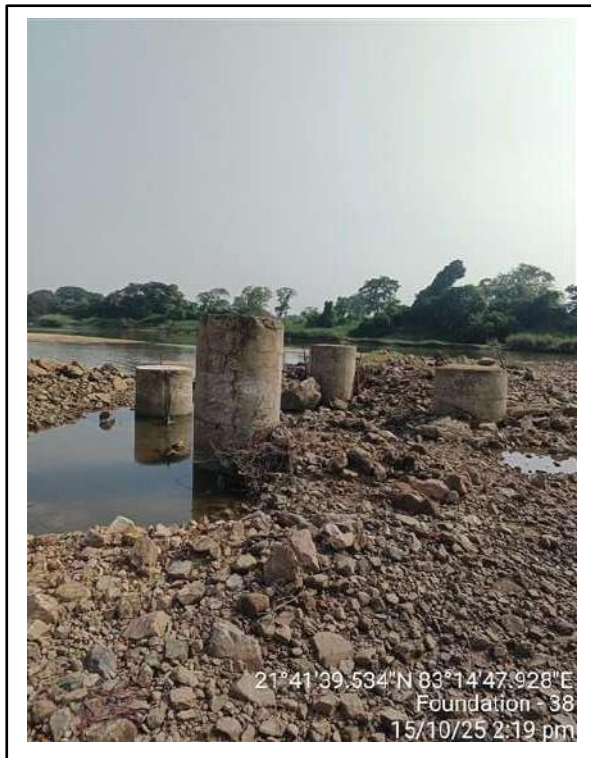
Picture-1: Piles foundation – 38 view

1. Pier – 38 is not constructed and its pile foundation is partially executed up to pile level only.
2. Total 4 Nos piles are observed in this pile foundation and no other structural members are not constructed.
3. Cracks on all pile concrete above the ground level

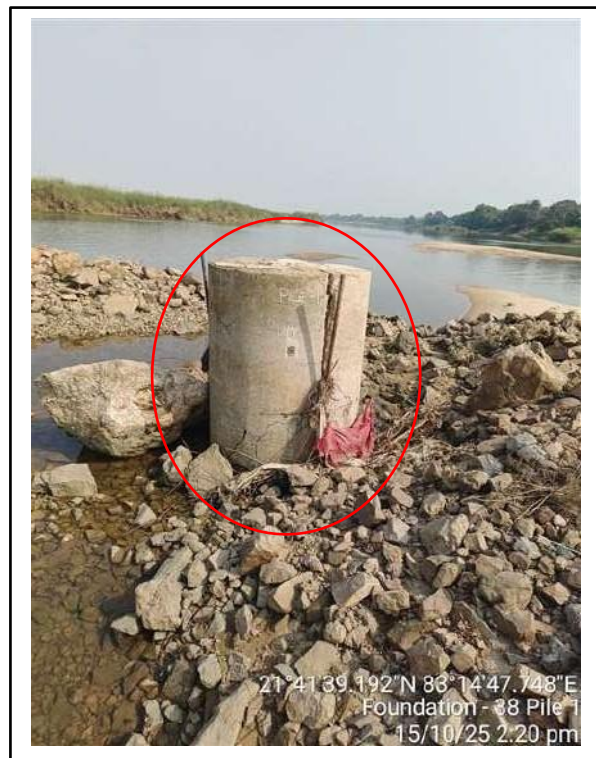
Picture-2: Cracks on pile concrete.

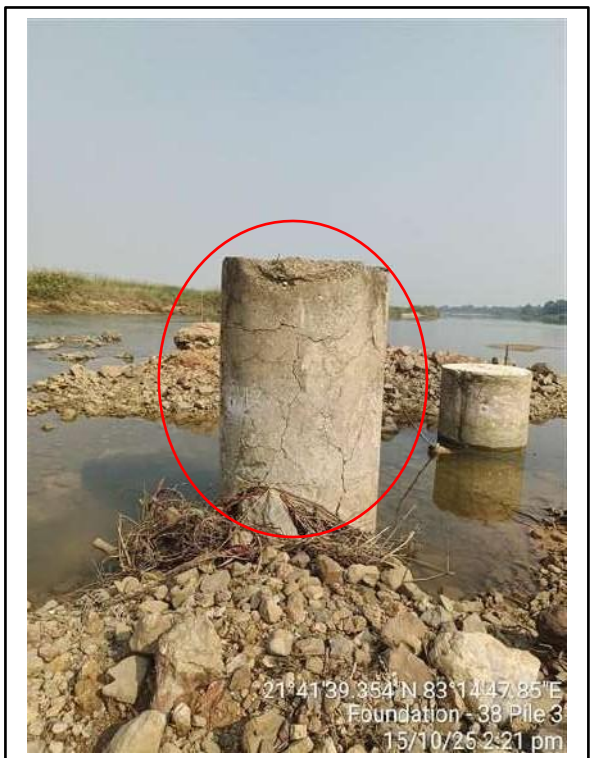
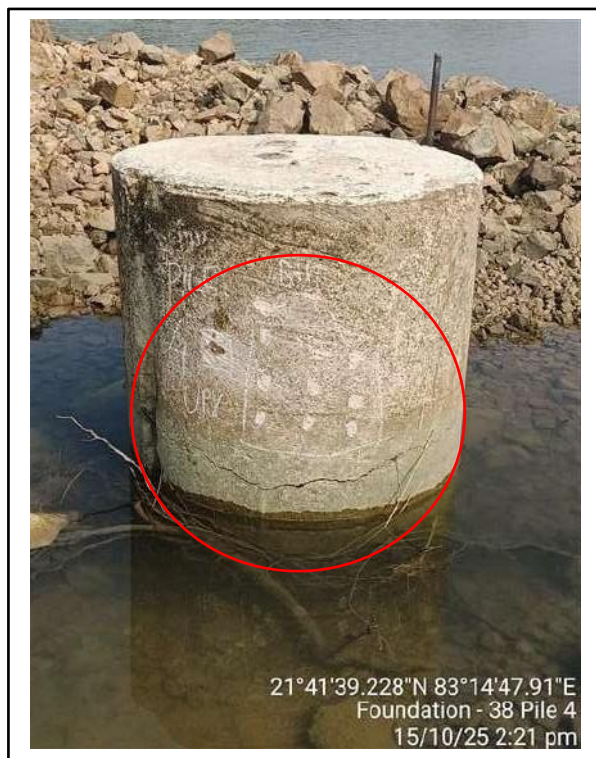
Picture-3 & 4: Cracks on pile concrete.

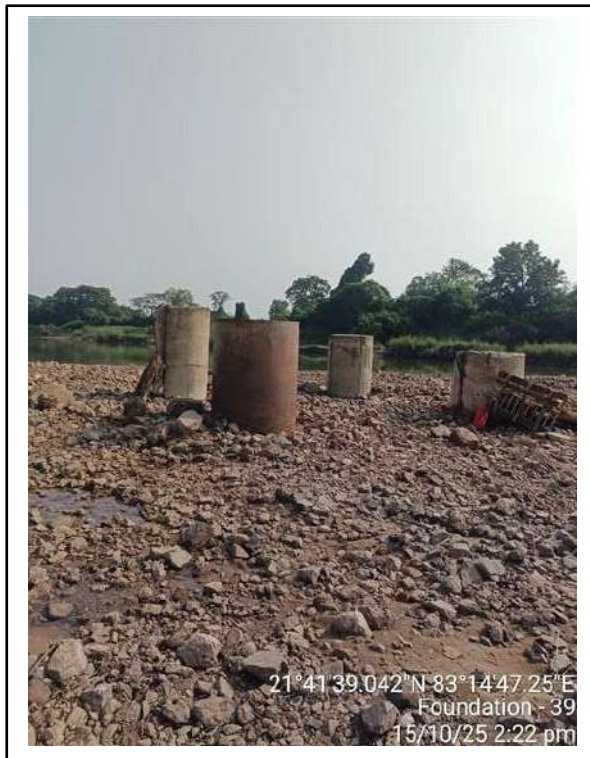
Picture-1: Piles foundation – 39 view

1. Pier – 39 is not constructed and its pile foundation is partially executed up to pile level only.
2. Total 4 Nos piles are observed in this pile foundation and no other structural members are not constructed.
3. Cracks on all pile concrete above the ground level

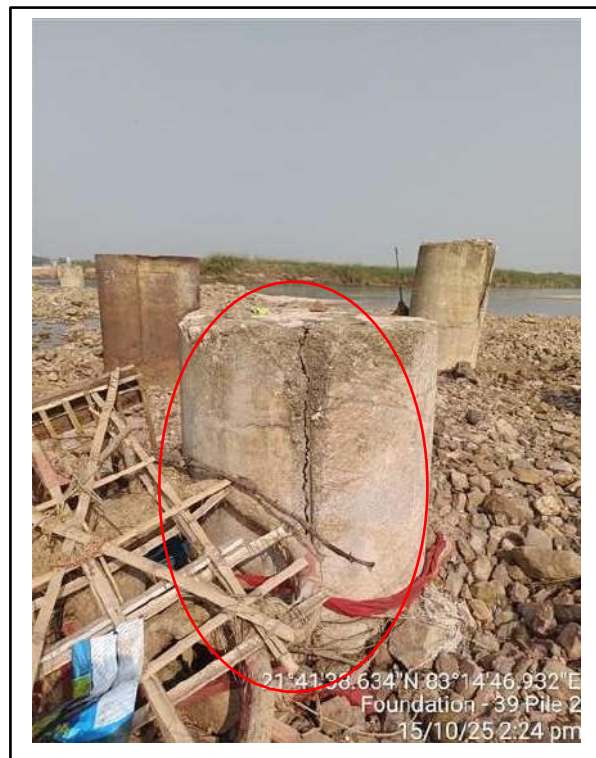
Picture-2: Cracks on pile concrete.

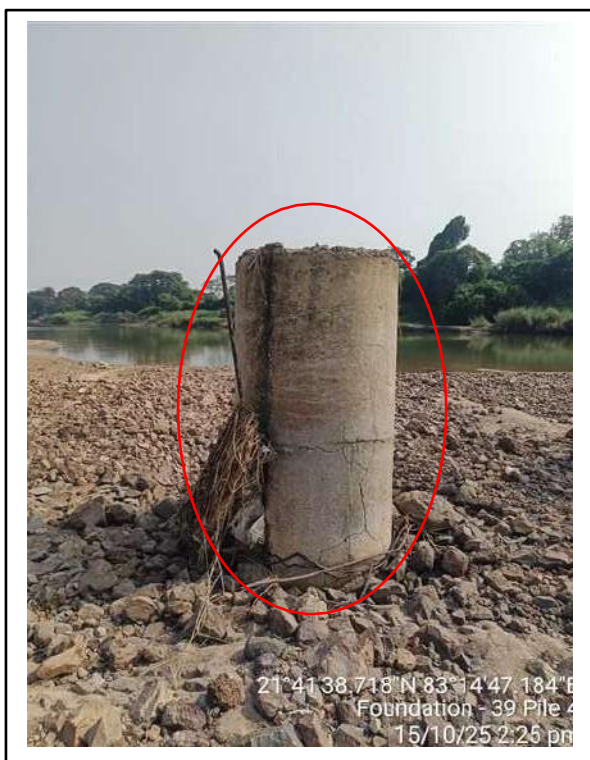
Picture-3: Cracks on pile concrete.

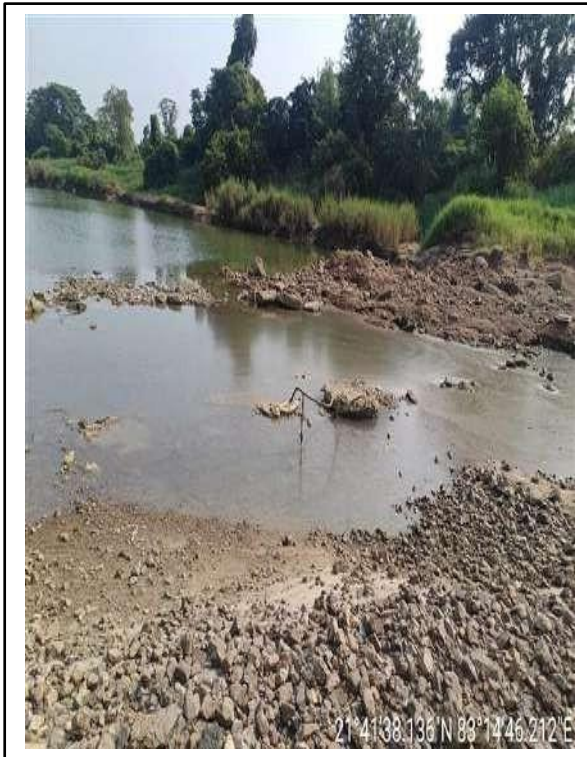
**Picture-1 & 2: Piles foundation – 40 view.**

1. Pier – 40 is not constructed and its pile foundation is partially executed up to pile level only.
2. Total 4 Nos piles are observed in this pile foundation and no other structural members are not constructed

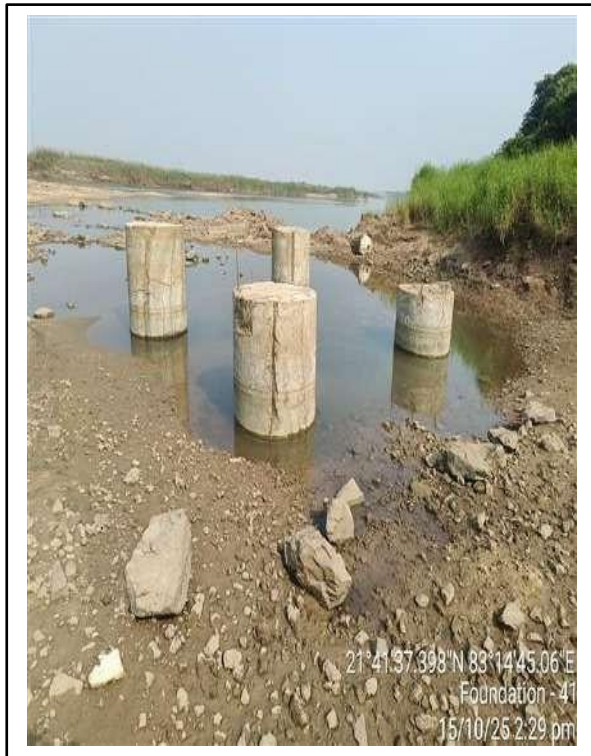
Picture-1: Piles foundation – 41 view

1. Pier – 41 is not constructed and its pile foundation is partially executed up to pile level only.
2. Total 4 Nos piles are observed in this pile foundation and no other structural members are not constructed.
3. Cracks on all pile concrete above the ground level

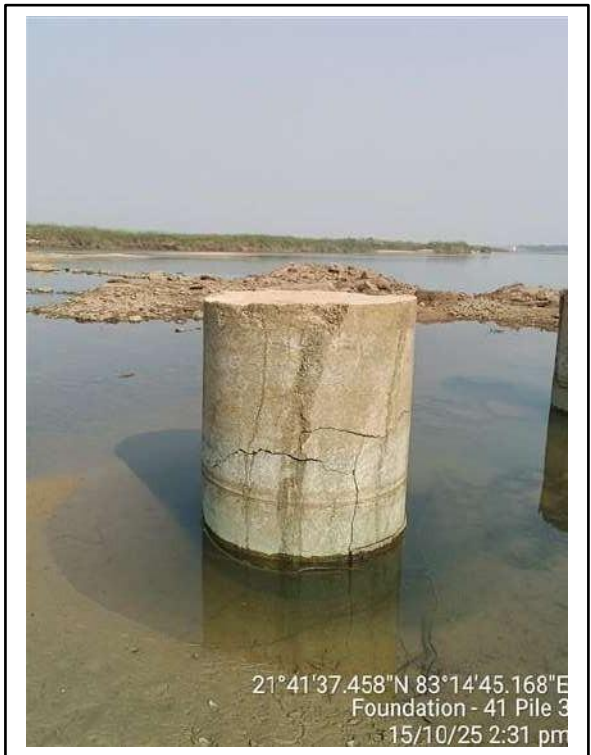
Picture-3 & 4: Cracks on pile concrete.

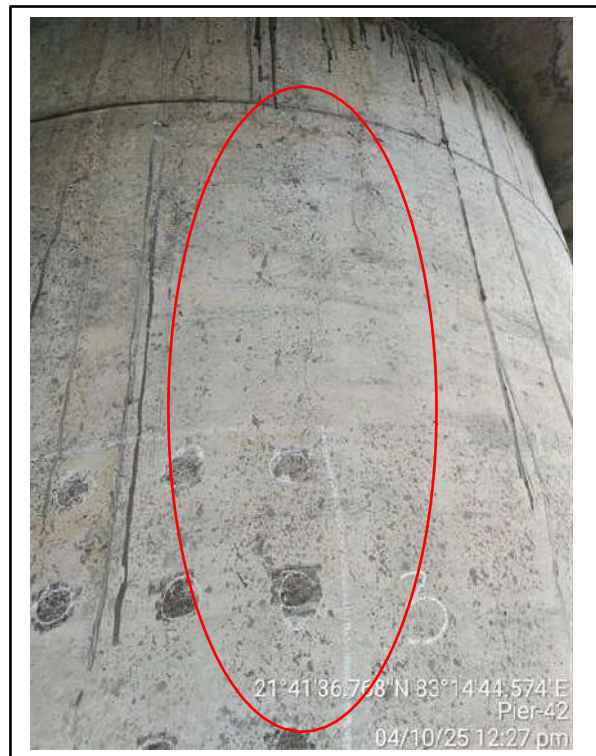
Picture-2: Cracks on pier surface.

S.NO	LOCATION	CRACK WIDTH IN MM
1	Pier -42	Pier 0.1 to 0.8
2		Pier Cap 0.1 to 0.4

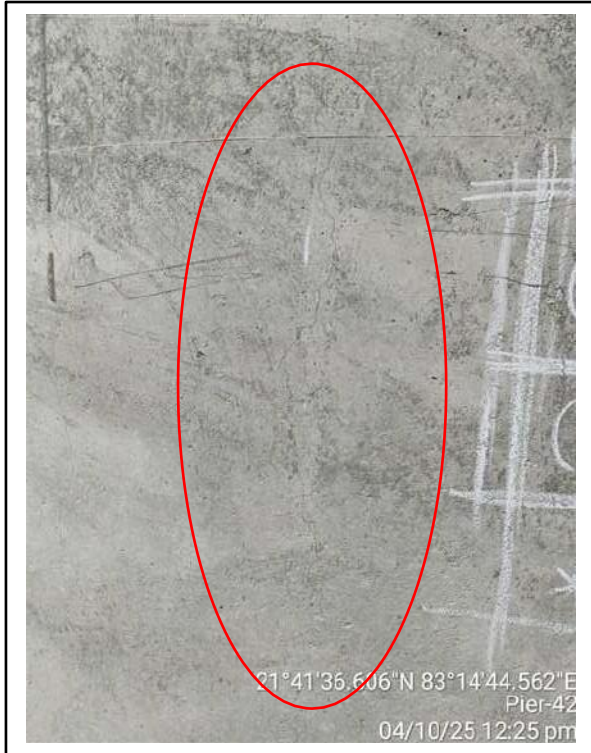
Picture-3: Cracks on pier surface.

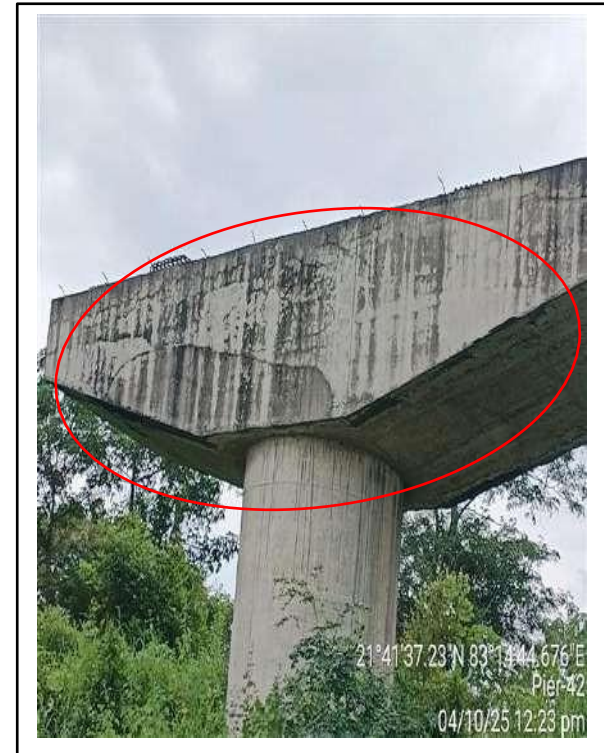
Picture-4: Minor cracks & leaching on pier cap

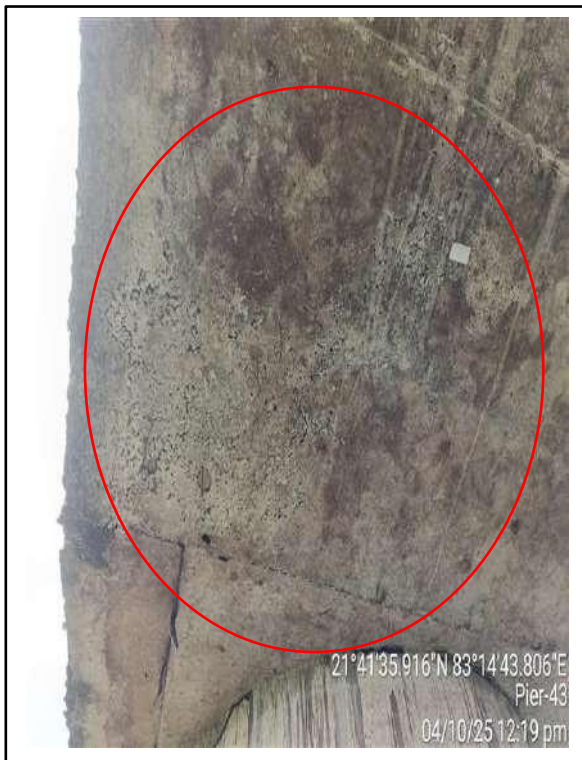
Element Name	Observation	Location of Distress
<b>Pier - 43</b>		
Pier cap	MC	Minor cracks observed on pier cap surface at all faces along the main reinforcement direction.
	L	Leaching observed on pier cap top and all side faces at various locations.
	R	Rust observed on pedestal reinforcement over pier cap.
Pier	C	Vertical cracks observed on pier surface from bottom to top level at various locations.
	MC	Minor discontinues horizontal cracks observed on pier surface at various locations.

Picture-3: Honeycombs on pier cap bottom face.

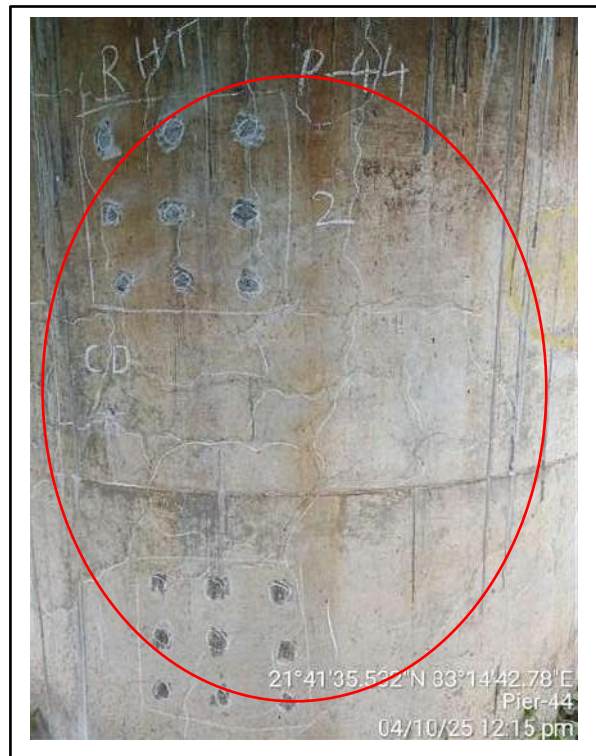
Picture-2: Cracks on pier surface.

S.NO	LOCATION		CRACK WIDTH IN MM
1	Pier -44	Pier	0.2 to 1.5
2		Pier Cap	0.1 to 0.4

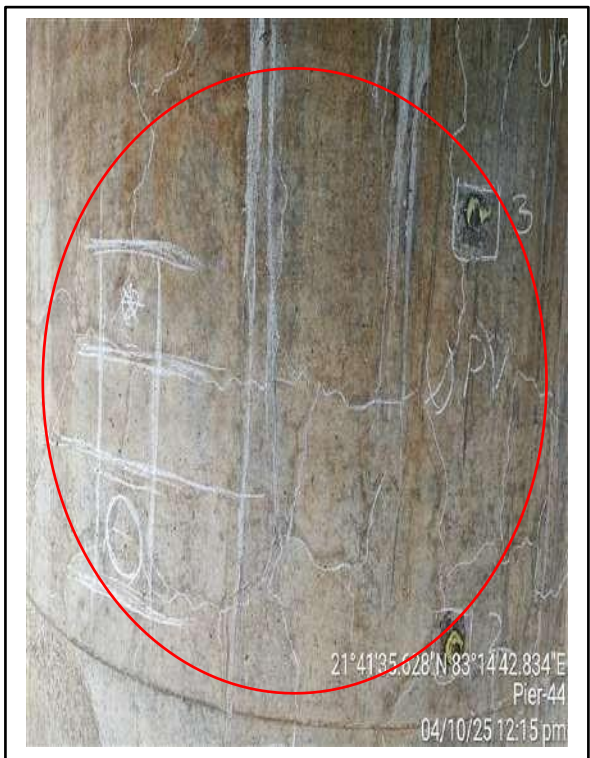
Picture-3: Cracks on pier surface.

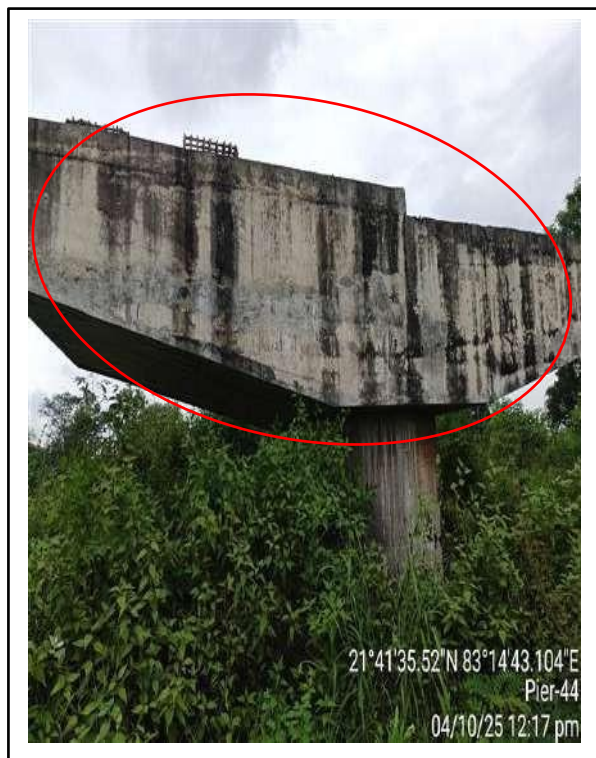
Picture-4: Leaching & minor cracks on cap.

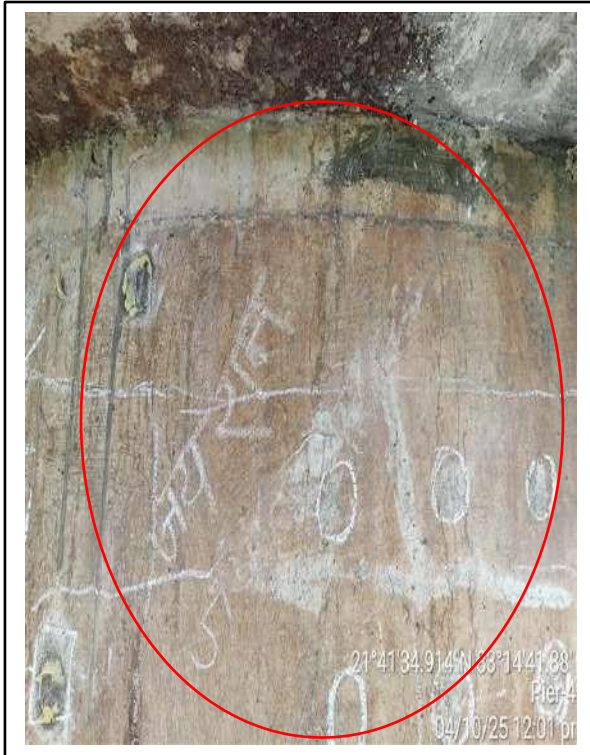
Picture-3: Cracks on pier surface.

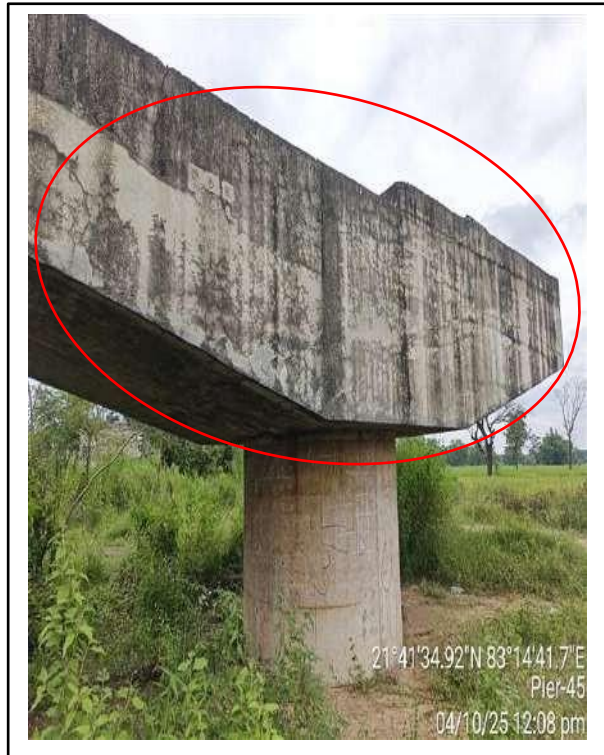
Picture-4: Leaching & minor cracks on cap

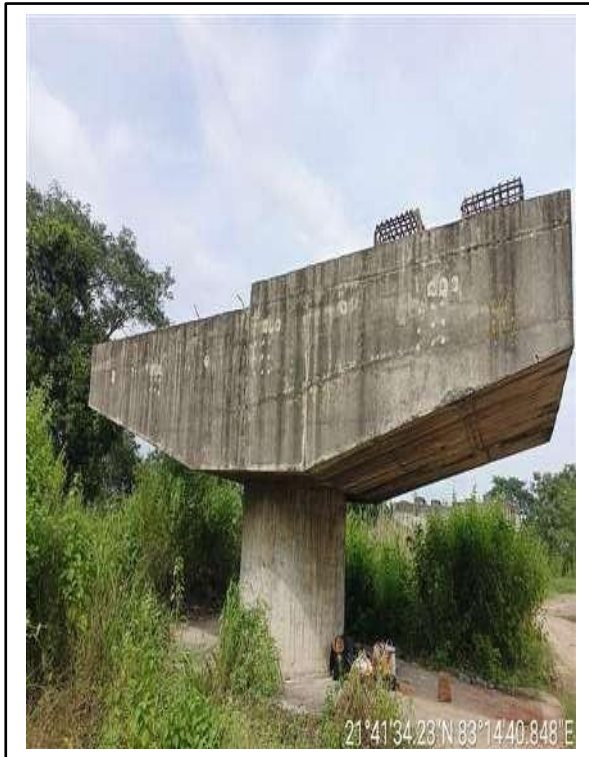
Picture-1: Pier - 46 view

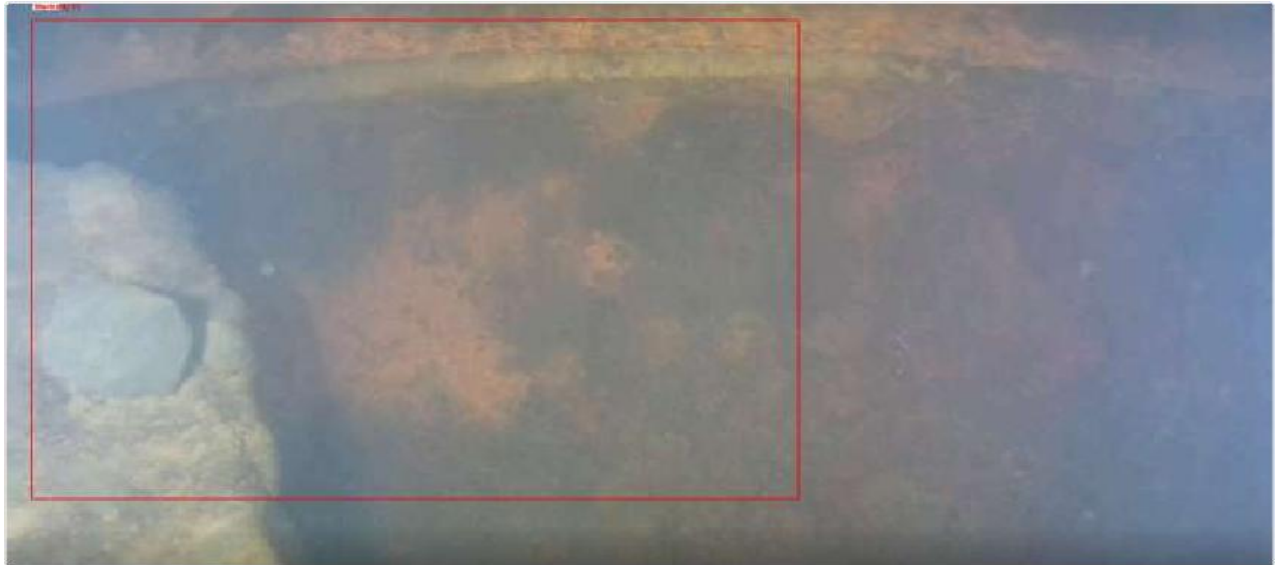
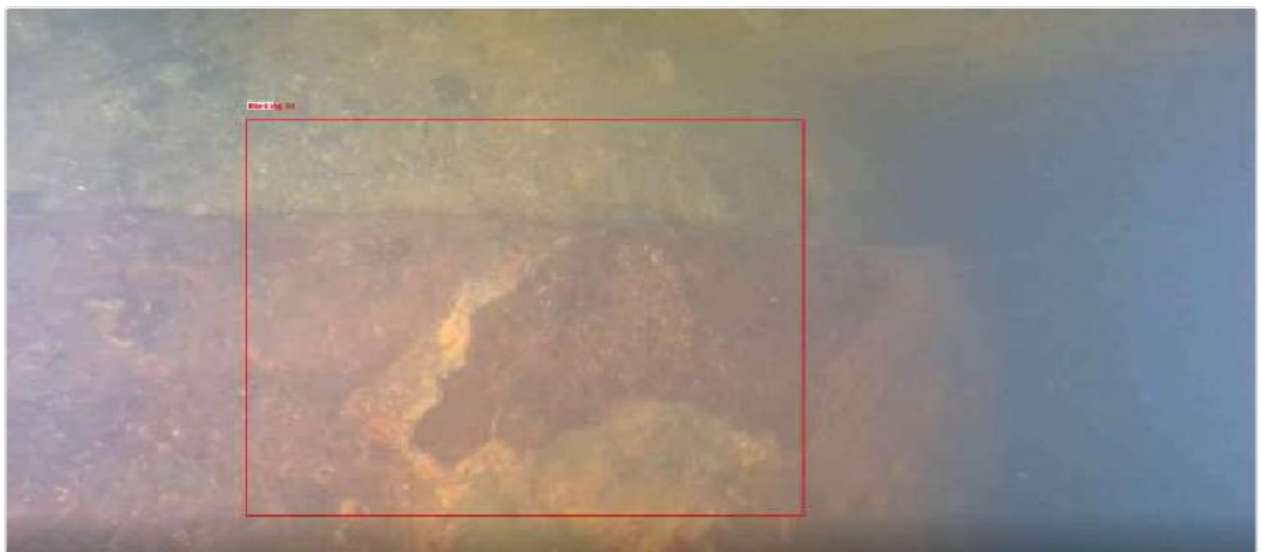
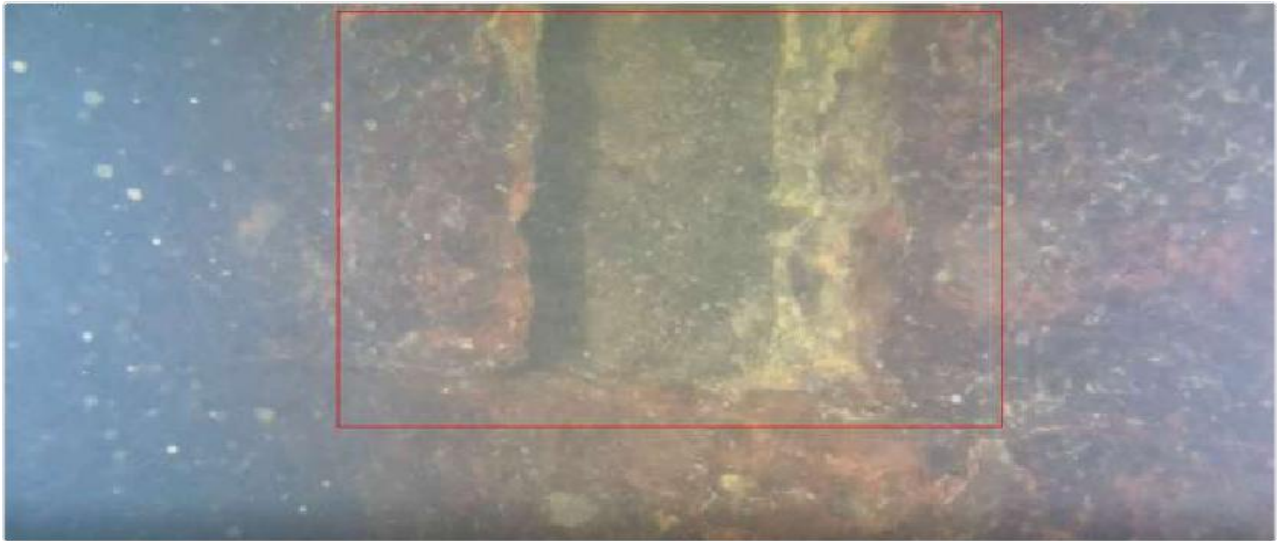
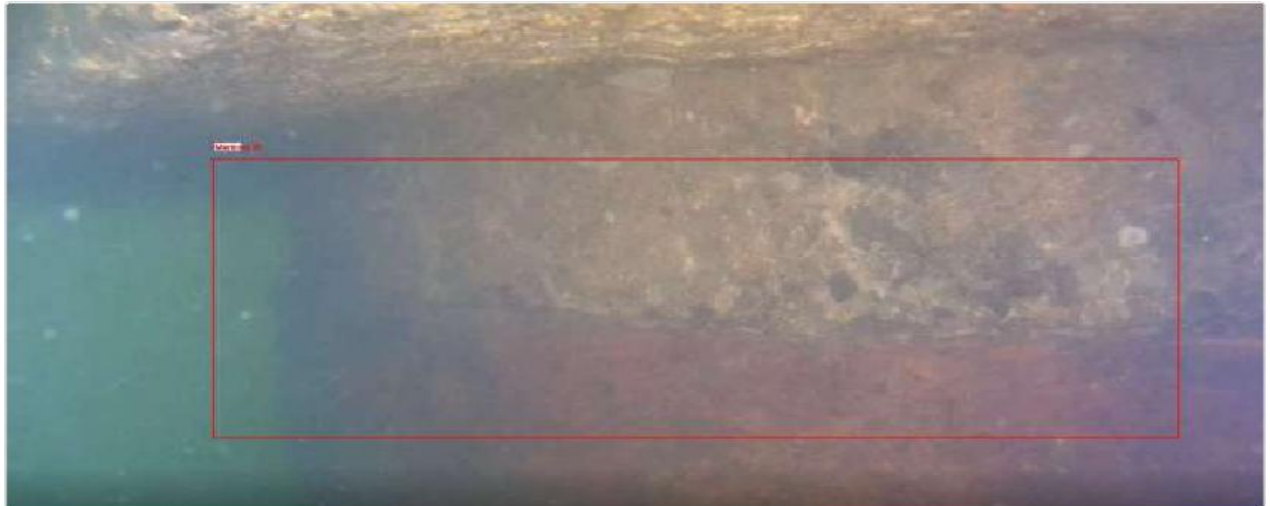
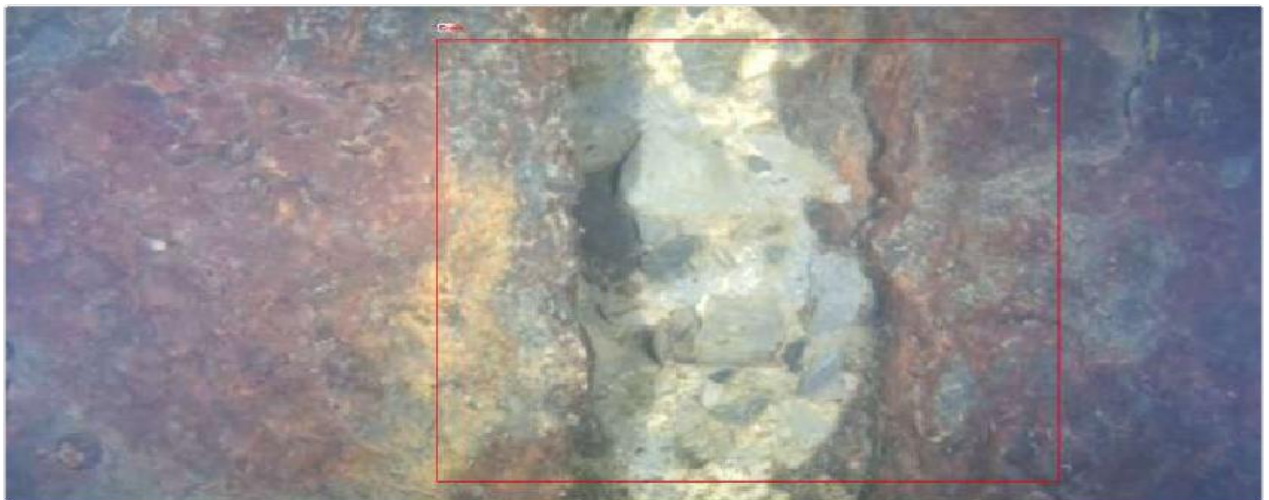
1. For all piles under the water, the steel liner is observed after 10cm offset from pile cap bottom level.
2. Corrosion observed on complete steel liners at various locations for all piles under the water.
3. Section losses observed on pile liners at various locations inside of the water.
4. Liner openings observed at various locations for piles.
5. Heavy sedimental debris observed near and around the all piles inside of the water.

**Corrosion on Liners**

1. The combination of open lining, missing sections and active corrosion suggests advanced degradation of the protective layer.
2. Risk of ongoing section loss of the lining, ingress of aggressive agents and potential acceleration of concrete and reinforcement deterioration is high.
3. Directly exposed concrete and corroded lining raise the likelihood of deeper material loss and possible reinforcement corrosion in the long term.
4. Missing or eroded liners and repeated exposure concrete observations indicate significant deterioration of the protective system.

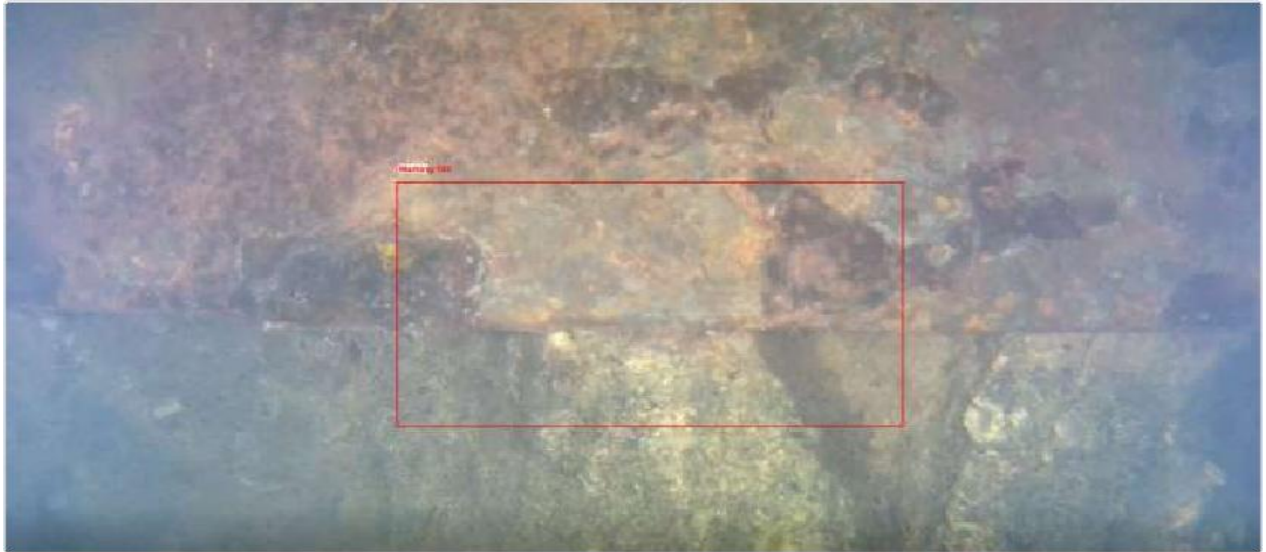
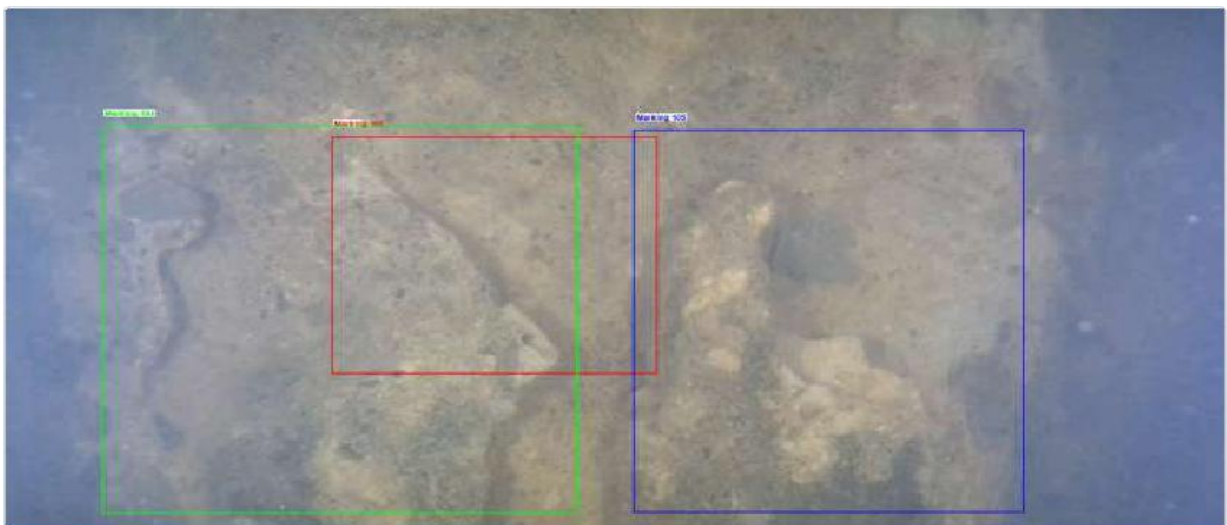
**Debris observed near and around the piles at bottom level.**
